INTERVALE ROAD

HISTORIC SITES & STRUCTURES SURVEY
 Individual Structure Survey Form

Riverside Farm

111 Intervale Road

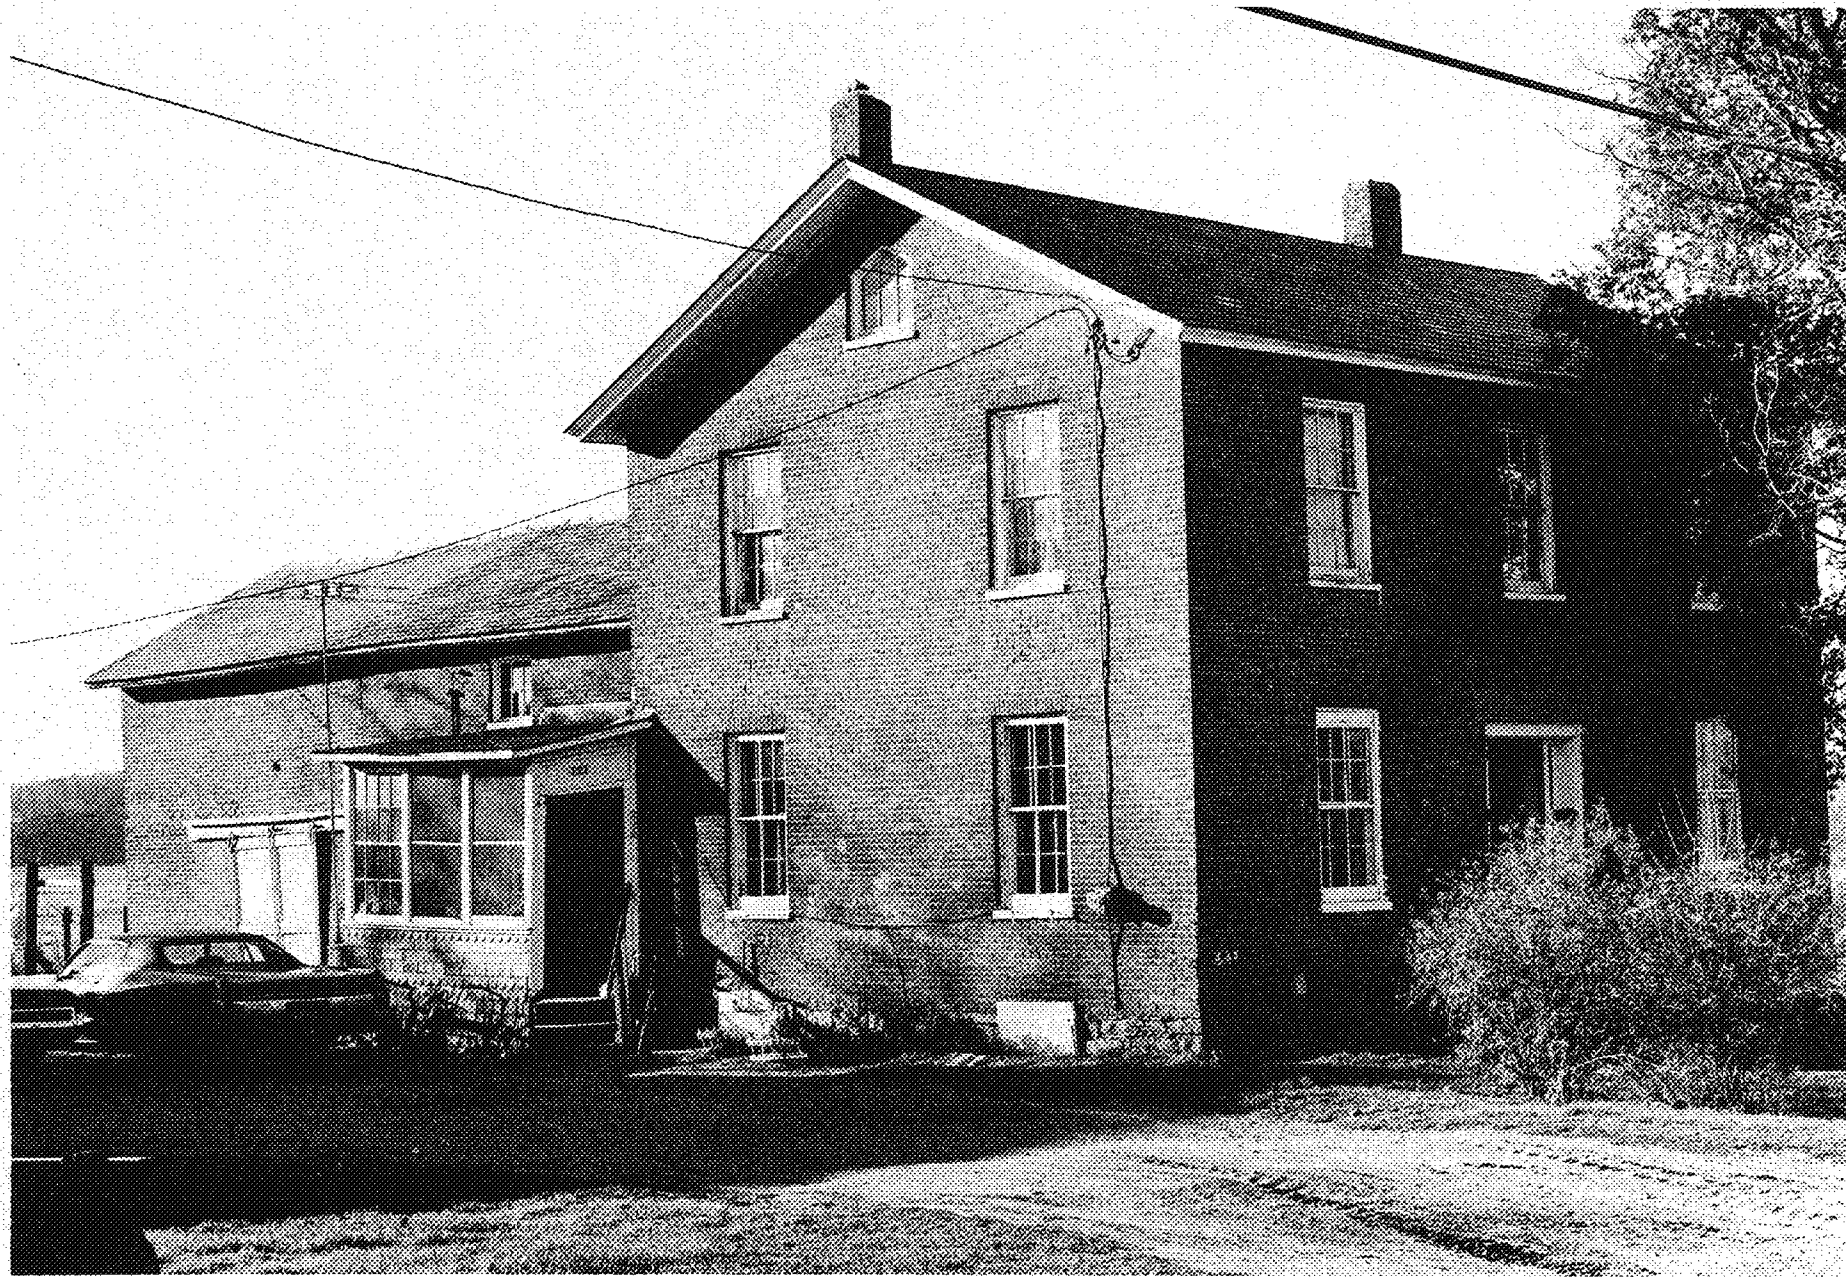
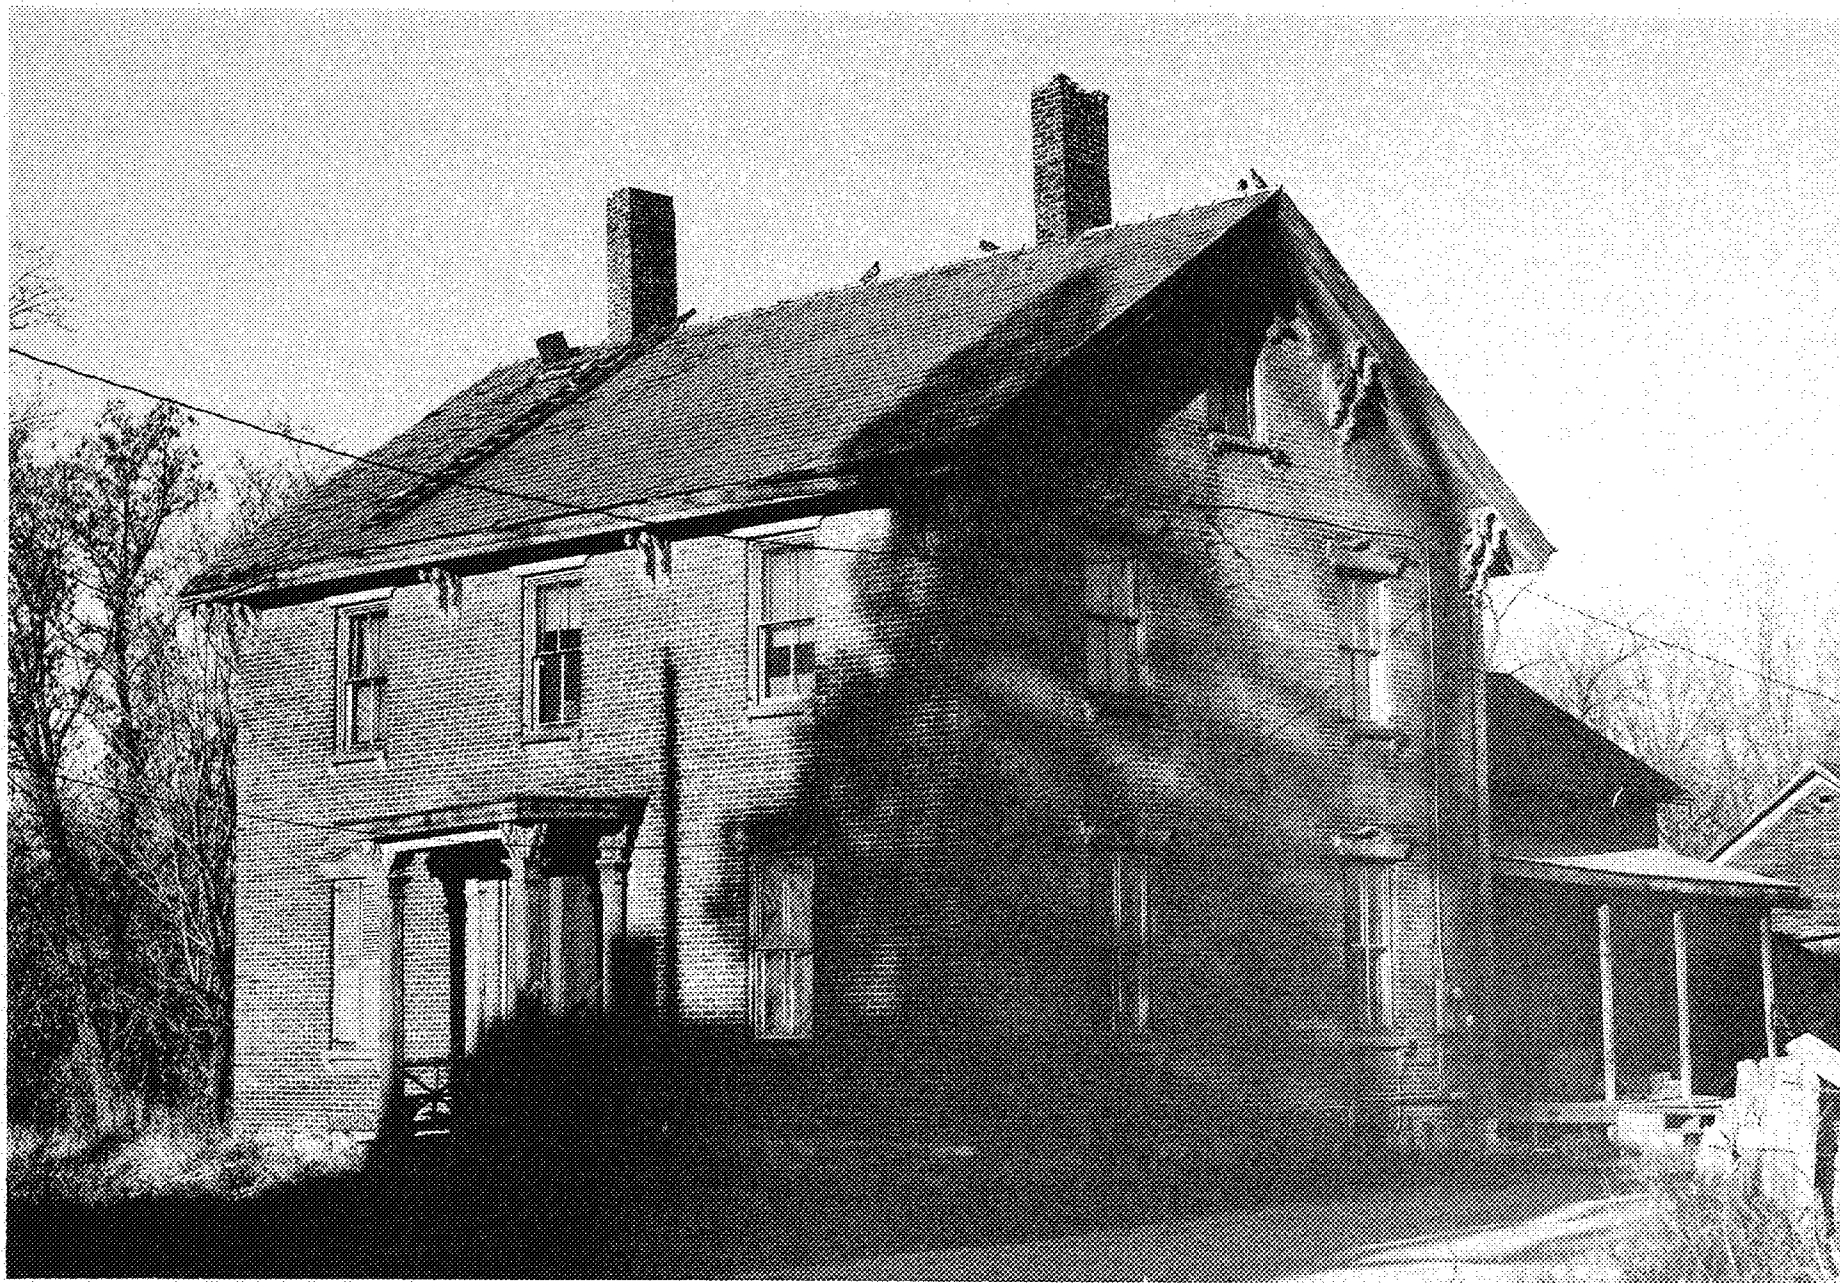
TomCar, Burlington Elec.
Dept., called 5/13/83
to let us know that
they were tearing down
the addition (garage)
at west end of house.
This addition was built
in 1930's, according to
Rena Calkins. It's
falling down & cost of
repair is excessive, so have
decided to demo it.
