PLATTSBURG AVENUE

HISTORIC SITES & STRUCTURES SURVEY
 Individual Structure Survey Form

Millington Residence
224 Plattsburgh Avenue
Burlington
Chittenden County
Vermont

INDEX TO PHOTOGRAPHS

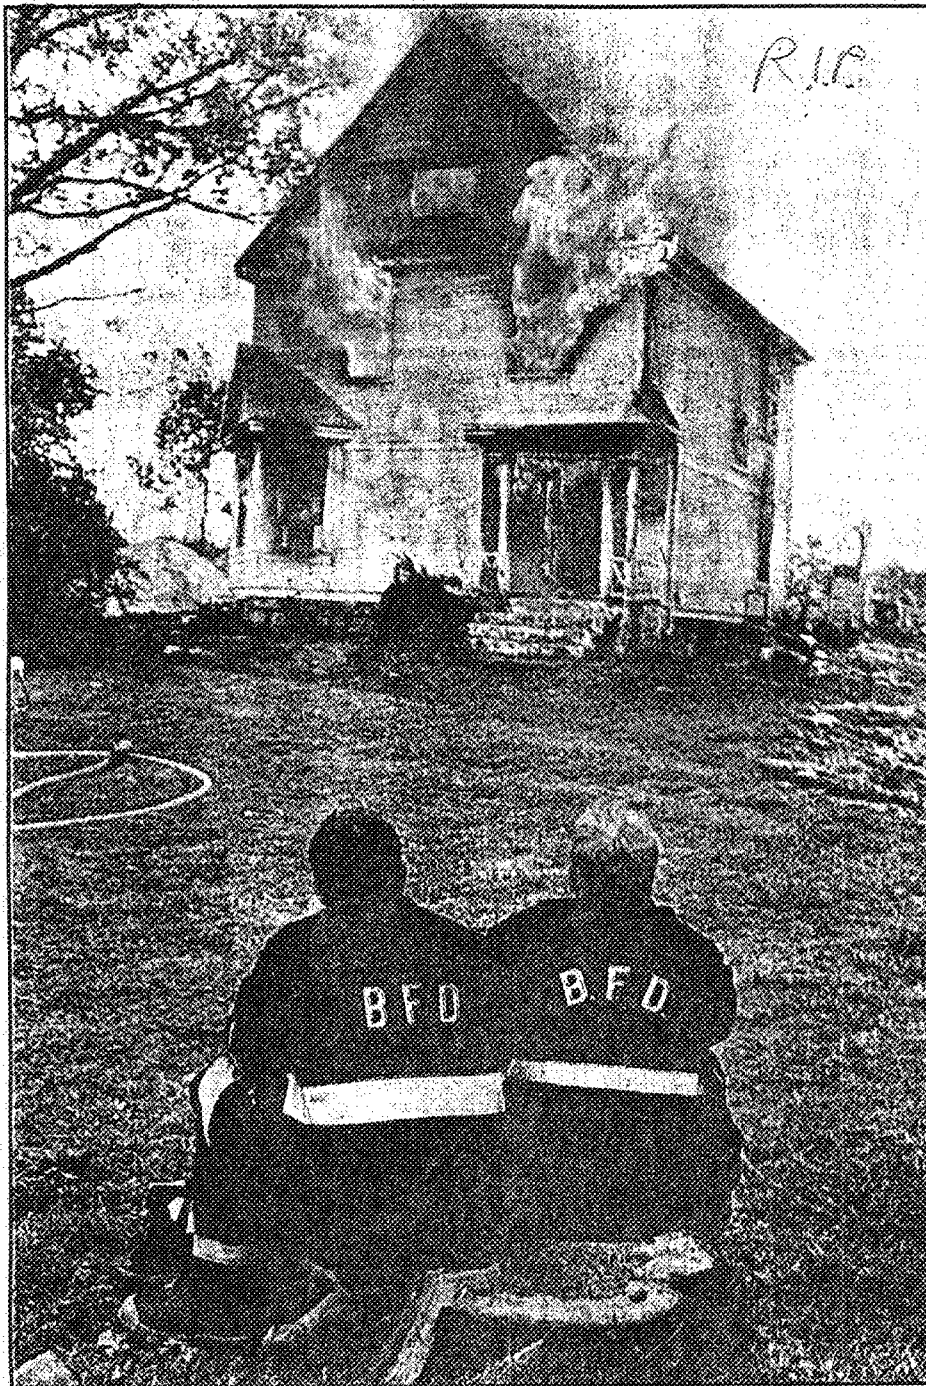
Let it burn

Burlington firefighters Rob Mullen and Alan Bright watch Tuesday morning as fire roars through a house on Plattsburg Avenue. The Burlington Fire Department had been using the house for practice fires last week and let the final fire burn down the structure.

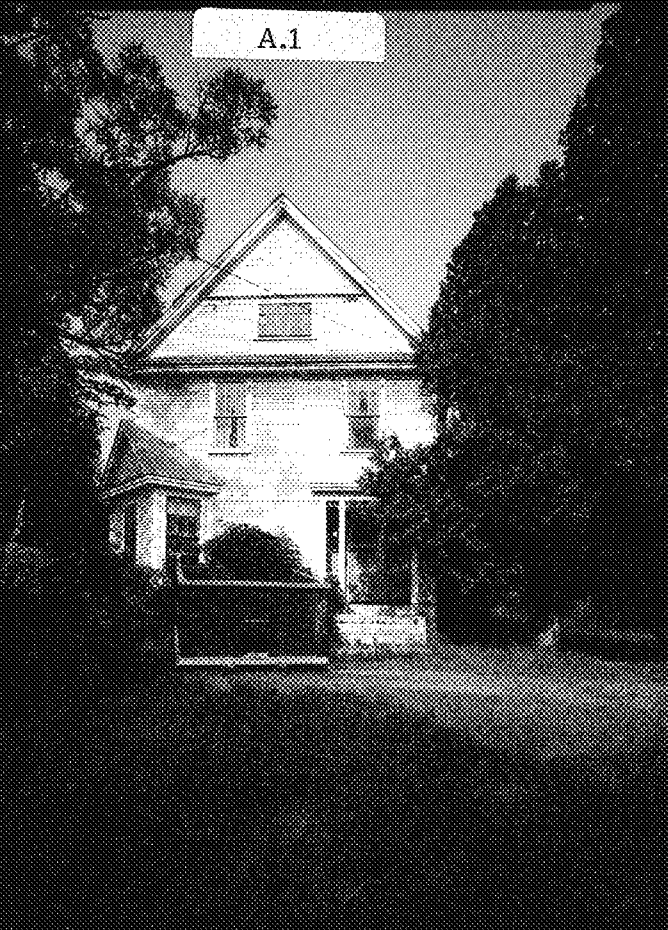
- A.1 - Front Elevation, House, View East
- A.2 - Front Corner, House, View Northeast
- A.3 - Side Elevation, Barn B, View East
- A.4 - Northeast Corner of House At Ell Connection, View Southwest

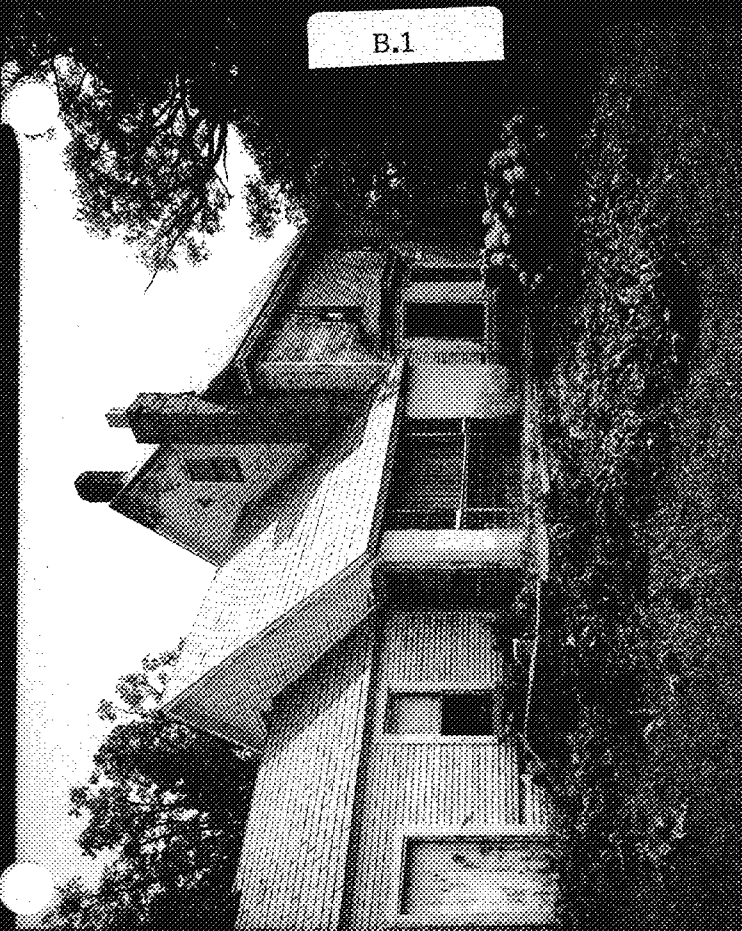
- B.1 - Southwest Corner of House, Ell, & Garage, View Northeast
- B.2 - Rear of Garage Addition, View East
- B.3 - Detail, Front Entry Doors
- B.4 - Overall Garage Addition, Ell, & House, View Northeast

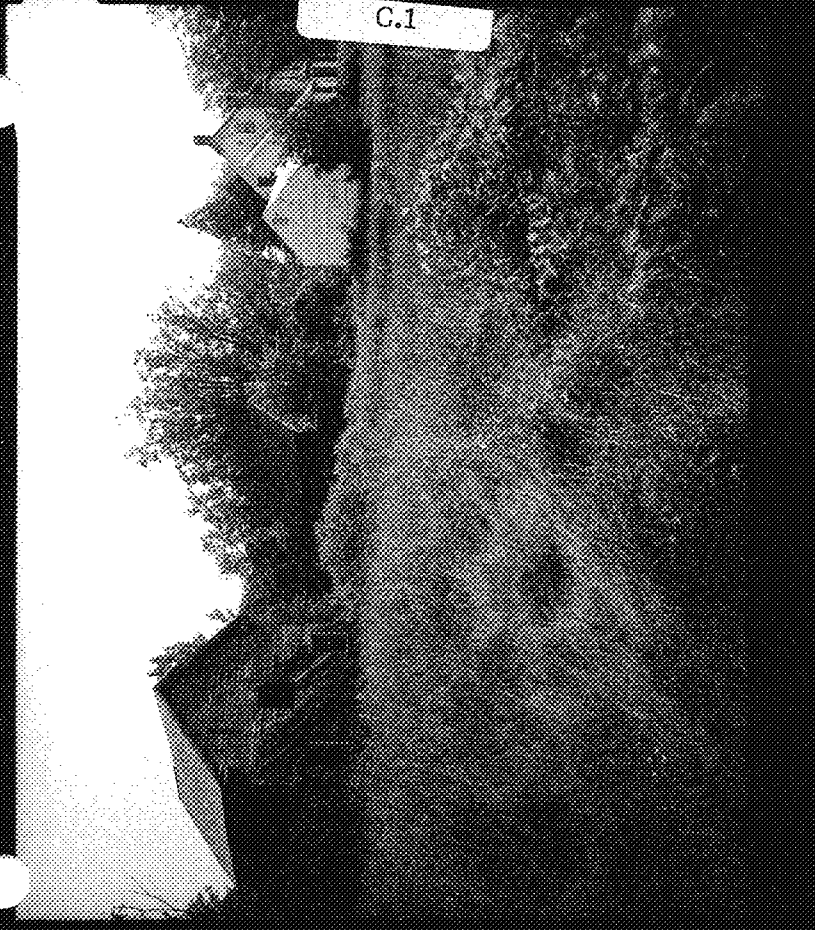
- C.1 - Overall Barn B, Barn A, House, View Northeast
- C.2 - Front Elevation Barn B, View North
- C.3 - Interior Barn A, View North
- C.4 - Garage Addition & Ell of House, View South

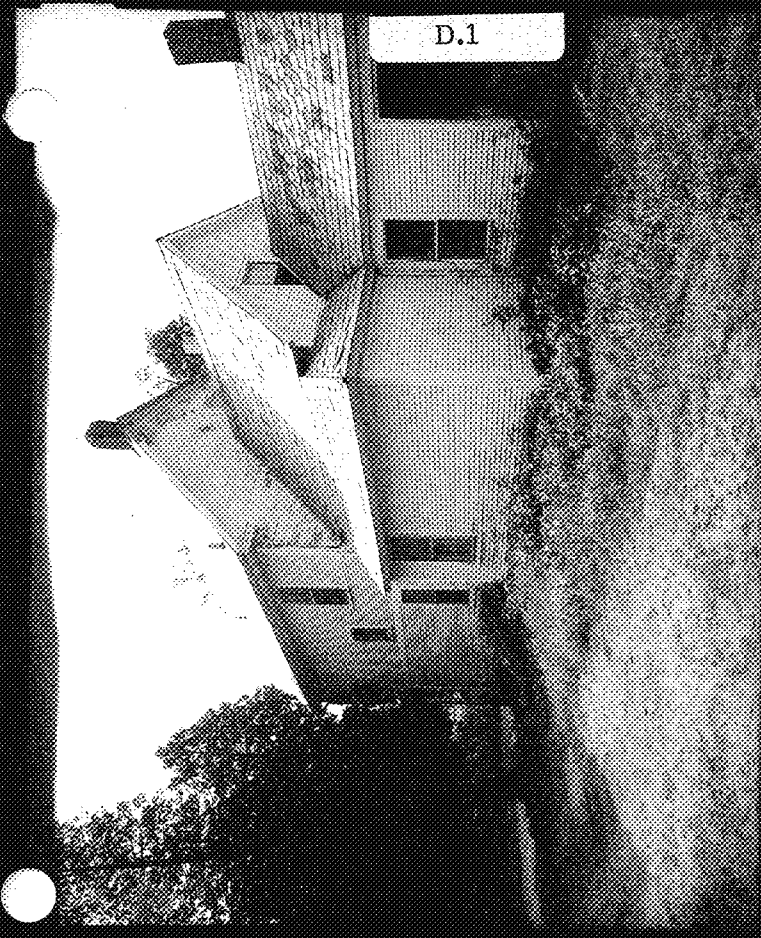
- D.1 - Northwest Corner of House, Ell, & Garage Addition, View Southeast
- D.2 - Front Elevation Barn C, View South
- D.3 - Interior Barn C, View South
- D.4 - Northeast Corner Barn C, View Southwest

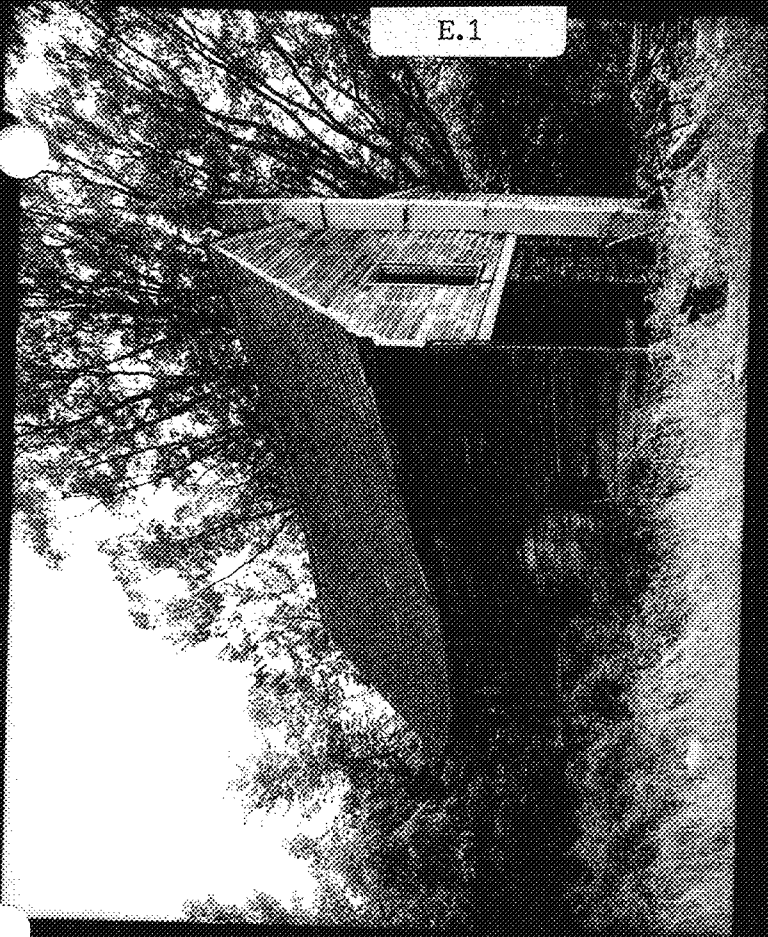
- E.1 - Southwest Corner Barn A, View Northeast
- E.2 - Front Elevation Barn A, View North
- E.3 - Southeast Corner Barn A, View Northwest
- E.4 - Overall Front of House With Landscaping, View Northwest

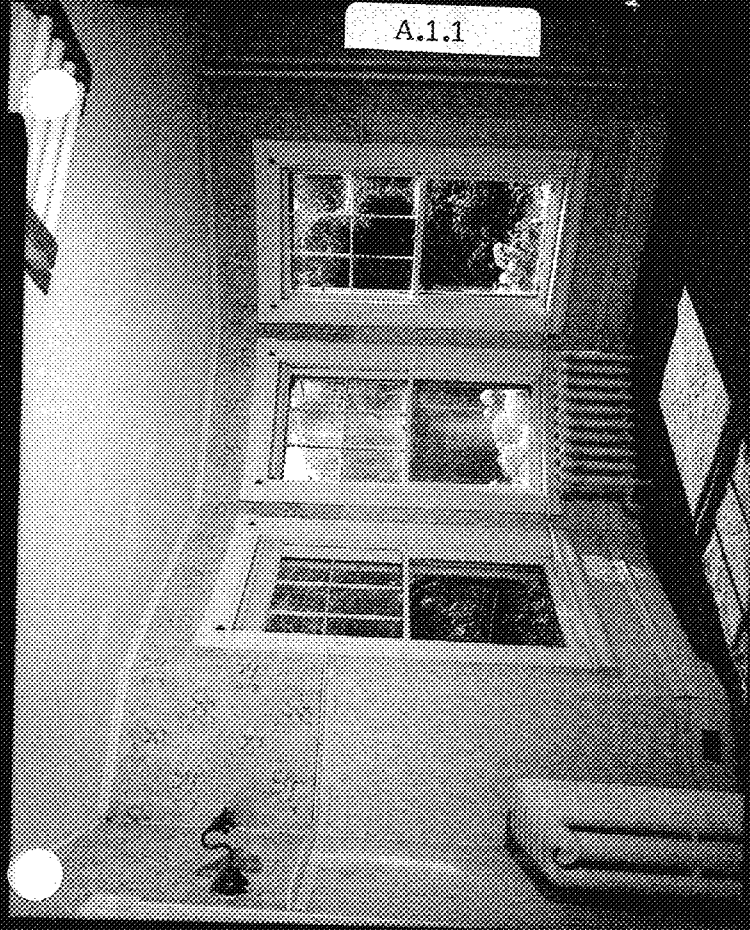
- A.1.1 - First Floor, Dining Room, View South
- A.1.2 - First Floor, Living Room, View Southeast
- A.1.3 - Second Floor, Southeast Bedroom
- A.1.4 - First Floor, Kitchen, View West

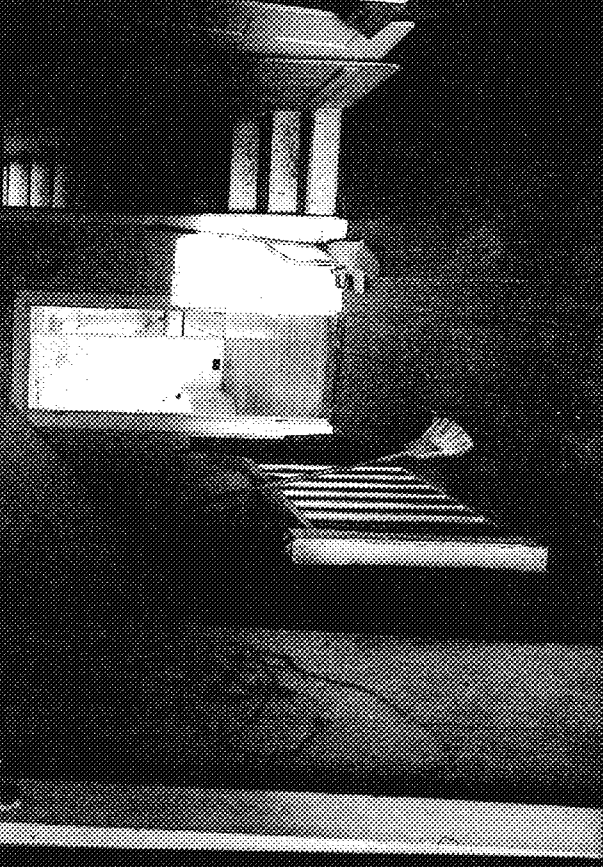
- C.1.1 - Second Floor, Ell & Stair to Attic, & Stair to Kitchen, View East
- C.1.2 - First Floor, Garage Addition, View West
- C.1.3 - First Floor, Living Room, View Northwest
- C.1.4 - Interior Barn B, View West
