SOUTH UNION STREET

## South Union St. -- Statement of Significance

HISTORIC SITES & STRUCTURES SURVEY  
 Individual Structure Survey Form

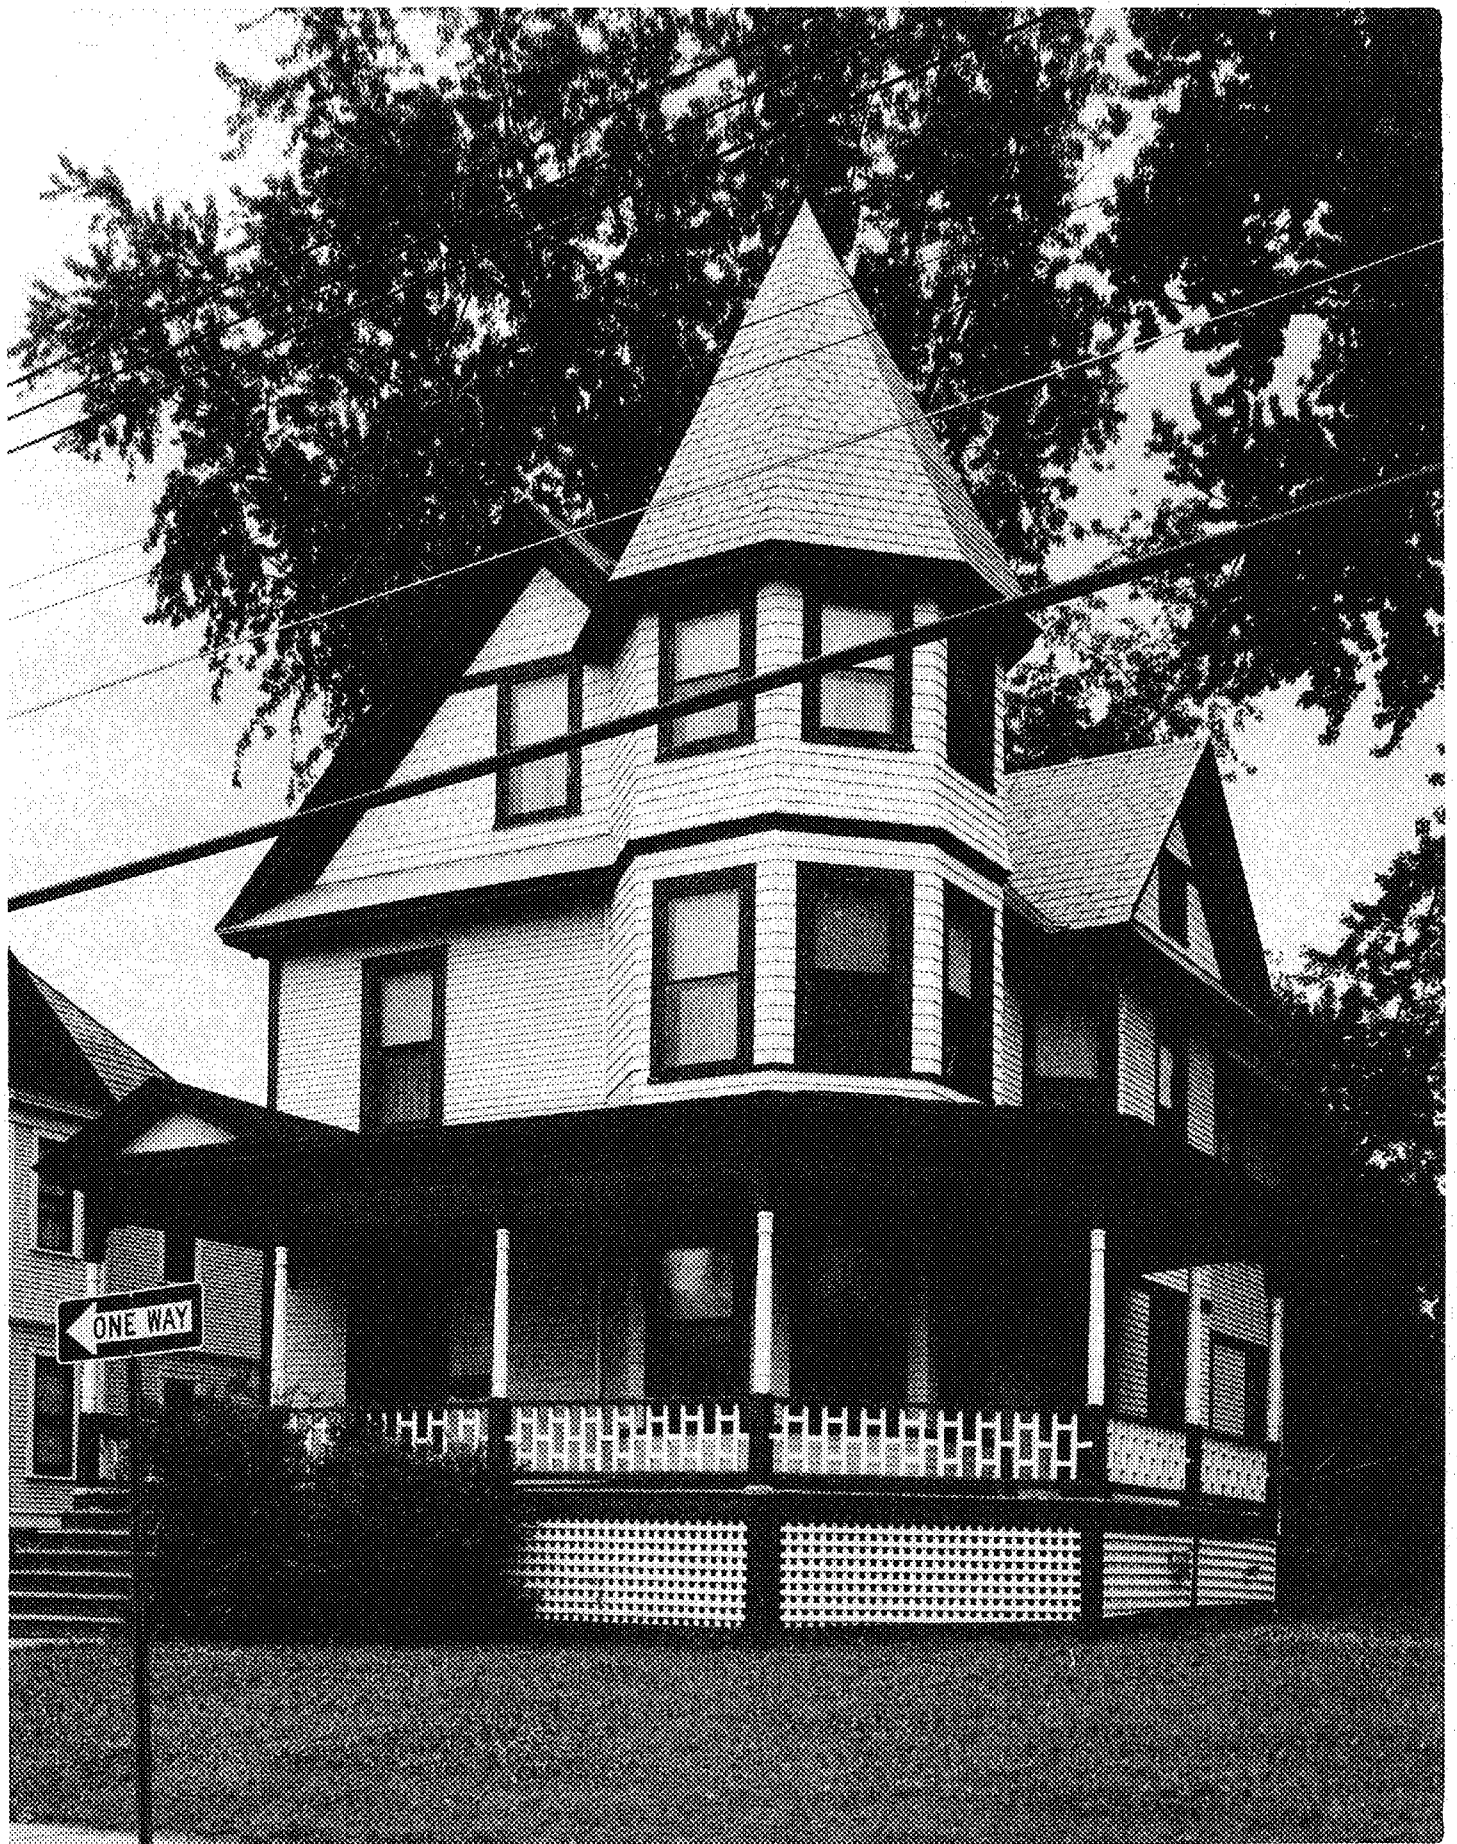
88 So. Union

Massing - irregular 1/2 cross-gable plan. Polygonal tower on SW corner which is 3 stories with a polygonal cap. Front porch.  
Fenestration - 1/1 sash windows with simple trebled surrounds. Stained glass window in entry, on north elevation.  
Cornice - exposed scroll cut rafter tails beneath eaves and pent roofs. Front and wrap around side porch around tower, supported by turned columns and scroll cut brackets. Clapboard flat surfaces - shingled gable ends and tower sawtooth cut shingle ends. Wooden water table band and band between floors.  
Foundation - black mortar joints with white scored strips.

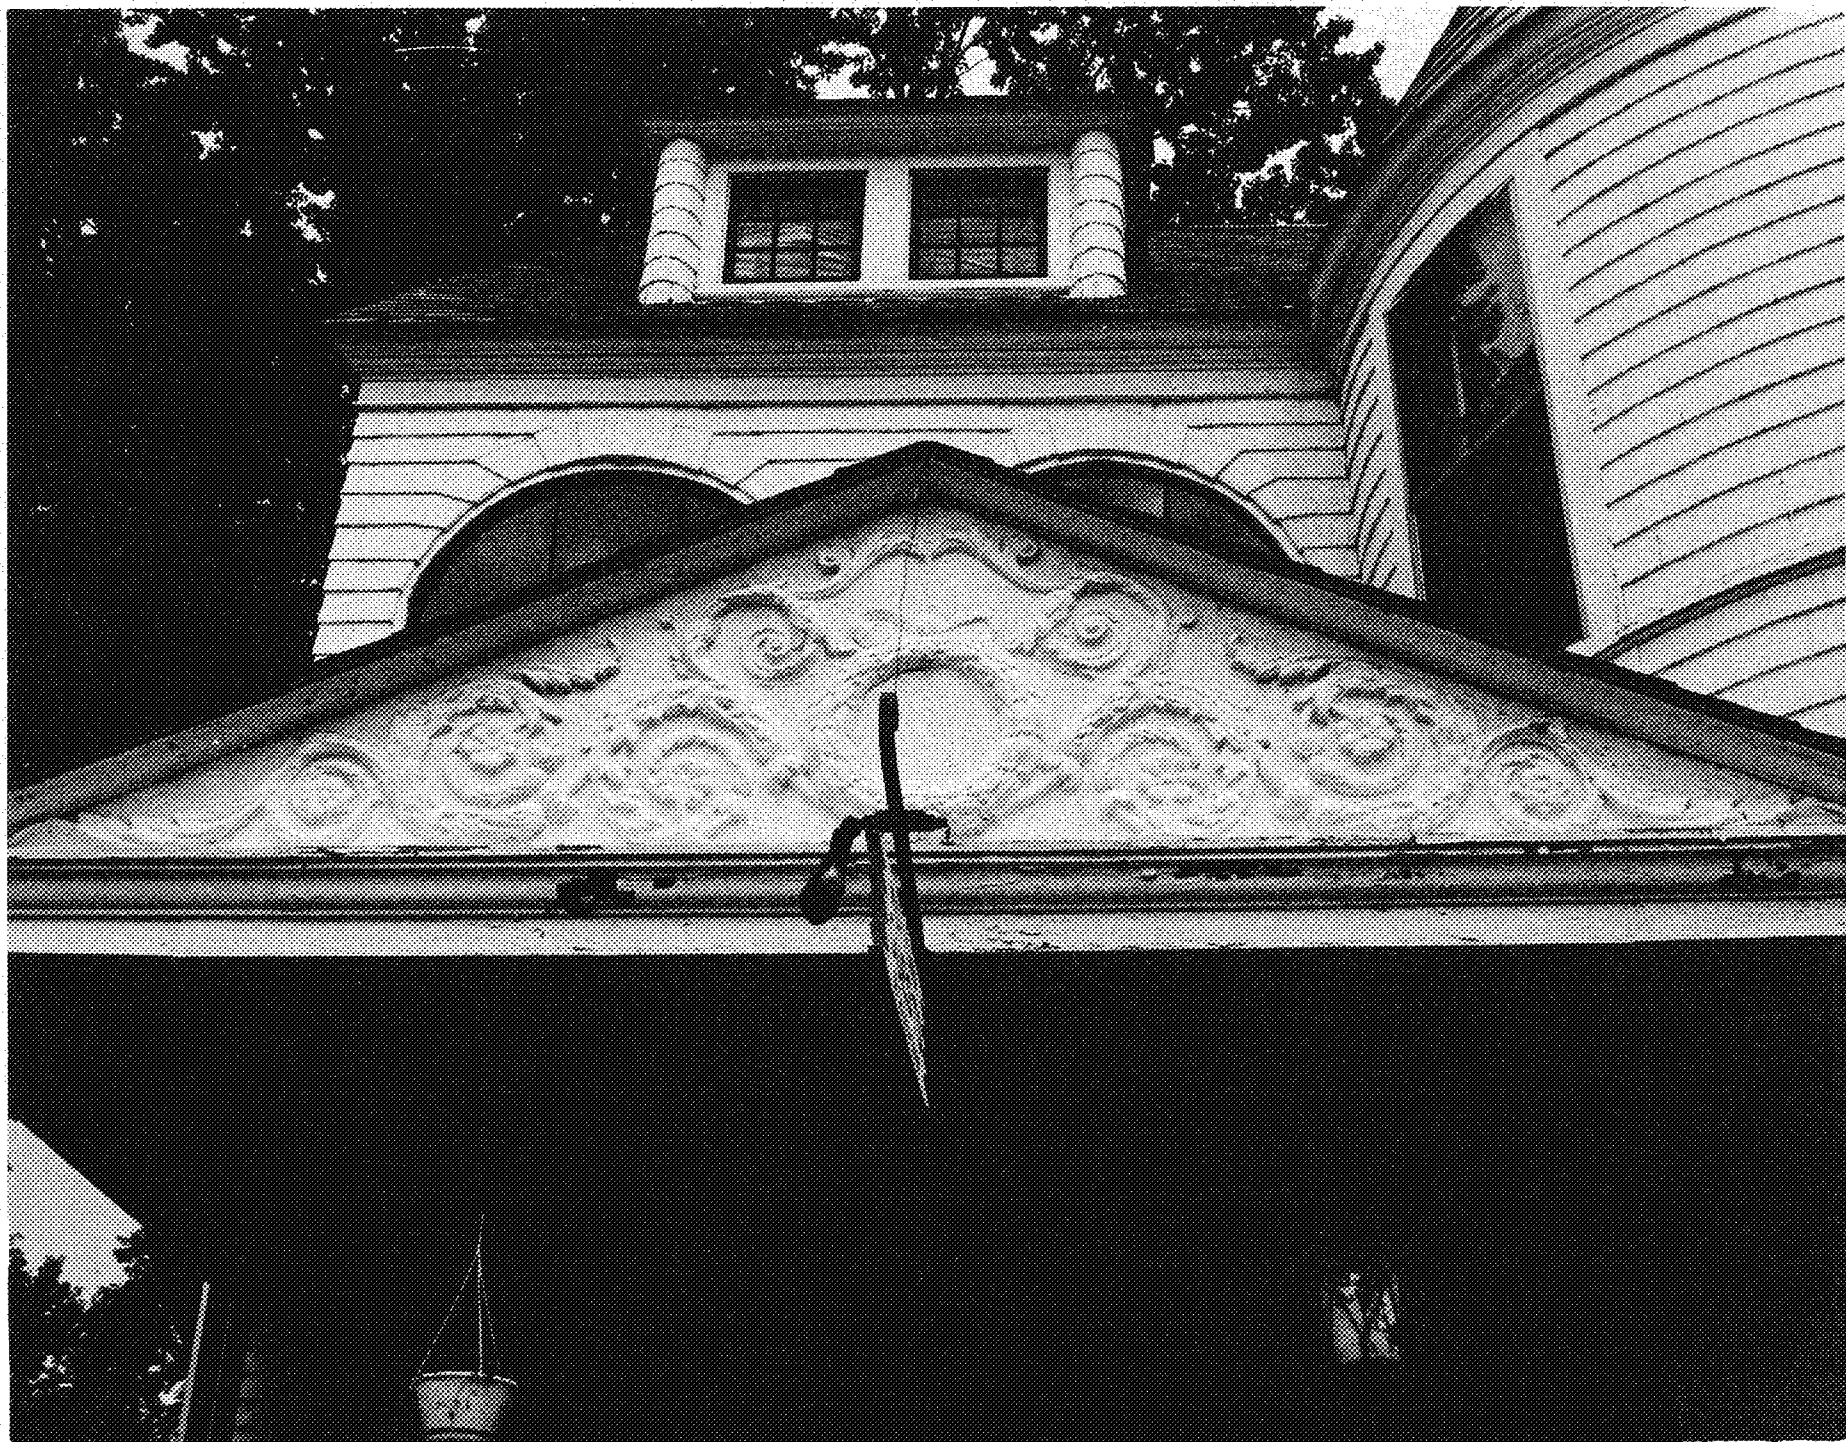
96 So. Union St

Penetration - 1/1 curved sash windows on tower and circular bay. Oval stained glass window at 2nd story south elevation. Stained glass rectangular window next to entrance 1st story. 9/1 sash windows in third story. Round headed arched windows on 2nd story facade.
