# WILSON STREET Burlington

Surveyor: Karen Czaikowski

Date: August 1983

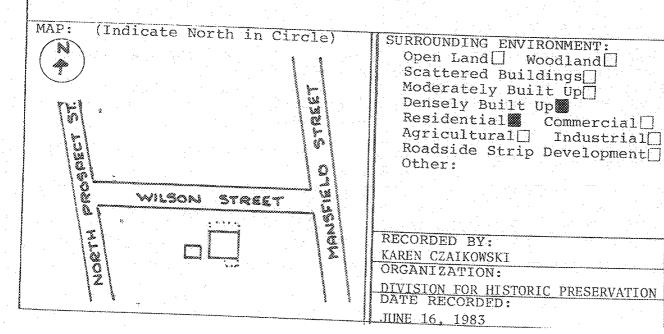
Two and one half story, Four-Square house with corner boards and water table first story clapboard with frieze and projecting box cornice. Center hip roof dormer with projecting box cornice, cornerboards and 3/1 sash windows. Second story of shingles. Front porch with battered columns rock-face concrete block piers, square-spindle railing, trellis skirt and pedimented cornice over entrance. Original front paneled door with large 3/4 length windows. Large tripartite window on first story with central pane, transom and 3/1 windows. 3/1 sash windows with lip molded lintels and plain surrounds.

Hip asphalt roof, clapboard single bay garage with altered overhead door (c.1925) (8'  $\times$  10').

Wilson Street began its suburban development in the late 1800's on Dodge family farmland. It continued to develop into the 1920's when this well-preserved structure was built. This is a good example of the shingled, clapboarded 4-square type, and is the best preserved example on Wilson Street

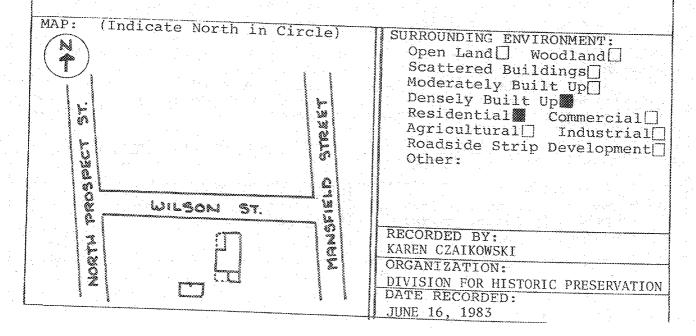
Two and one half story gable front L-plan house with west side ell entrance and altered porch (posts removed). Projecting box cornice, corner and water table. Full pedimented gable with decorative bands of shingles and 1/1 sash windows and plain surrounds with lip molded lintel. Rear enclosed porch with turned posts, shingled apron and rear 1 story shed. Interior center front chimney.

Gable end asphalt roof, clapboard garage with double track doors (c.1890) (14' x 12').

This well-preserved house, built on what was initially called Dodge Street after the Dodge family farm land, exemplifies the rural development of eastern Burlington in the later 19th century. This typical "tri-gabled ell" dwelling, seen often in Burlington, is the only one on Wilson Street.
