CHERRY STREET

HISTORIC SITES & STRUCTURES SURVEY
Individual Structure Survey Form

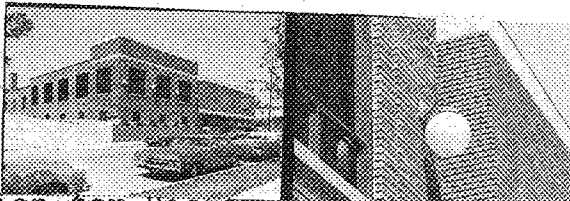
SURVEY NUMBER:
50-56 Cherry

Building facade divided in 3 bays by brick piers with ornamental brick-work in top section. Concrete is used ornamentally in these top sections of the piers as well as a string course band across the top section of the building. A extremely well done top section has been added to the building for air conditioning. It reflects the brick work of the original structure. 4 original lamp fixtures are attached to each of the 4 piers.

Built in 1929 to replace a smaller bakery. The firm of Girard Baking Co. replaced the Fraser Baking Co. at the same time, and survived the depression and WW II. McCaulliff's built the addition for their office supply business in 1972

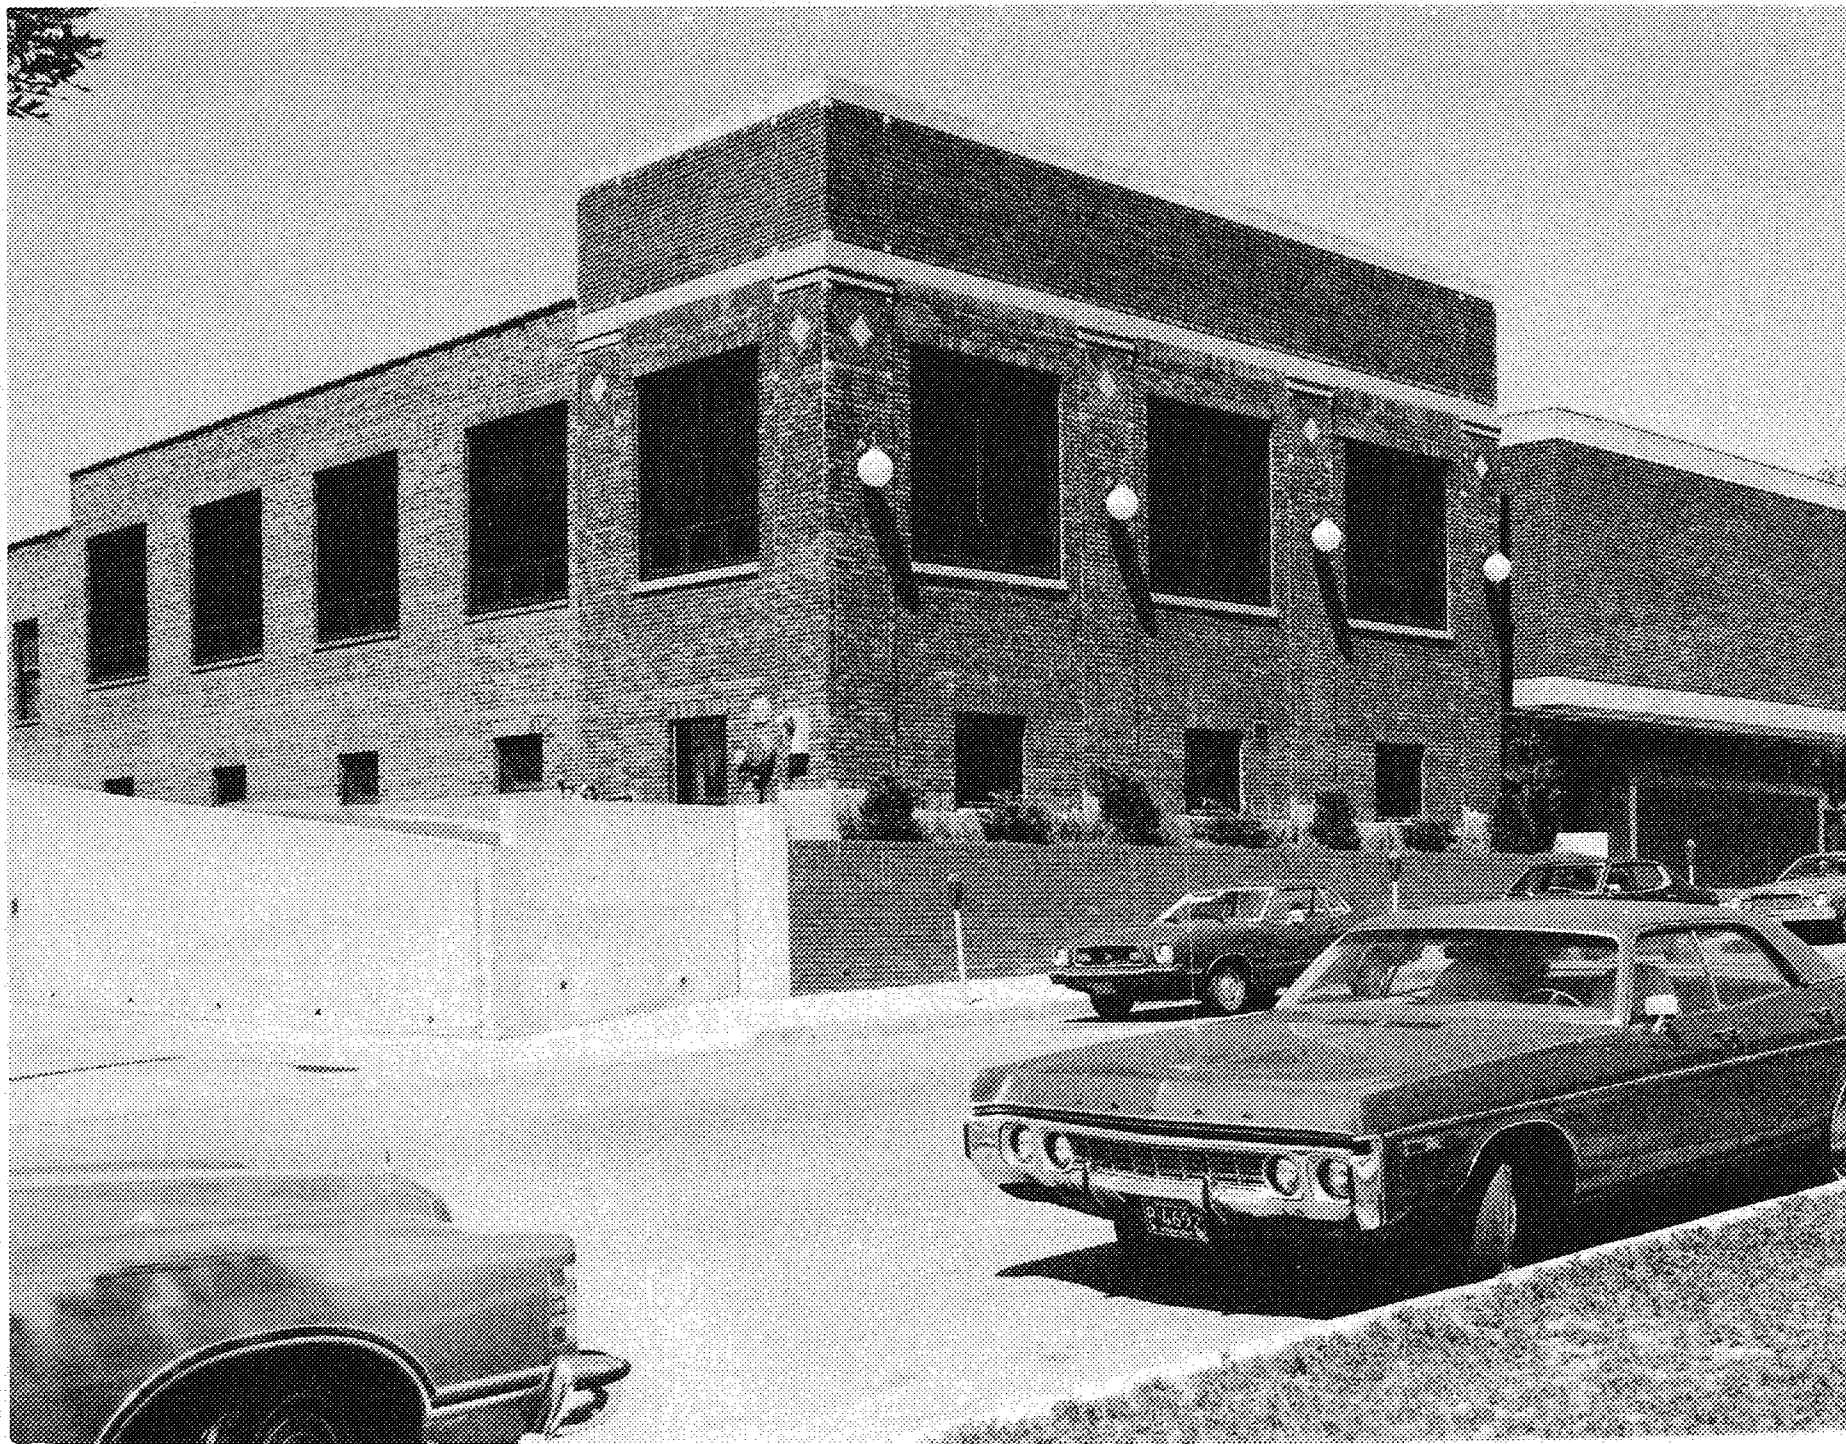
50 Cherry St
77A 193 CS

An addition has been added to the east elevation which is brick & concrete and reflects the massing, texture and rhythms of the original Bakery Bldgs.

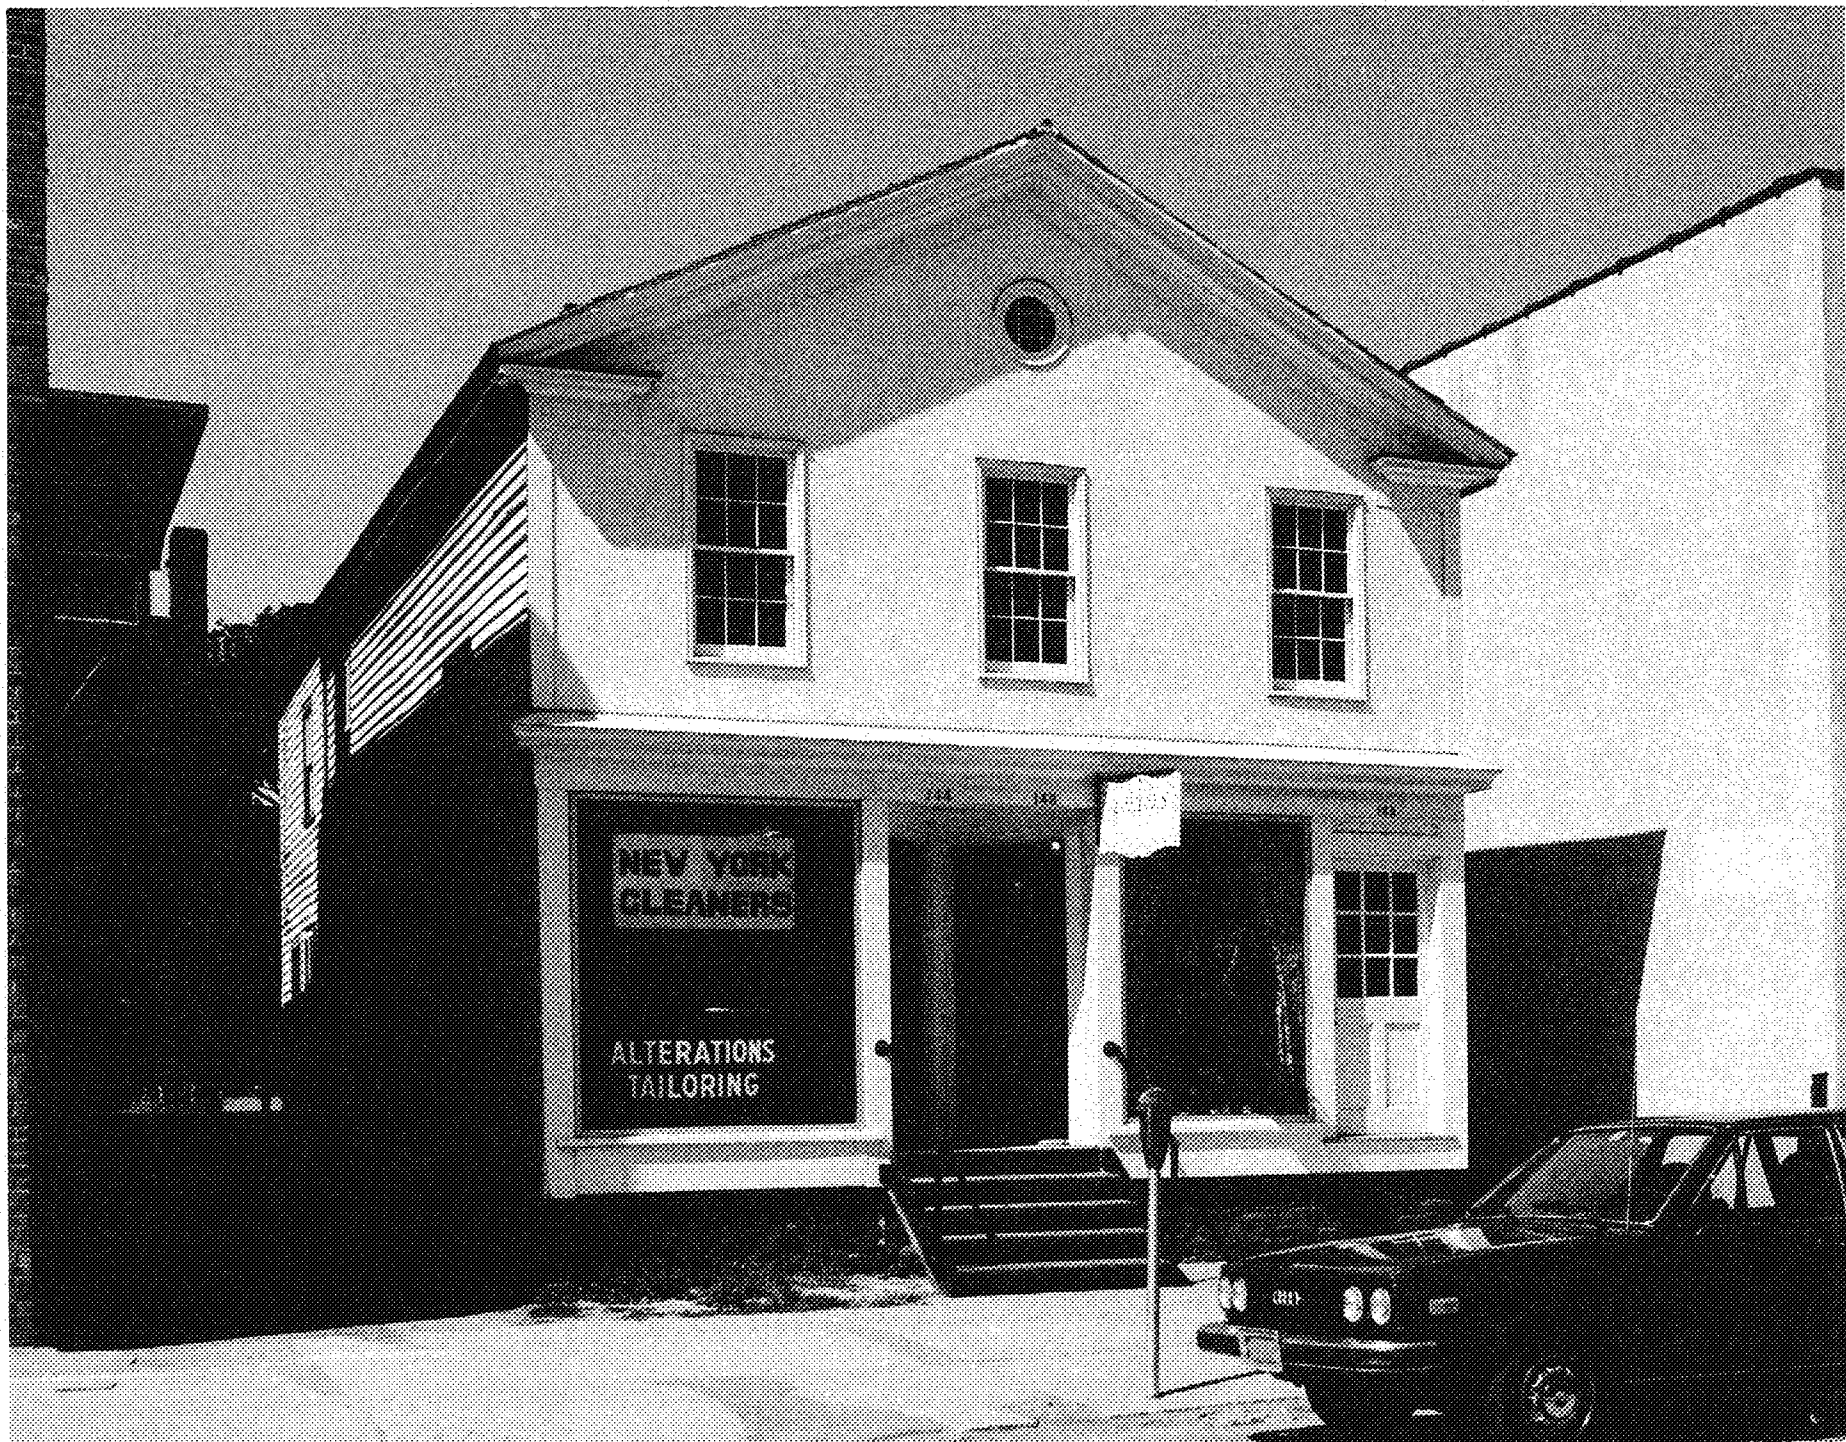
144-148 Cherry St.

6/6 sash windows, wood storefront cornice over recessed central, double entrance on diagonal and two plate glass windows above storefront cornice up to gable end is stuccoed. Circular glazed window in gable end.
