CHURCH STREET

History of Church St.

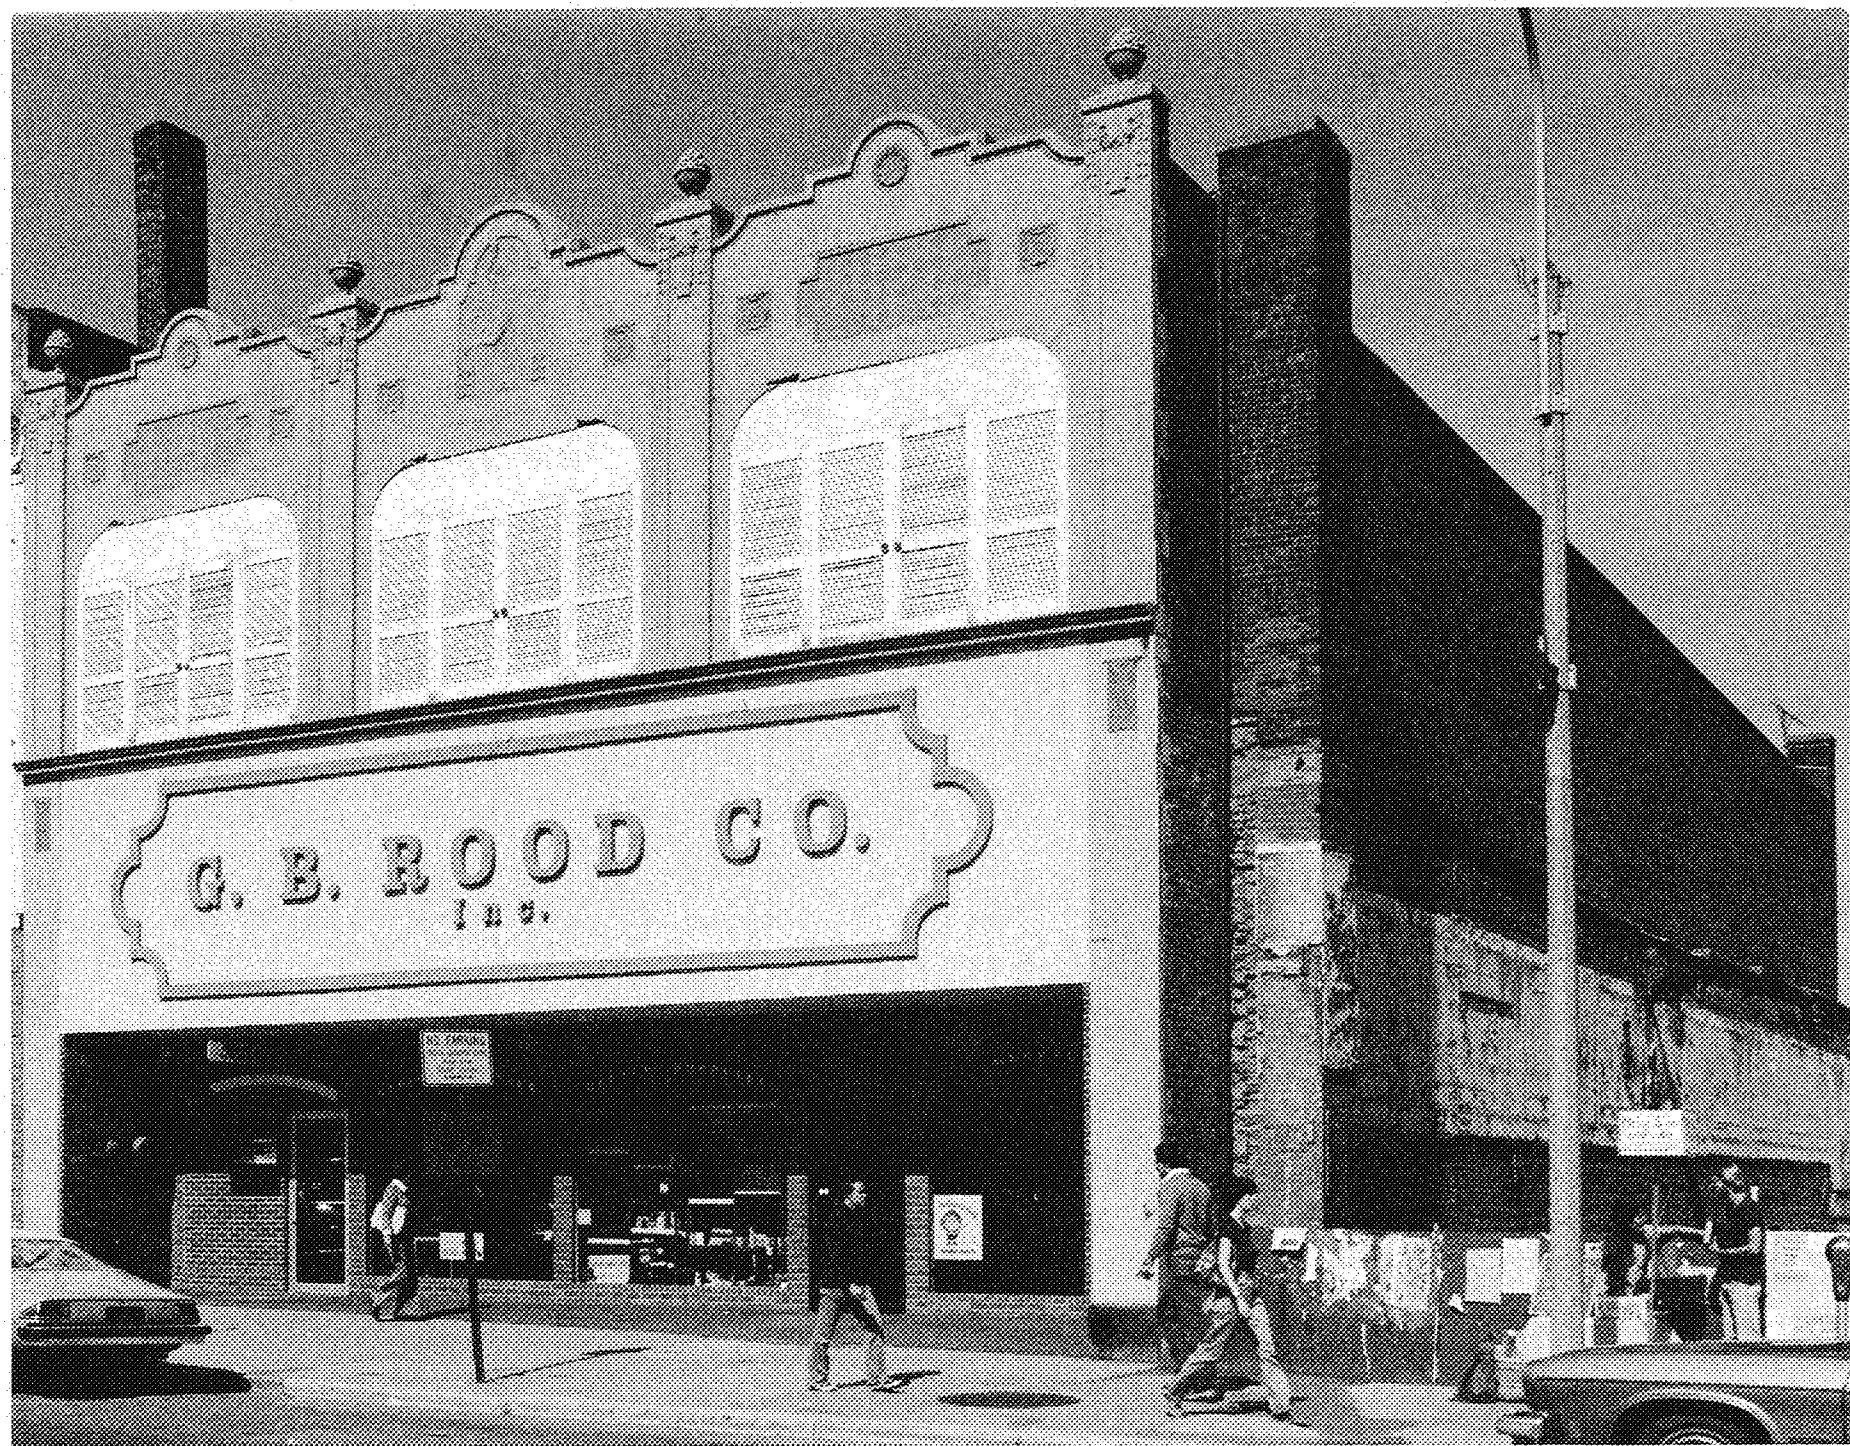
52 Church St

This concrete block structure is architecturally unique in Burlington. The Italianate styling and colorful inserted bus relief panels are not only beautifully graceful, but illustrate a pre depression fancifulness. Apparanly this building was built in 1929 and then stood vacant for some two years. Given the economic conditions of those years, this is not surprising. The first business here was Montgomery Ward, who may have built the structure. Ward was still here in 1948.

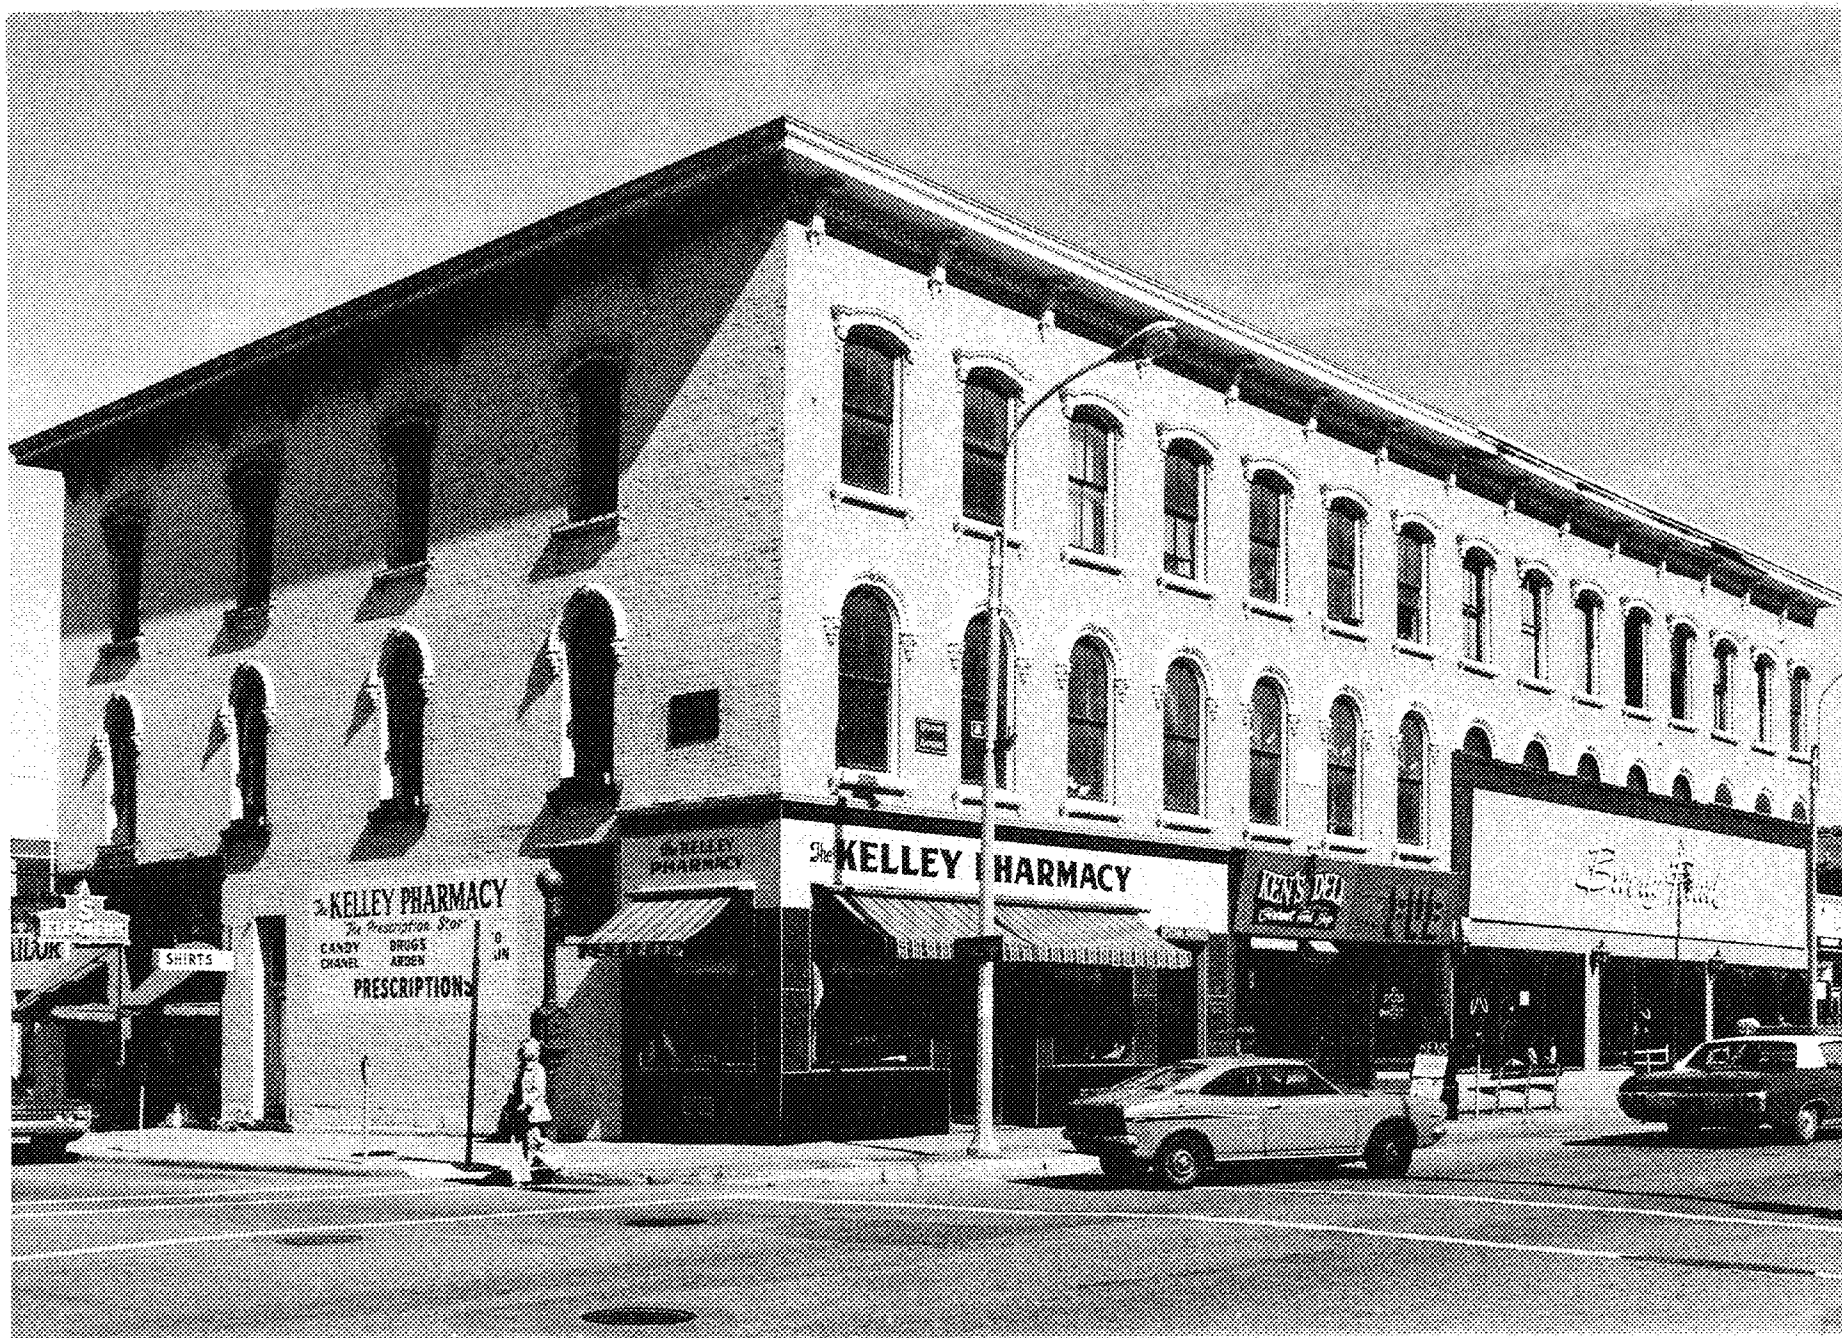
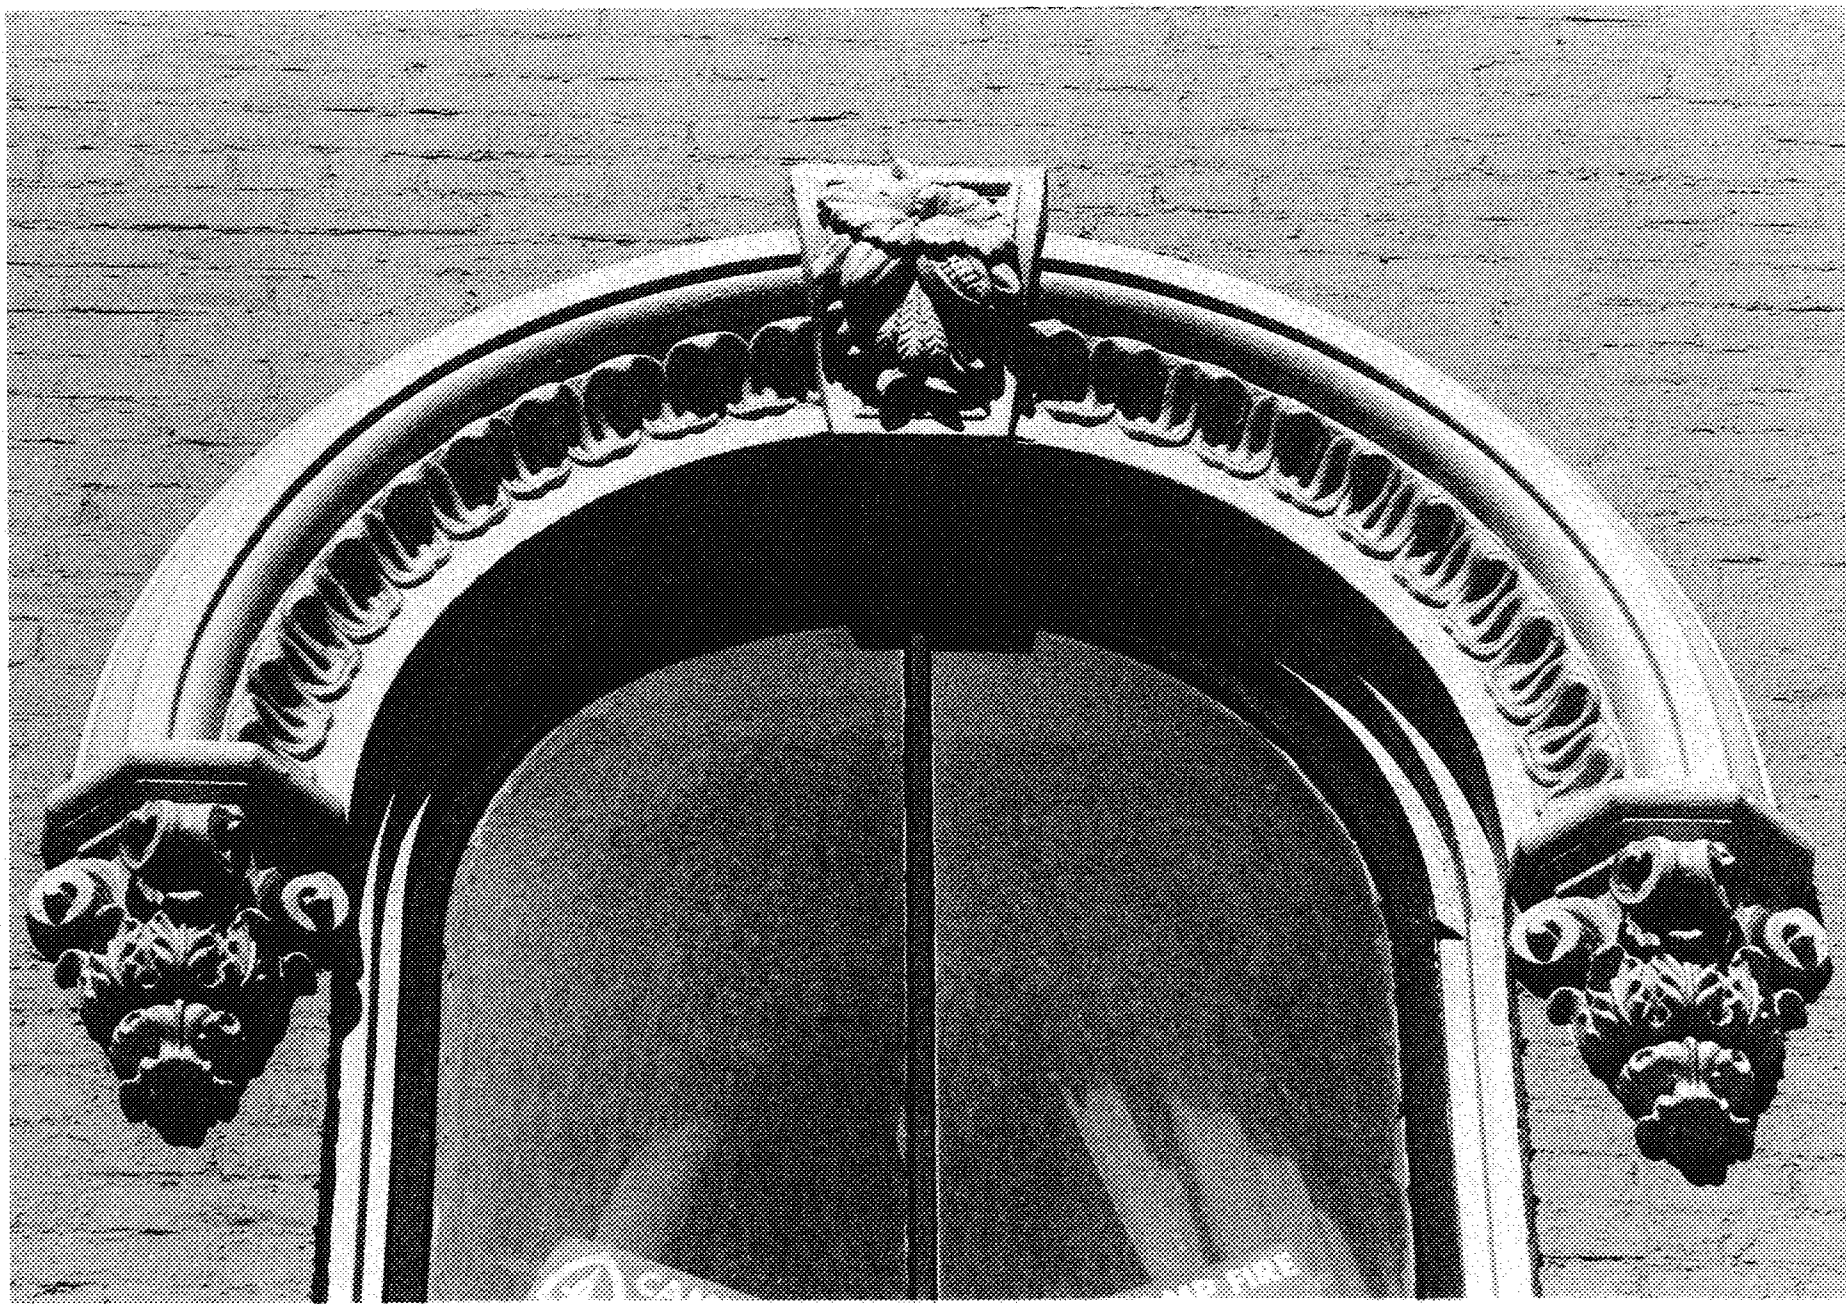
75-59 Church St.

Built in 2 sections. Cast iron lintels, round arched with keystones on the second floor segmental-arched on the 3rd floor. Some of the elaborate drop pendants on the 2nd floor arches have been removed to accommodate a large sign, above the Beverly Pearl Shop. The cornice is bracketed and denticulated. A fire has caused damage to the upper floors of the northerly section of the building and the future of this section is in question. An original storefront, remains on the Bank Street elevation - Israel Soloman's tailor shop as well as an early neon sign. The store front of #71 is also almost entirely intact although signs have covered the cornice. A ca. 1940 carrara glass storefront remains at Kelly Pharmacy.

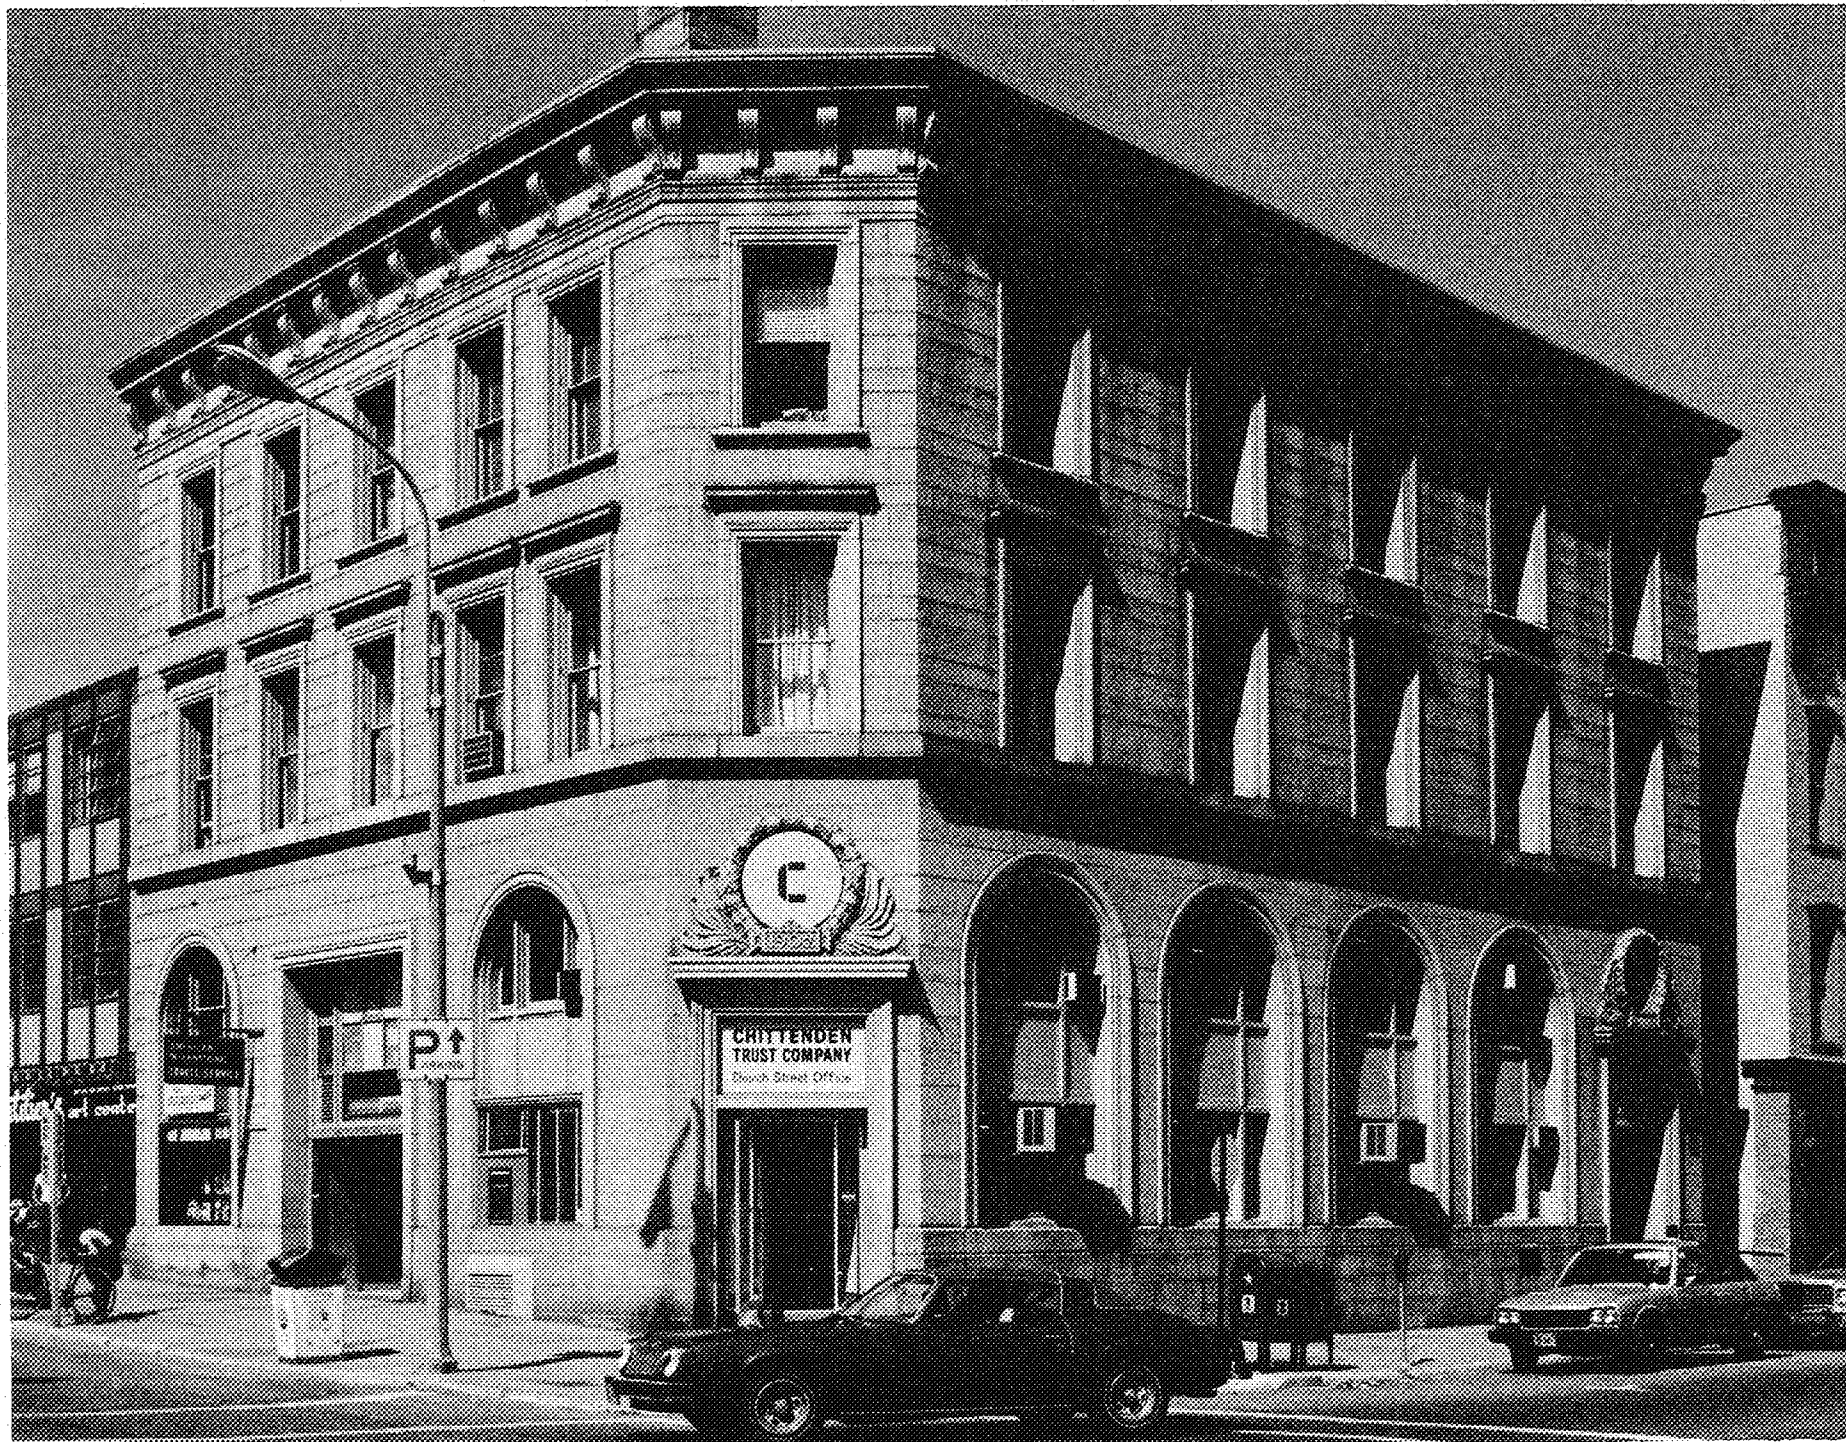
112-116 Church St

This massive Renaissance revival structure is unique in Burlington. The beautifully cut granite and detailed cornice illustrate a level of sophistication which is fitting for the banking interests which have occupied the building.
