ORCHARD TERRACE

Orchard Terrace -- Statement of Significance

HISTORIC SITES & STRUCTURES SURVEY
Individual Structure Survey Form

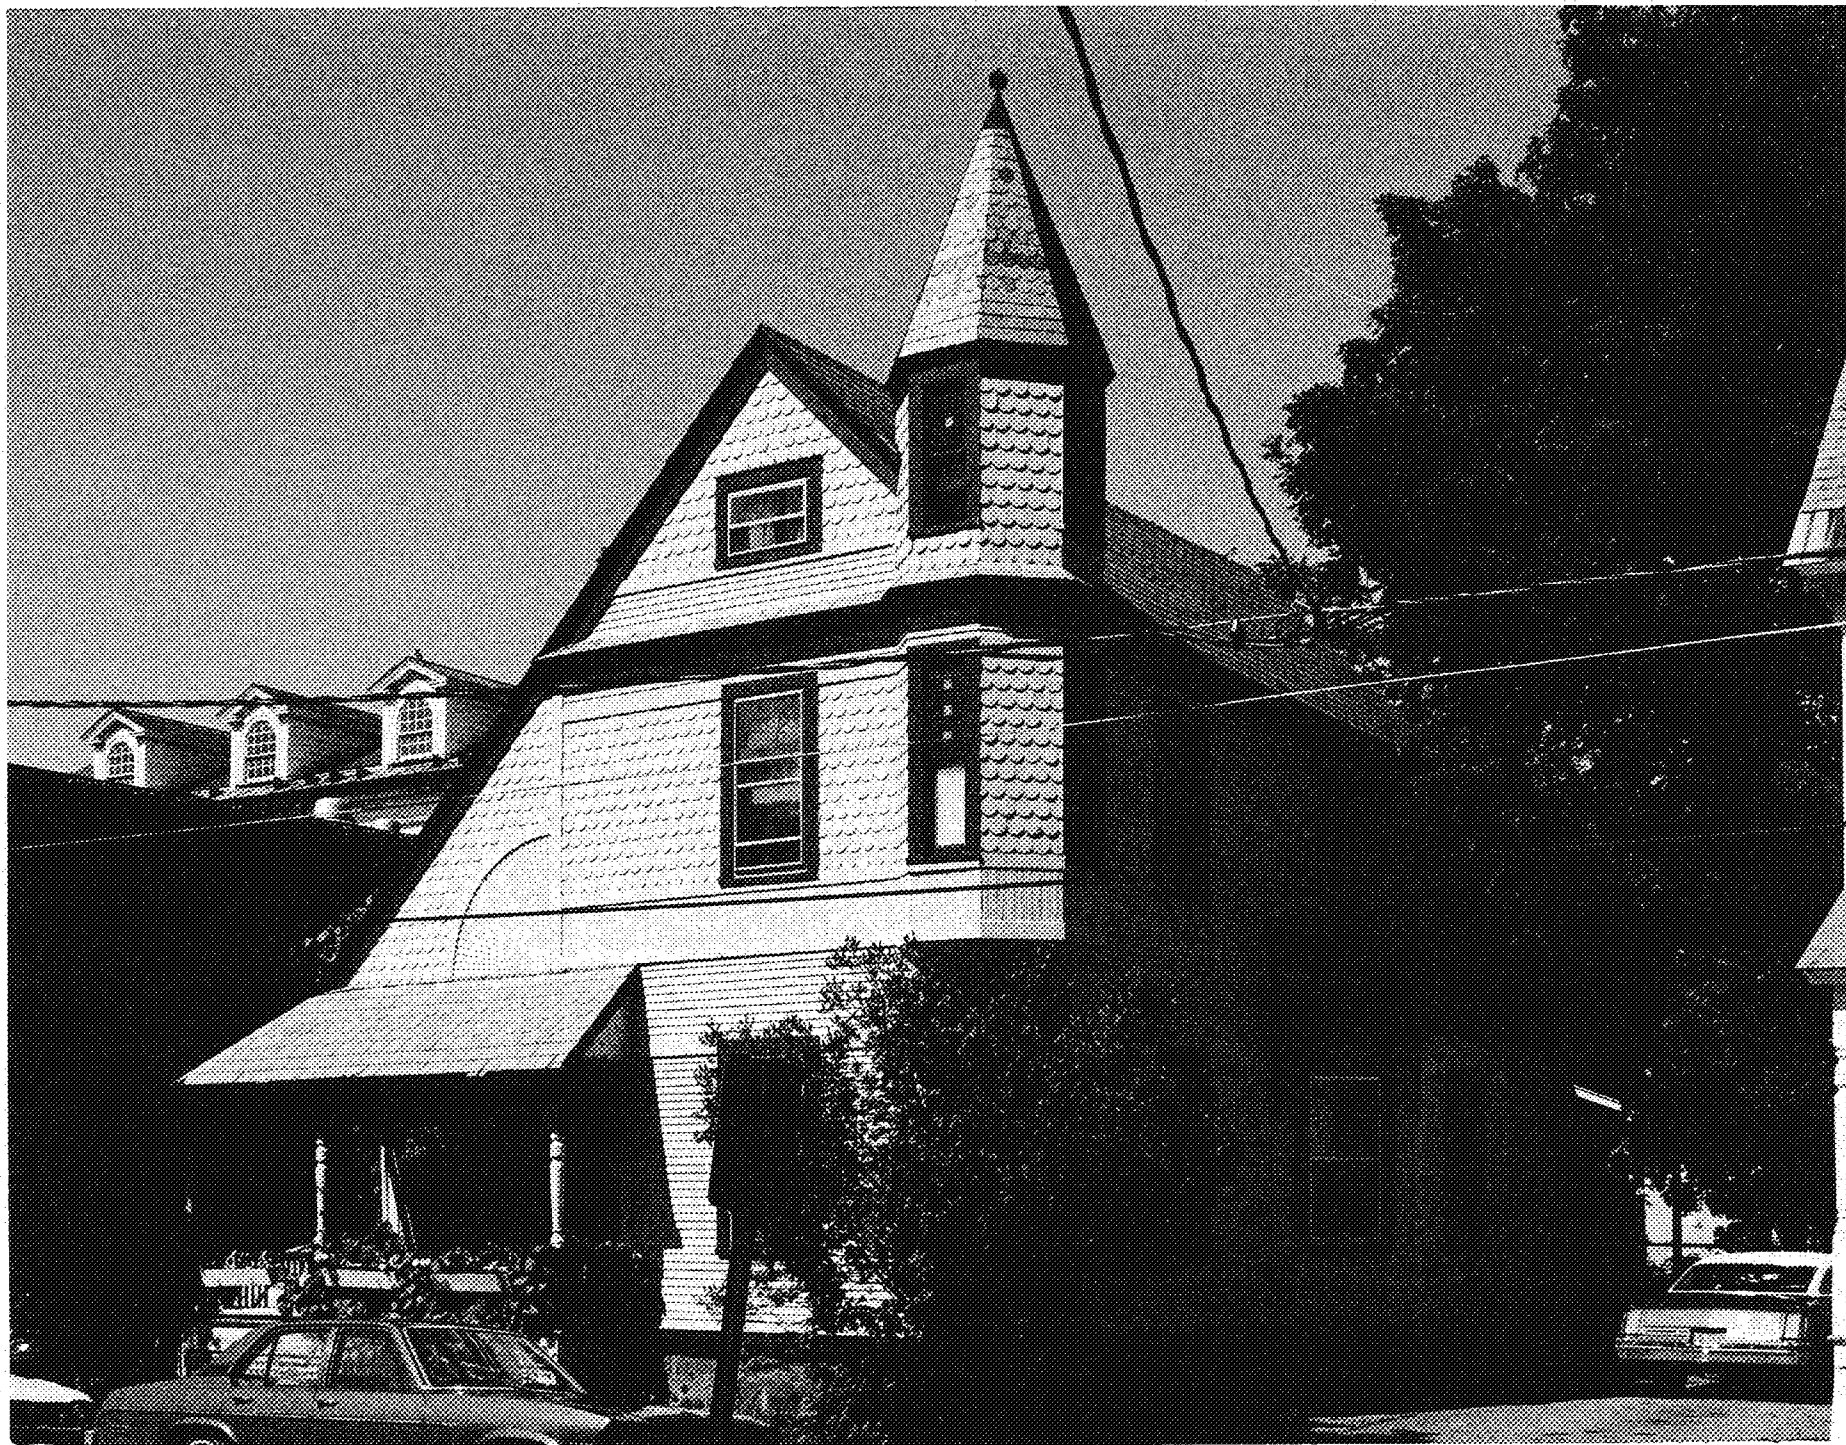
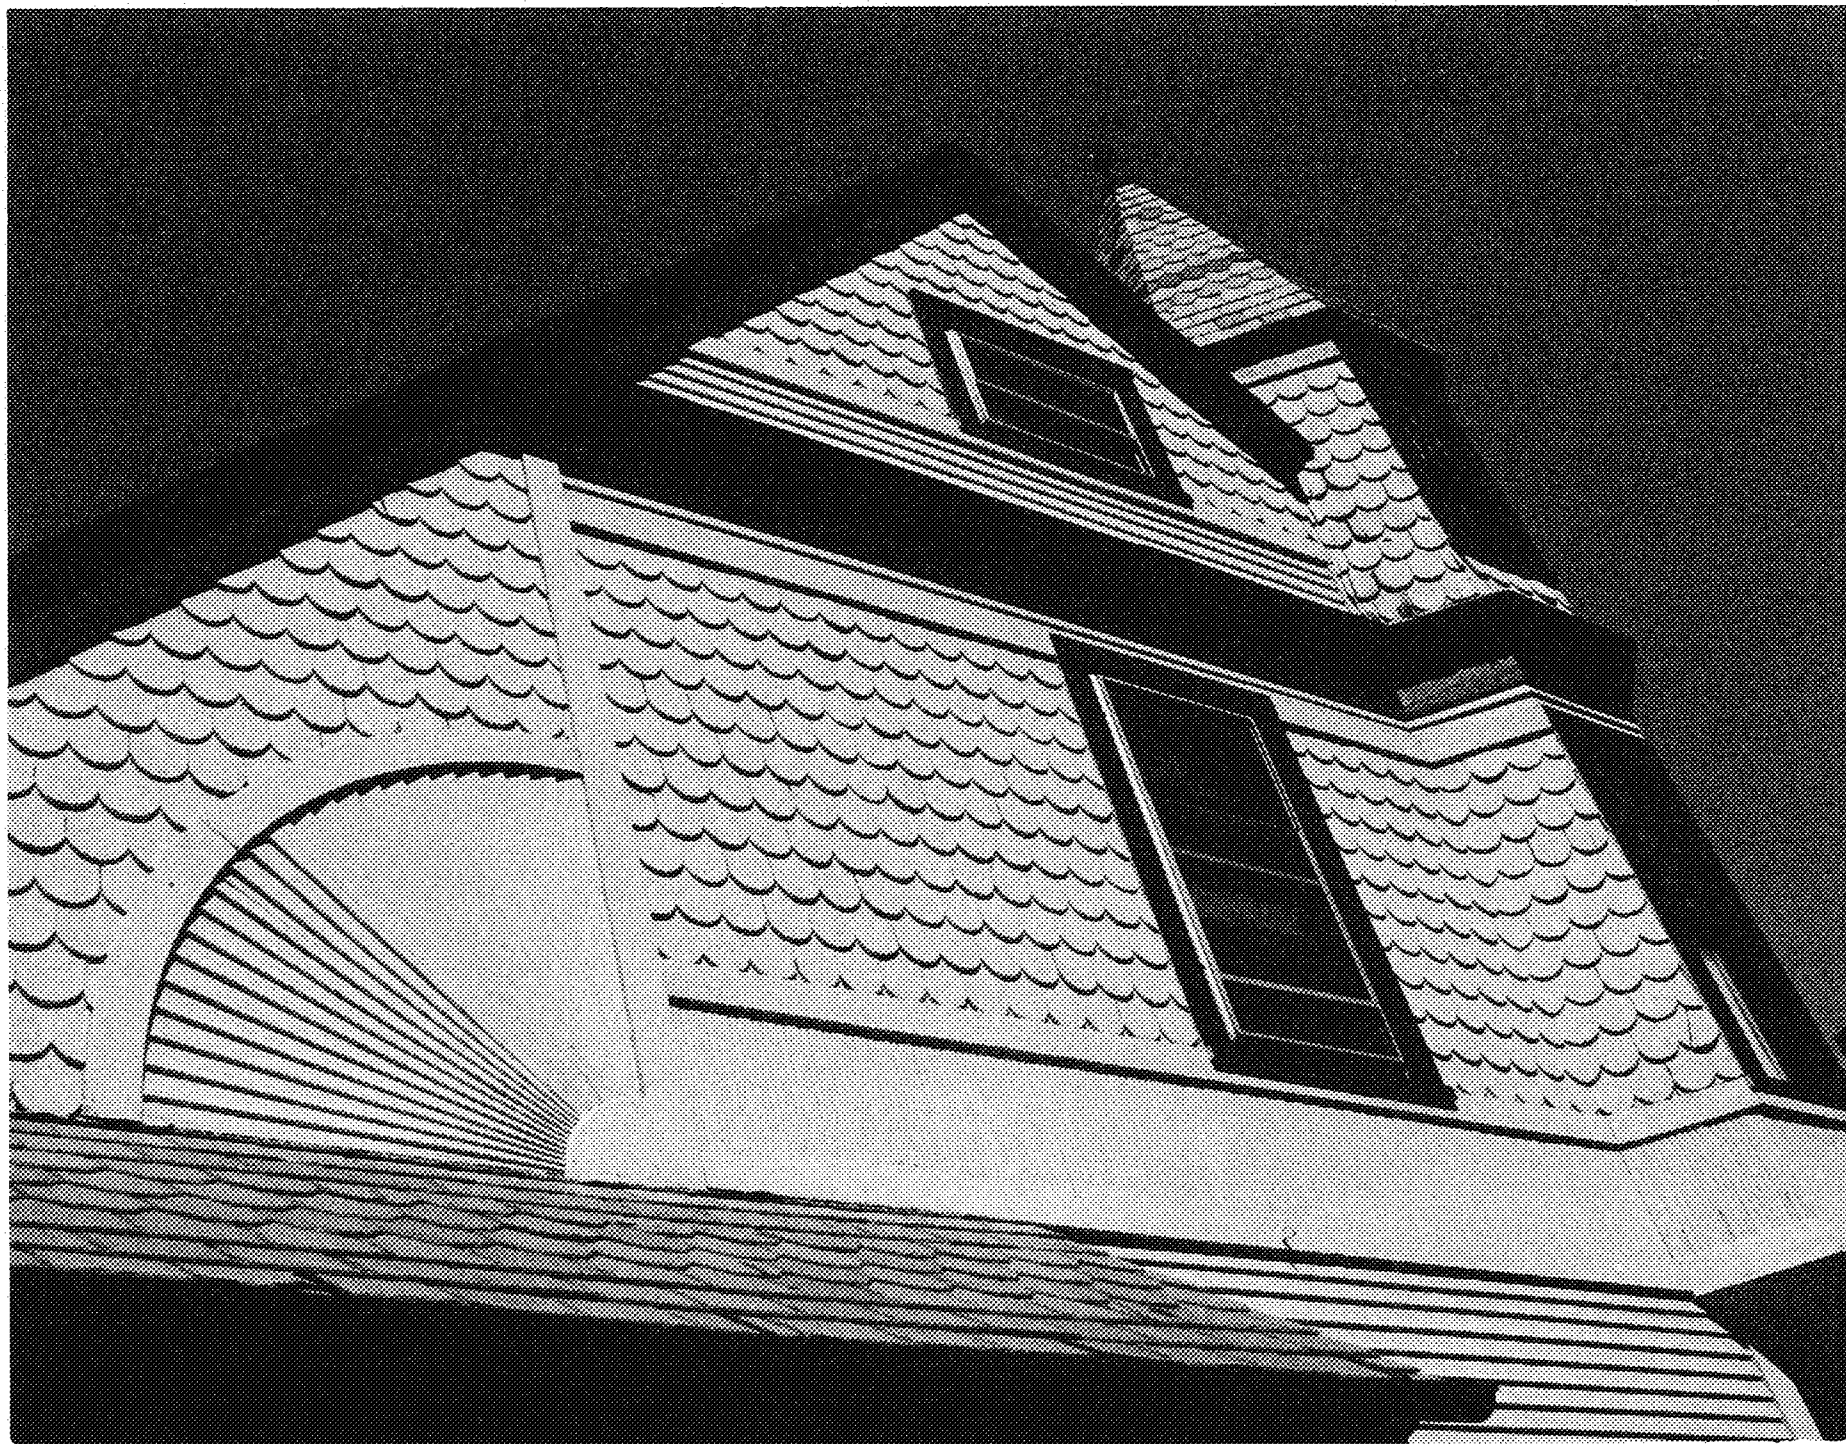
25 Orchard Terr.

Massing - building is composed of 2 2 1/2 story salt box style sections together as an ell. The gable is oriented to the street on one section the long roof is on the south end. A turret begins at 2nd story of northeast corner and projects above the roof with a polygonal roof. A bay on north wall with shed roof. Porch on facade.

Fenestration - 1/1 sash windows with plain surrounds. Various ornamental stained glass windows. Tower windows are colored multi-pane sash windows.

Extras - radiating 1/4 fan in 2nd story facade. Bands of beaded boards, imbricated shingles and clapboards. Roof slates are banded and colored red, blue & grey. This house is super.

This extraordinary Queen Anne house is virtually the epitomy of the style with colored multi-pane windows, a turret, and complexities in roofline. It creates a striking picturesque effect which is rarely achieved to this degree in Burlington. This was the residence of Mrs. H. A. Ray.

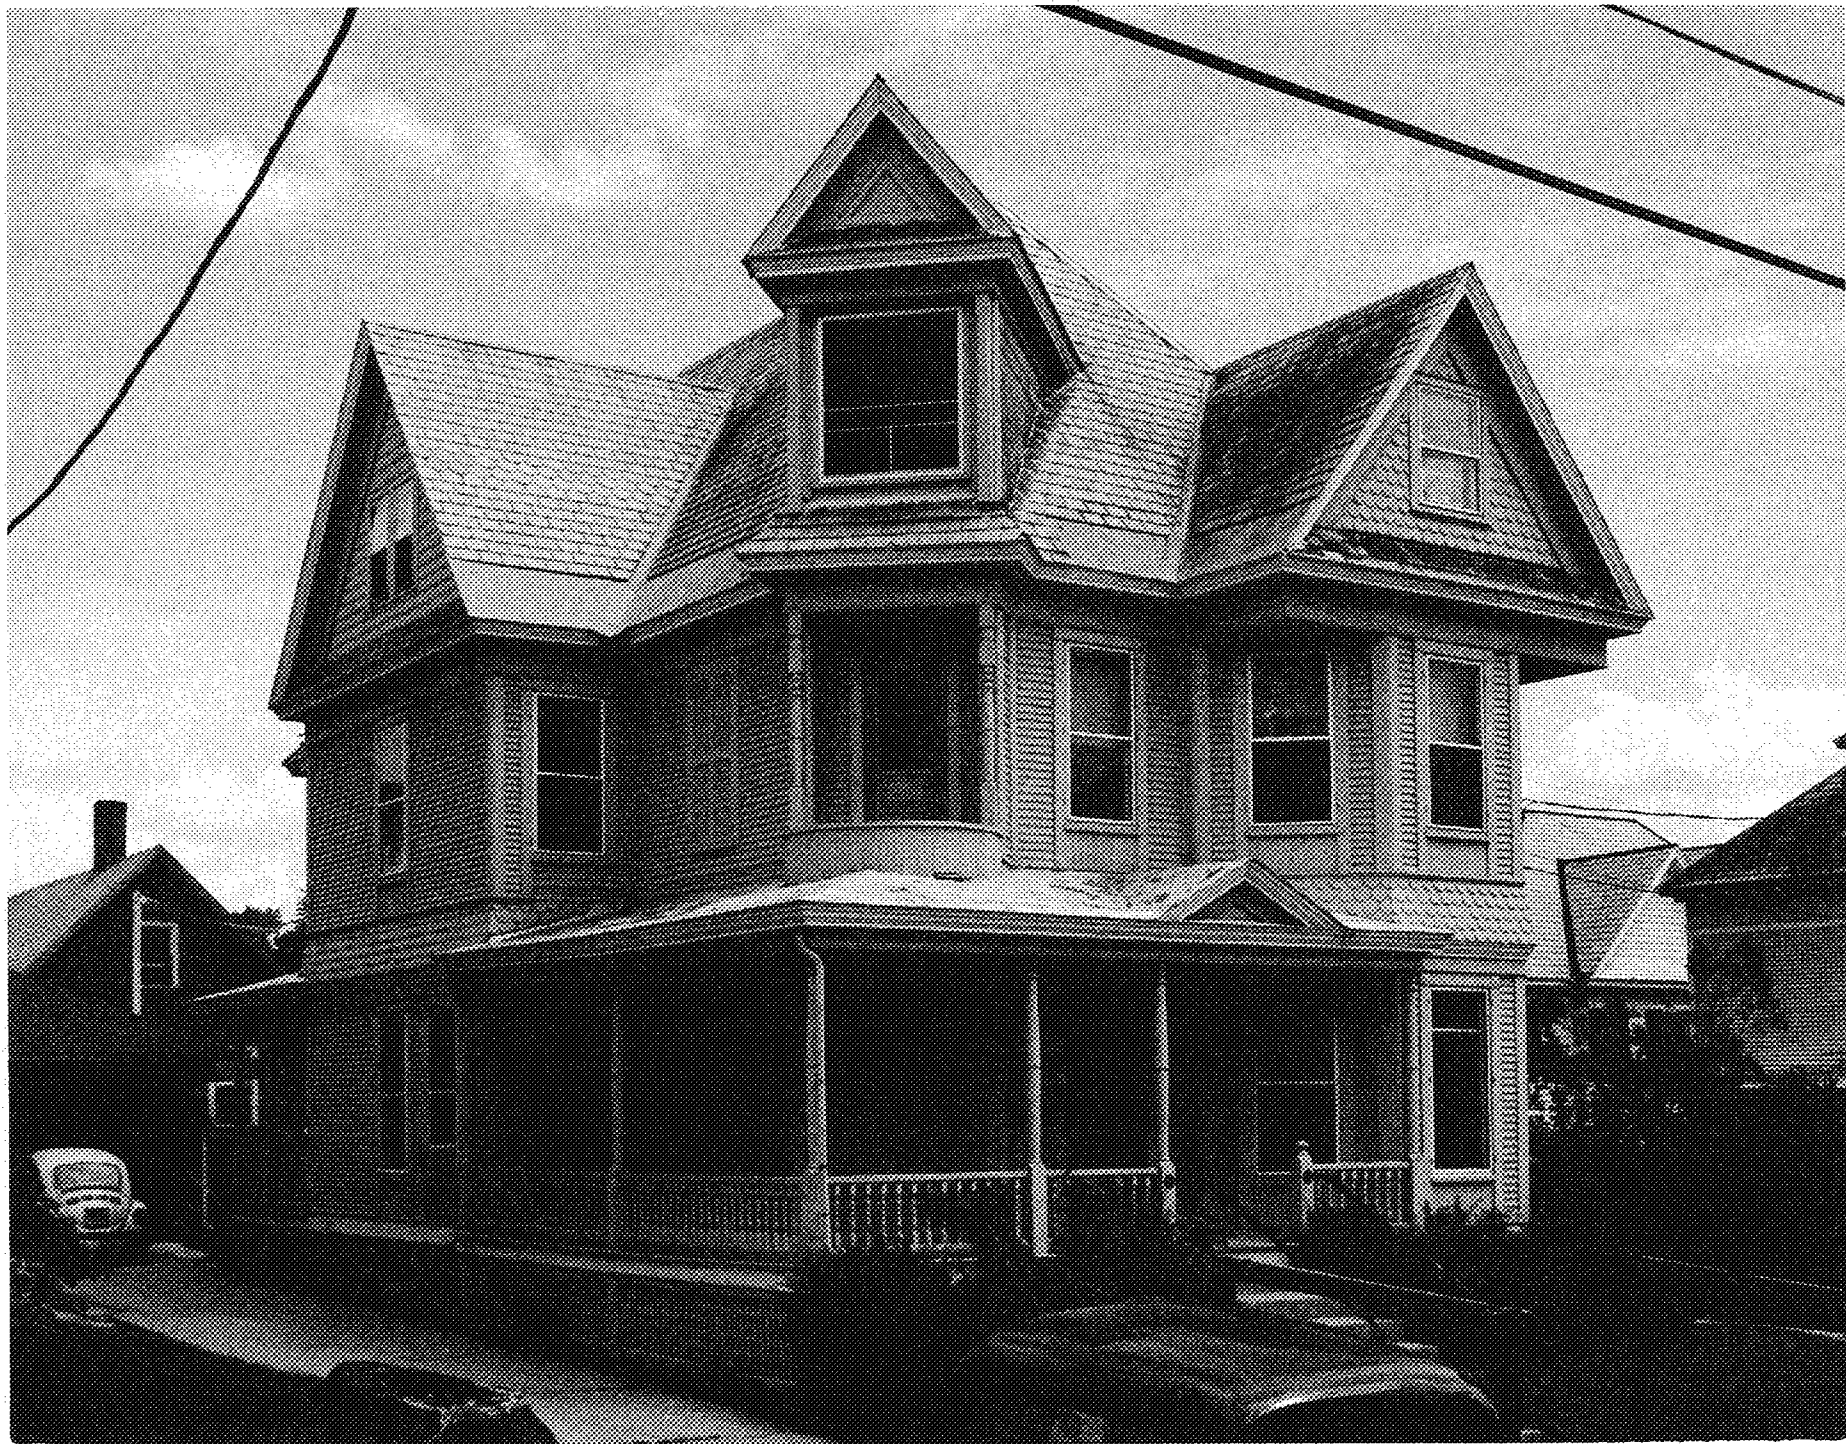
38 Orchard Ter.

Fenestration - 1/1 sash windows with low relief pyramidal corner blocks, with beaded tongue & Groove panels at base. Very elaborate stained glass windows on two facade 1st story windows.
