PINE STREET

### Pine street -- Statement of Significance

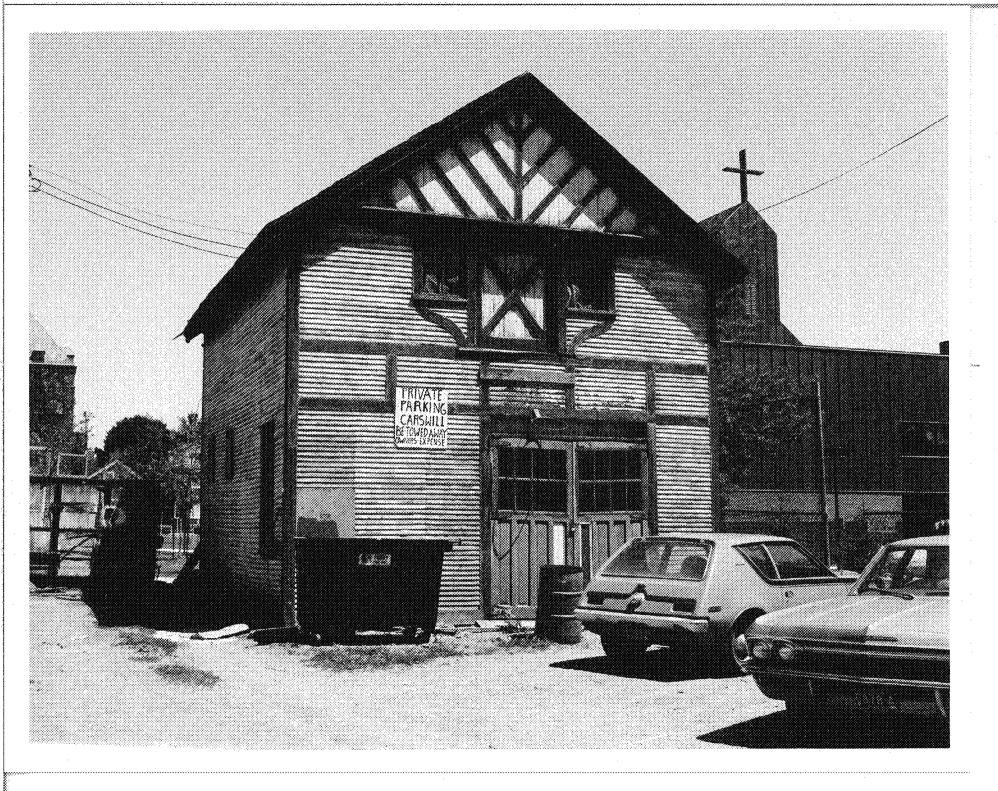
b Pine St (garage) 77 A 191 CS.

ADDITIONAL APCHITECTURAL OR STRUCTURAL DESCRIPTION:			
The gable end faces the street. Gab angled boards. Below this is a door to t with criss-crossed boards and flanked by sisting of vertical boards between horizo above the main door. Curved wood pieces upper level door and give the building a from the usual stick work of the period.	2 windows. More stick work con- ntal boards decorates the space connect the small windows to the		
RELATED STRUCTURES: (Describe)			
STATEMENT OF SIGNIFICANCE:			
	<b>*</b>		
This is one of the nicest barns on t			
the whole area. The tudor style stick wo here is noteworthy.	rk is not common and its appearance		
	ŧ		
REFERENCES:			
MAP: (Indicate North In Circle)	SURROUNDING ENVIRONMENT:		
MAP: (Indicate North in Circle)	Open Land  Woodland		
	Scattered Buildings  Moderately Built Up		
	Densely Built Up		
	Residential Commercial Agricultural Industrial		
	Roadside Strip Development

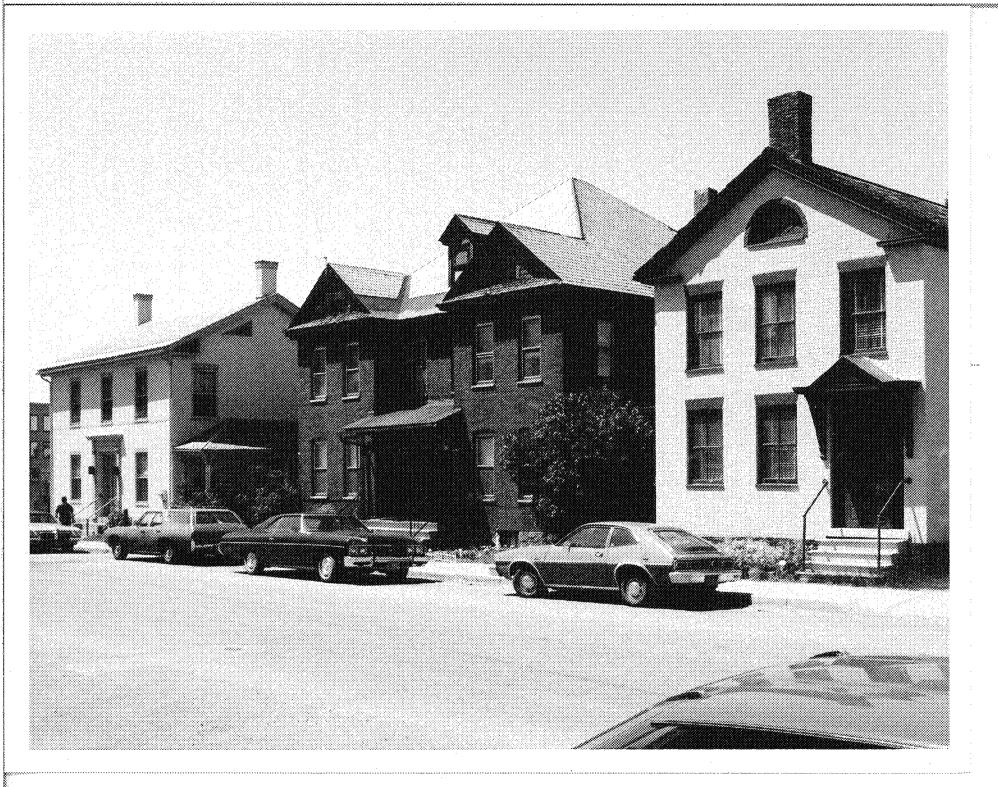
23, 27-29, 33 Pine St 77 A 191 CS.

ADDITIONAL APCHITECTURAL OR STRUCTURAL DESCRIPTION:	
2 interior end chimneys with corbelled block foundation. 2/2 sash windows with march. Entrance with stone steps wooden pito brick outer wall as door frame. Door it area, thin pilasters, then multi-paneled dand Dart architrave above this recessed entin each gable end.	adiating brick voussoirs flat lasters and full entablature applied s recessed with paneled sidelight loor with a large single light. Egg
RELATED STRUCTURES: (Describe)	
	į
STATEMENT OF SIGNIFICANCE:	<b>≭</b>
This is an important component to the This fine Federal style house establishes the Urban Renewal Zone.  This house was probably built soon af the 1830 map). Its history is unknown unt to Burlington from Lawrenceville, N. Y. an years, but his widow remained here until 1 Ross, headmaster of the Rock Point School, the surrounding neighborhood, it became a REFERENCES:	an important position, bordering  Ter 1830 (it does not appear on il 1868, when W. S. Hall moved do bought it. He died in a few 888; it was then bought by H. H. as an investment. Like most of

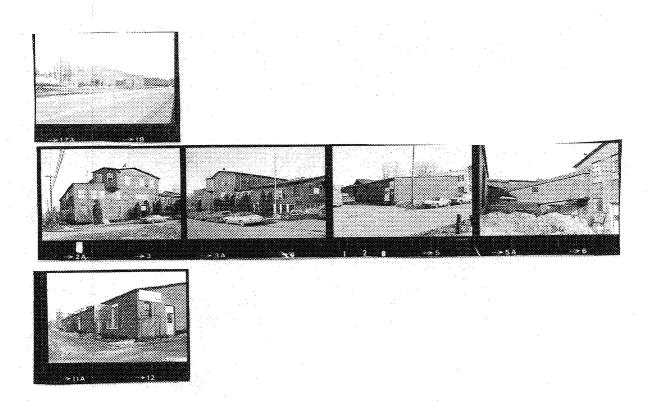
## E. B. & A. C. Whiting Co., Pine Street, Burlington

A unique industry is that conducted by Messrs. E. B. & A. C. Whiting, founded about sixteen years ago. The factory constitutes an important manufacturing plant consisting of a large three-story building with additions attached, the whole having about 1,400 feet of floorage area. Special machinery of ingenious and novel construction is employed in the details of the work, and steam power provides the motive force, about twenty-five to thirty skilled operatives being given employment. The firm are manufacturers of Fibre for brush manufacturers, and use chiefly a vegetable fibre which grows in Mexico, which is used as a substitute for bristles in the manufacture of brushes. It is known to the trade under the name of Tampico. It is prepared by this firm in any desired grade or color, and it is an excellent substitute for the bristles, largely diminishing the cost, and yet for many varieties of brushes quite as useful. This concern is the only one in the country that makes a specialty of this business. Their facilities are altogether complete, and their long experience enables them to mix the materials to perfection, obtaining the best results. They also deal in veneer for brushmakers, supplying them in large quantities.

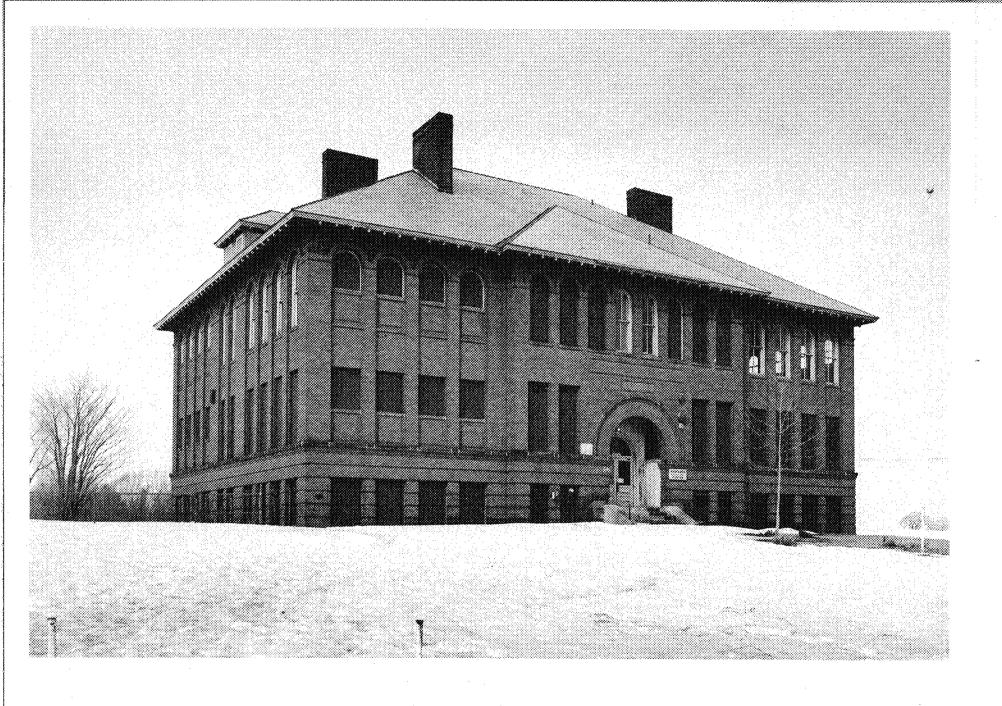
Vt. Div. for Historic Preservation Chittenden County, Burlington 2/78 Champlain School, 809 Pine St. W 78-A-59 Clark Schoettle

ADDITIONAL APCHITECTURAL OR STRUCTURAL DESCRIPTION:		
Mass - large rectangular block with central entrance pavillion 8 bays wide on main facade. Large moderate pitched hipped roof with 4 brick chimneys.  Fenestration - 2/2 sash. Brick flat arches over raised basement and 1st story windows. Round headed 2nd story windows, 1st & 2nd story windows have brick panels or spandrels beneath sills. 2nd story arched windows are outlined by a course of burnt bricks which forms the arch of each window in a continuous band.		
Entrance - recessed in a wide round headed arched opening. 2 door entrance with semi-circular fanlight. Above the entrance set into the wall are two stone tablets, with Champlain School, the other with 1609-1909.  Cornice - overhanging cornice with exposed rafter tails. Beneath eaves on brick wall surfece is a latice pattern of burnt brick and regular brick headers. High raised basement, capped by stone belt course. Water table is brick with bands of burnt brick.
