PITKIN STREET

HISTORIC SITES & STRUCTURES SURVEY  
 Individual Structure Survey Form

COUNTY:	Chittenden
TOWN:	Burlington
LOCATION:	13 Pitkin St.
COMMON NAME:	
FUNCTIONAL TYPE:	dwelling
OWNER:	Elizabeth Murphy Estate
ADDRESS:	13 Pitkin St.
ACCESSIBILITY TO PUBLIC:	Yes <input type="checkbox"/> No <input checked="" type="checkbox"/> Restricted <input type="checkbox"/>
LEVEL OF SIGNIFICANCE:	Local <input checked="" type="checkbox"/> State <input type="checkbox"/> National <input type="checkbox"/>

DATE BUILT: 1899
<b>GENERAL DESCRIPTION:</b> Structural System 1. Foundation: Stone <input checked="" type="checkbox"/> Brick <input type="checkbox"/> Concrete <input type="checkbox"/> Concrete Block <input type="checkbox"/> 2. Wall Structure a. Wood Frame: Post & Beam <input type="checkbox"/> Balloon <input checked="" type="checkbox"/> b. Load Bearing Masonry: Brick <input type="checkbox"/> Stone <input type="checkbox"/> concrete <input type="checkbox"/> Concrete Block <input type="checkbox"/> c. Iron <input type="checkbox"/> d. Steel <input type="checkbox"/> e. Other: 3. Wall Covering: Clapboard <input checked="" type="checkbox"/> Board & Batten <input type="checkbox"/> Wood Shingle <inpu

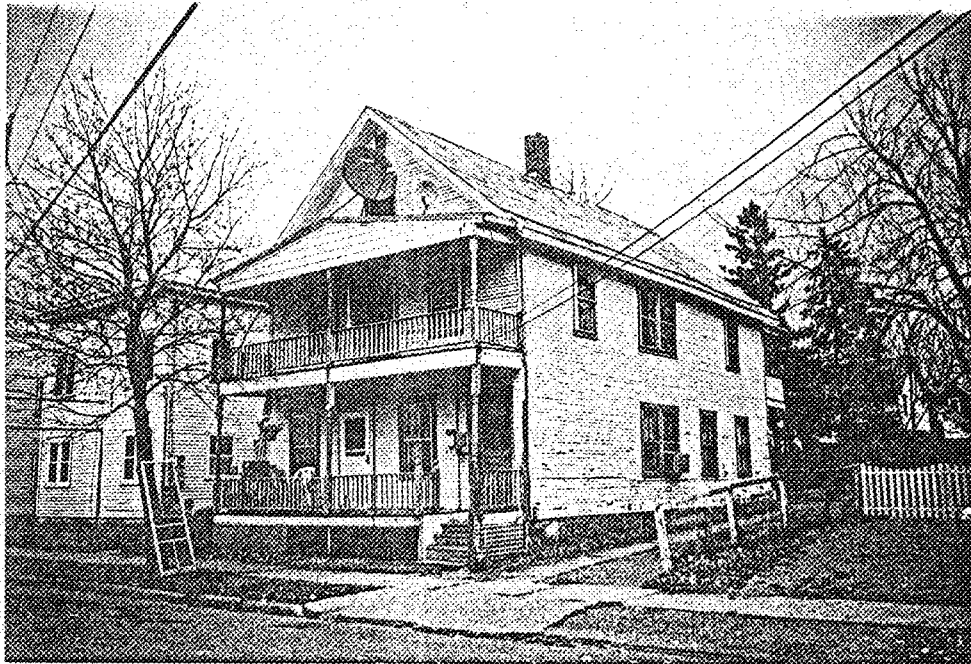
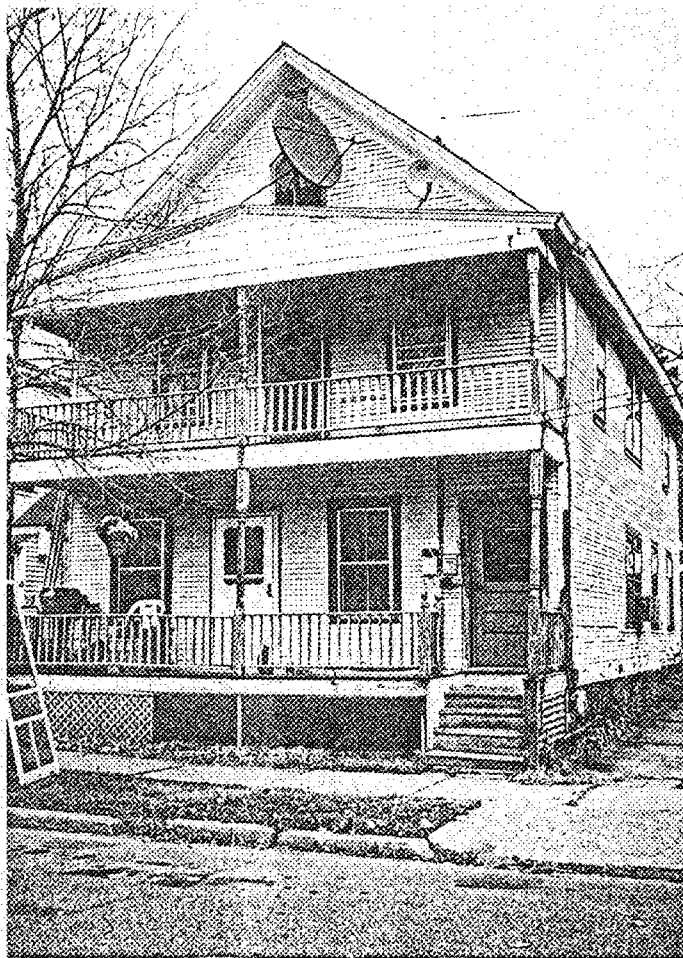
78 Pitkin St.  
Burlington, VT.

The duplex is a 2 ½-story, gable front, rectangular, wood frame structure with a contemporaneous 2-story porch on the front elevation and a c. 1920 2-story porch across the rear facade. Other historic features include clapboard siding, slate roofing shingles, two-over-two double hung windows, a central brick chimney and horizontal panel, exterior doors with an upper light, at the front right entrance and rear entries. The front gable peak has a pointed arch, two-over-two window, and the rear gable windows have peaked lintel boards. The left, front entry has a replacement metal door with small arched light. The front porch has a gable roof, molded cornice, wood shingle tympanum, Queen Anne style posts, modern square stick balustrade, exposed roof framing, steps at the far right fronting the right entry, square newel posts with spherical caps, board decks and a lattice skirt. The rear porch has a shed roof, concrete first floor deck, board deck on the second floor, beaded board closed railing on the second level and at the stairs to the second floor, beaded board ceilings, square posts, and novelty board siding on the infilled portion of the right (north) third of the porch on both floors. On the first floor the area under the stairs, and between the stairs and the rear wall of the building, has been enclosed with various types of lumber. The building is located on a rectangular lot, which has a driveway parallel to the south side of the structure and a small back yard.
