SOUTH WILLARD STREET

South Willard St. -- Statement of Significance

HISTORIC SITES & STRUCTURES SURVEY
 Individual Structure Survey Form

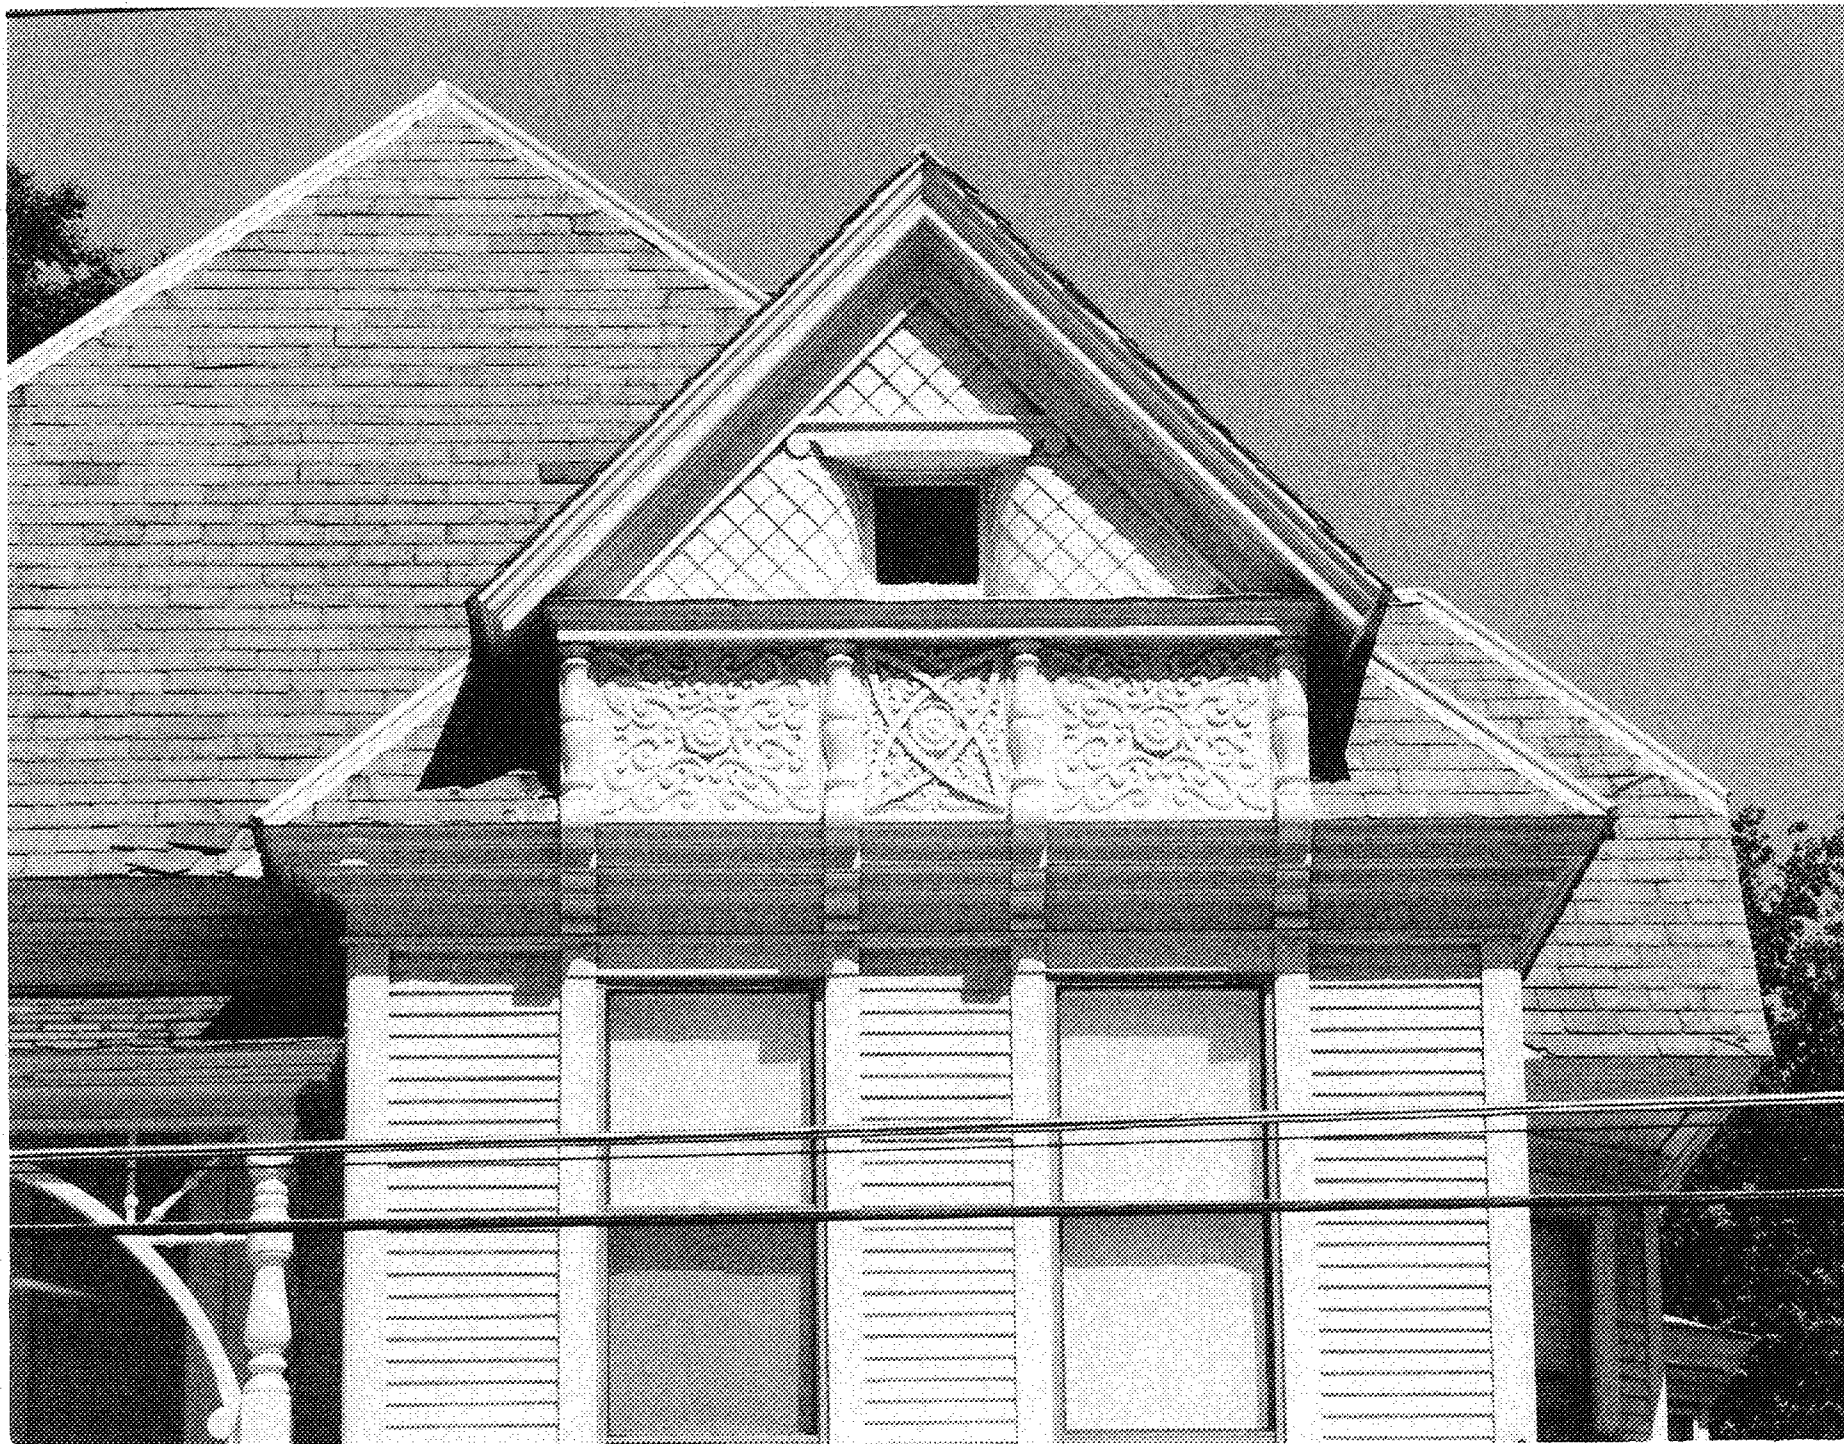
20 So. Willard St

Massing - rectangular block with hipped roof to the facade and jerkin head roof at the rear. Block is broken by a 2 1/2 story gable bay which is swelled at the 1st story and squared at the 2nd. There are also two side bays, on the N & S sides each 2 1/2 stories with jerkin head roofs.

Fenestration - very nice, leaded stained glass window in entrance hall and up the stairway. Otherwise 1/1 sash windows.

Beautiful Queen Anne residence with extravagant amount of carved detail and surface textures. Burnham was a photographer and art store owner from 1875 to 1907 in the Central Block on Church St. Harry Smith, manager of Nat. Biscuit Co., also lived here from 1898 on. Solid middle-class residence.

extension in front of entrance, with carved gable end. 2nd story facade porch on north end with battered shingle bases & turned columns. With spindle brackets.

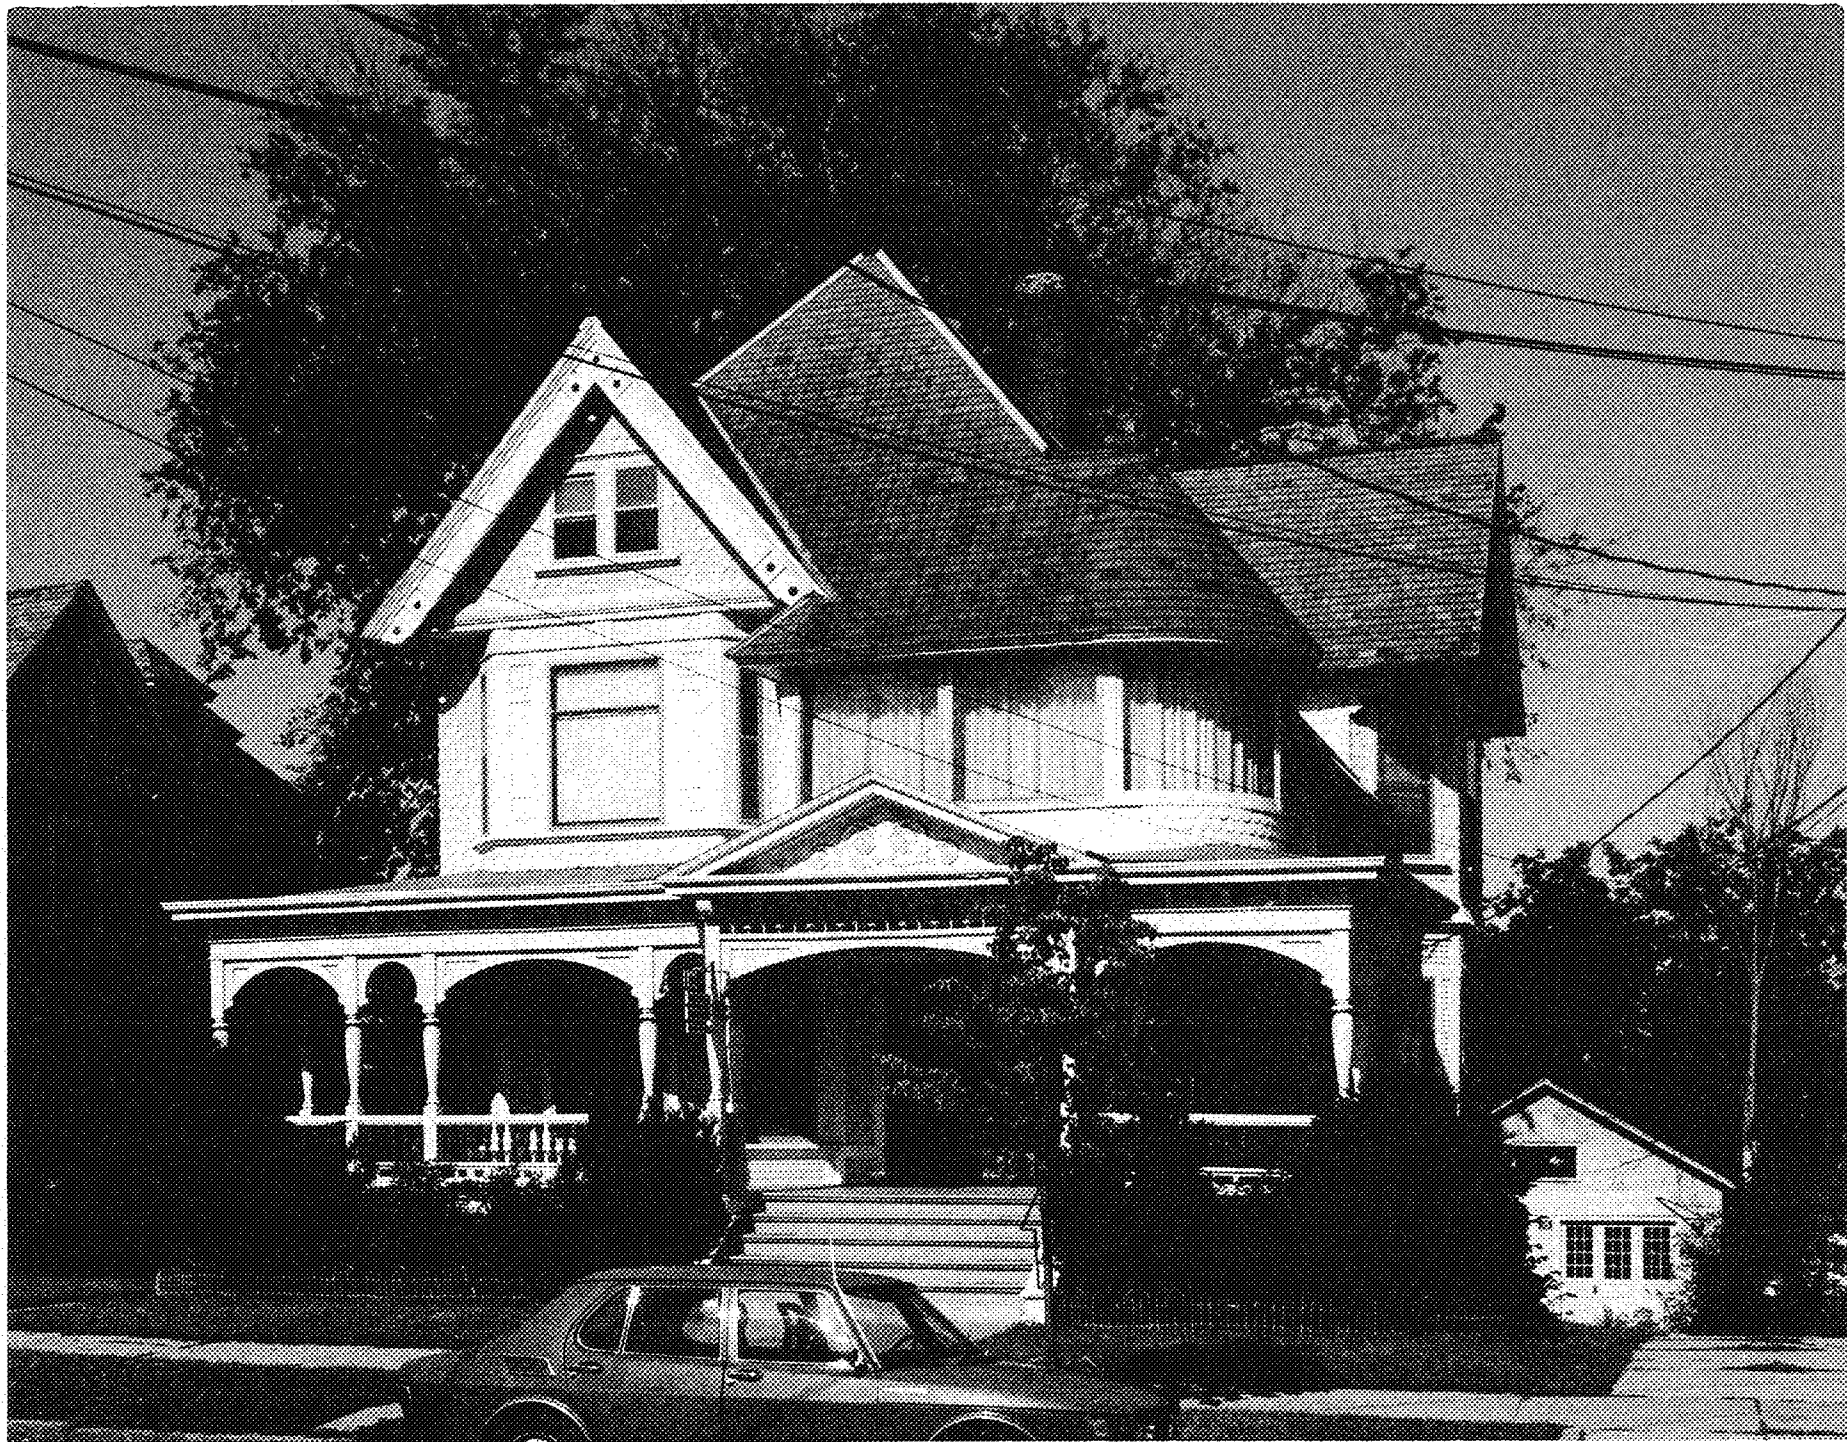
41 So. Willard St

Massing - very irregular and nonsymmetrical. Generally it is a central block with a steep hipped roof with 2 1/2 story gable roofed projecting bays with canted walls on the east, north west and south walls. A first story porch wraps around the facade and both sides. The second story of the facade elevation has a semi-conical roof section on the NE corner coping what may have been a porch but is now glazed with a carved piece of glass. Fenestration - stained & clouded glass window on N wall (staircase), others are 1/1 sash.

to porch. Porch supported by turned posts. Metal cresting details on roof ridges elaborate detailing. 1st story - clapboarded 2nd story imbricated shingles with sawtooth cut above stringcourse between 1st & 2nd story.

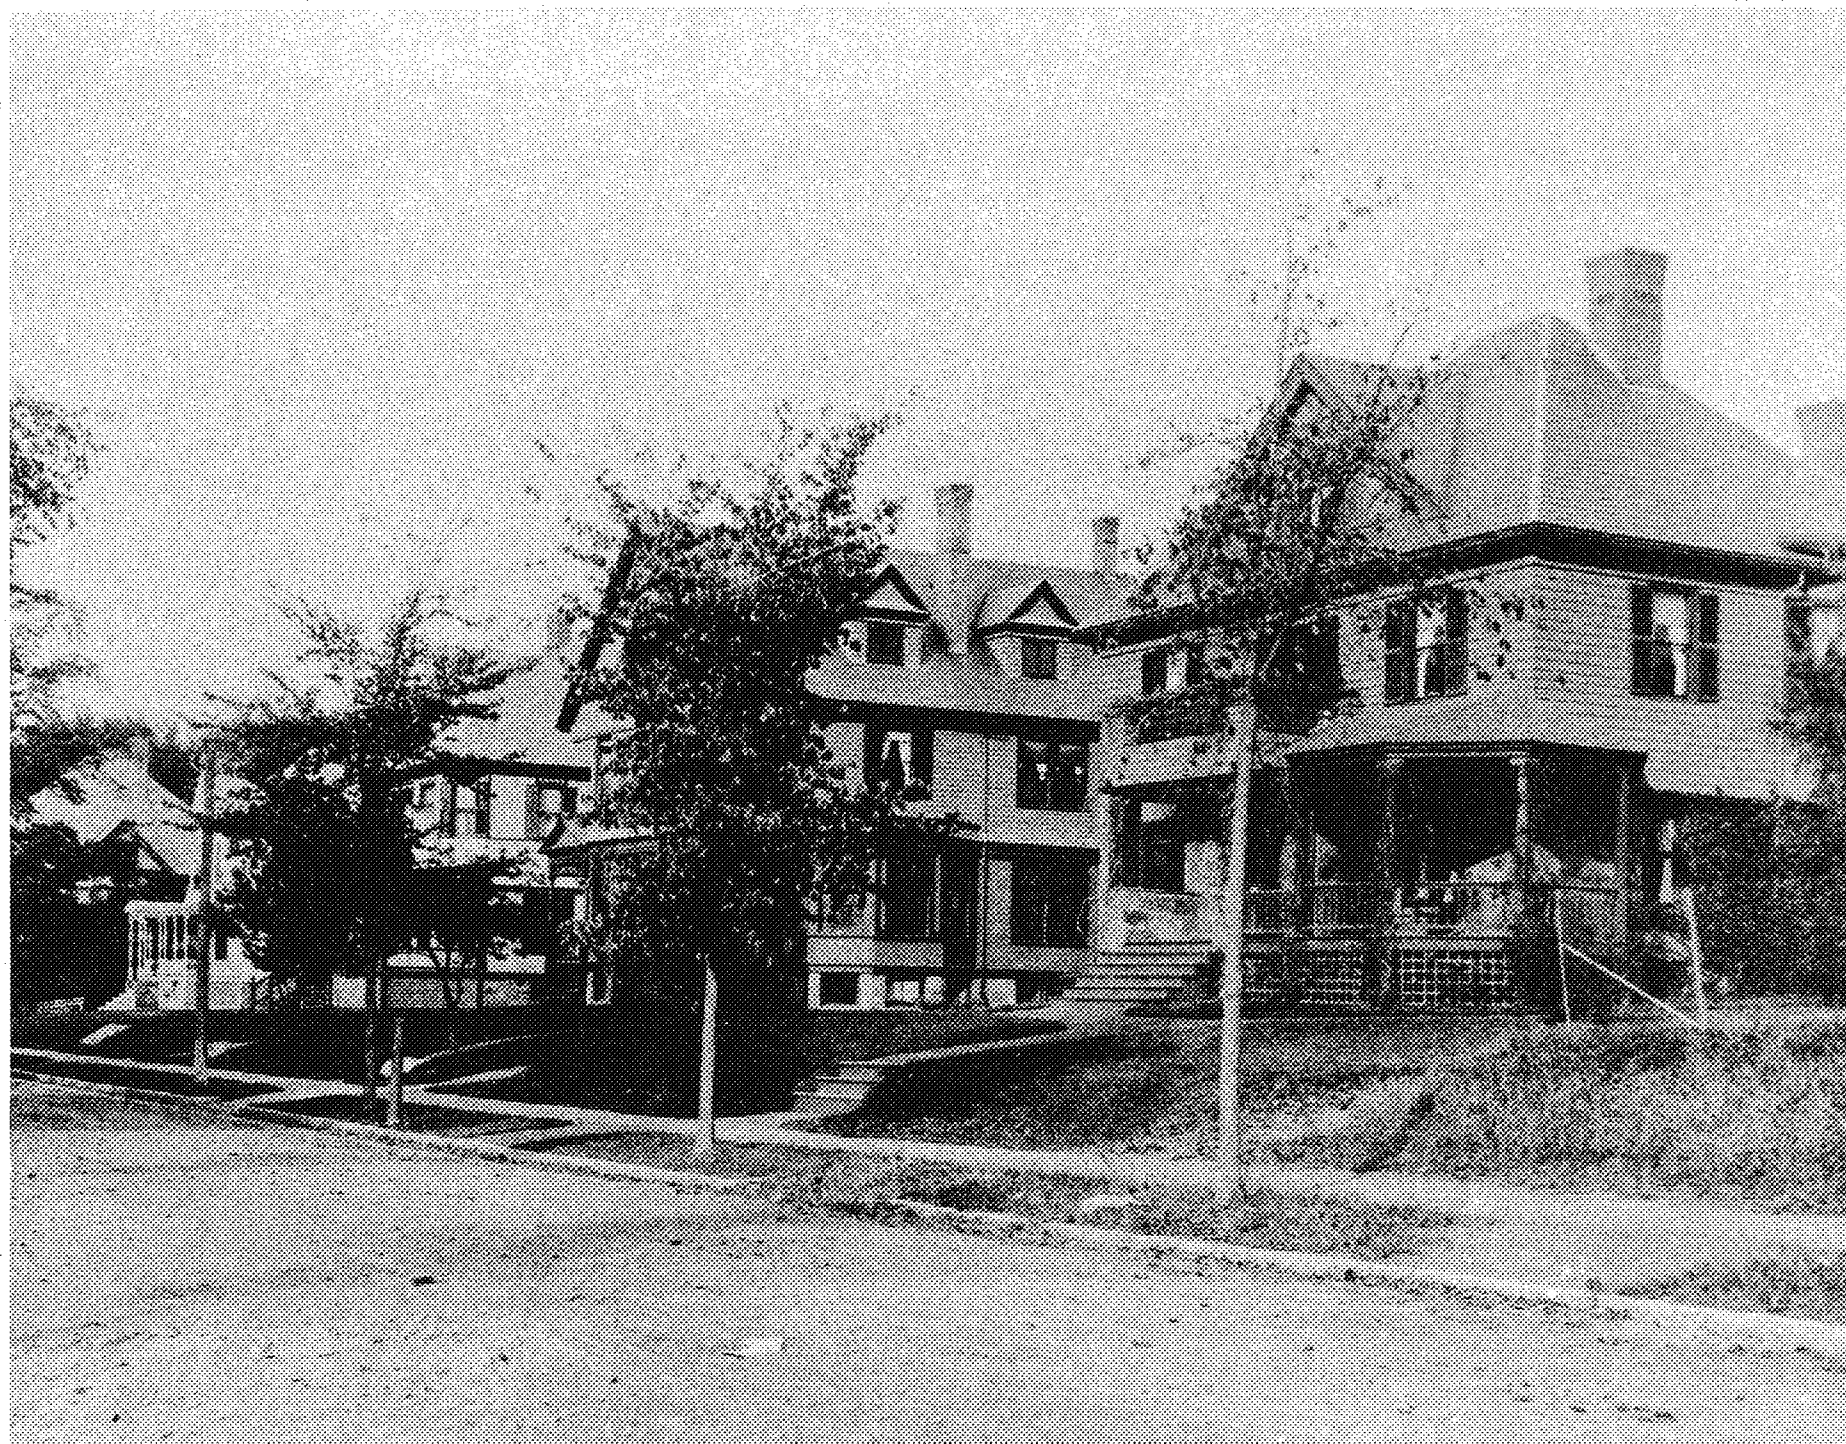
44 So. Willard, Willard St.

Fenestration - stained glass window in bay on S. wall. 1/1 sash windows, in dormer - triple window each with 6/1 sashes.

2nd story is shingled. In gable end it is verticle board with curved boards applied in an English Tudor fashion.

Interior - unique corner fireplace.

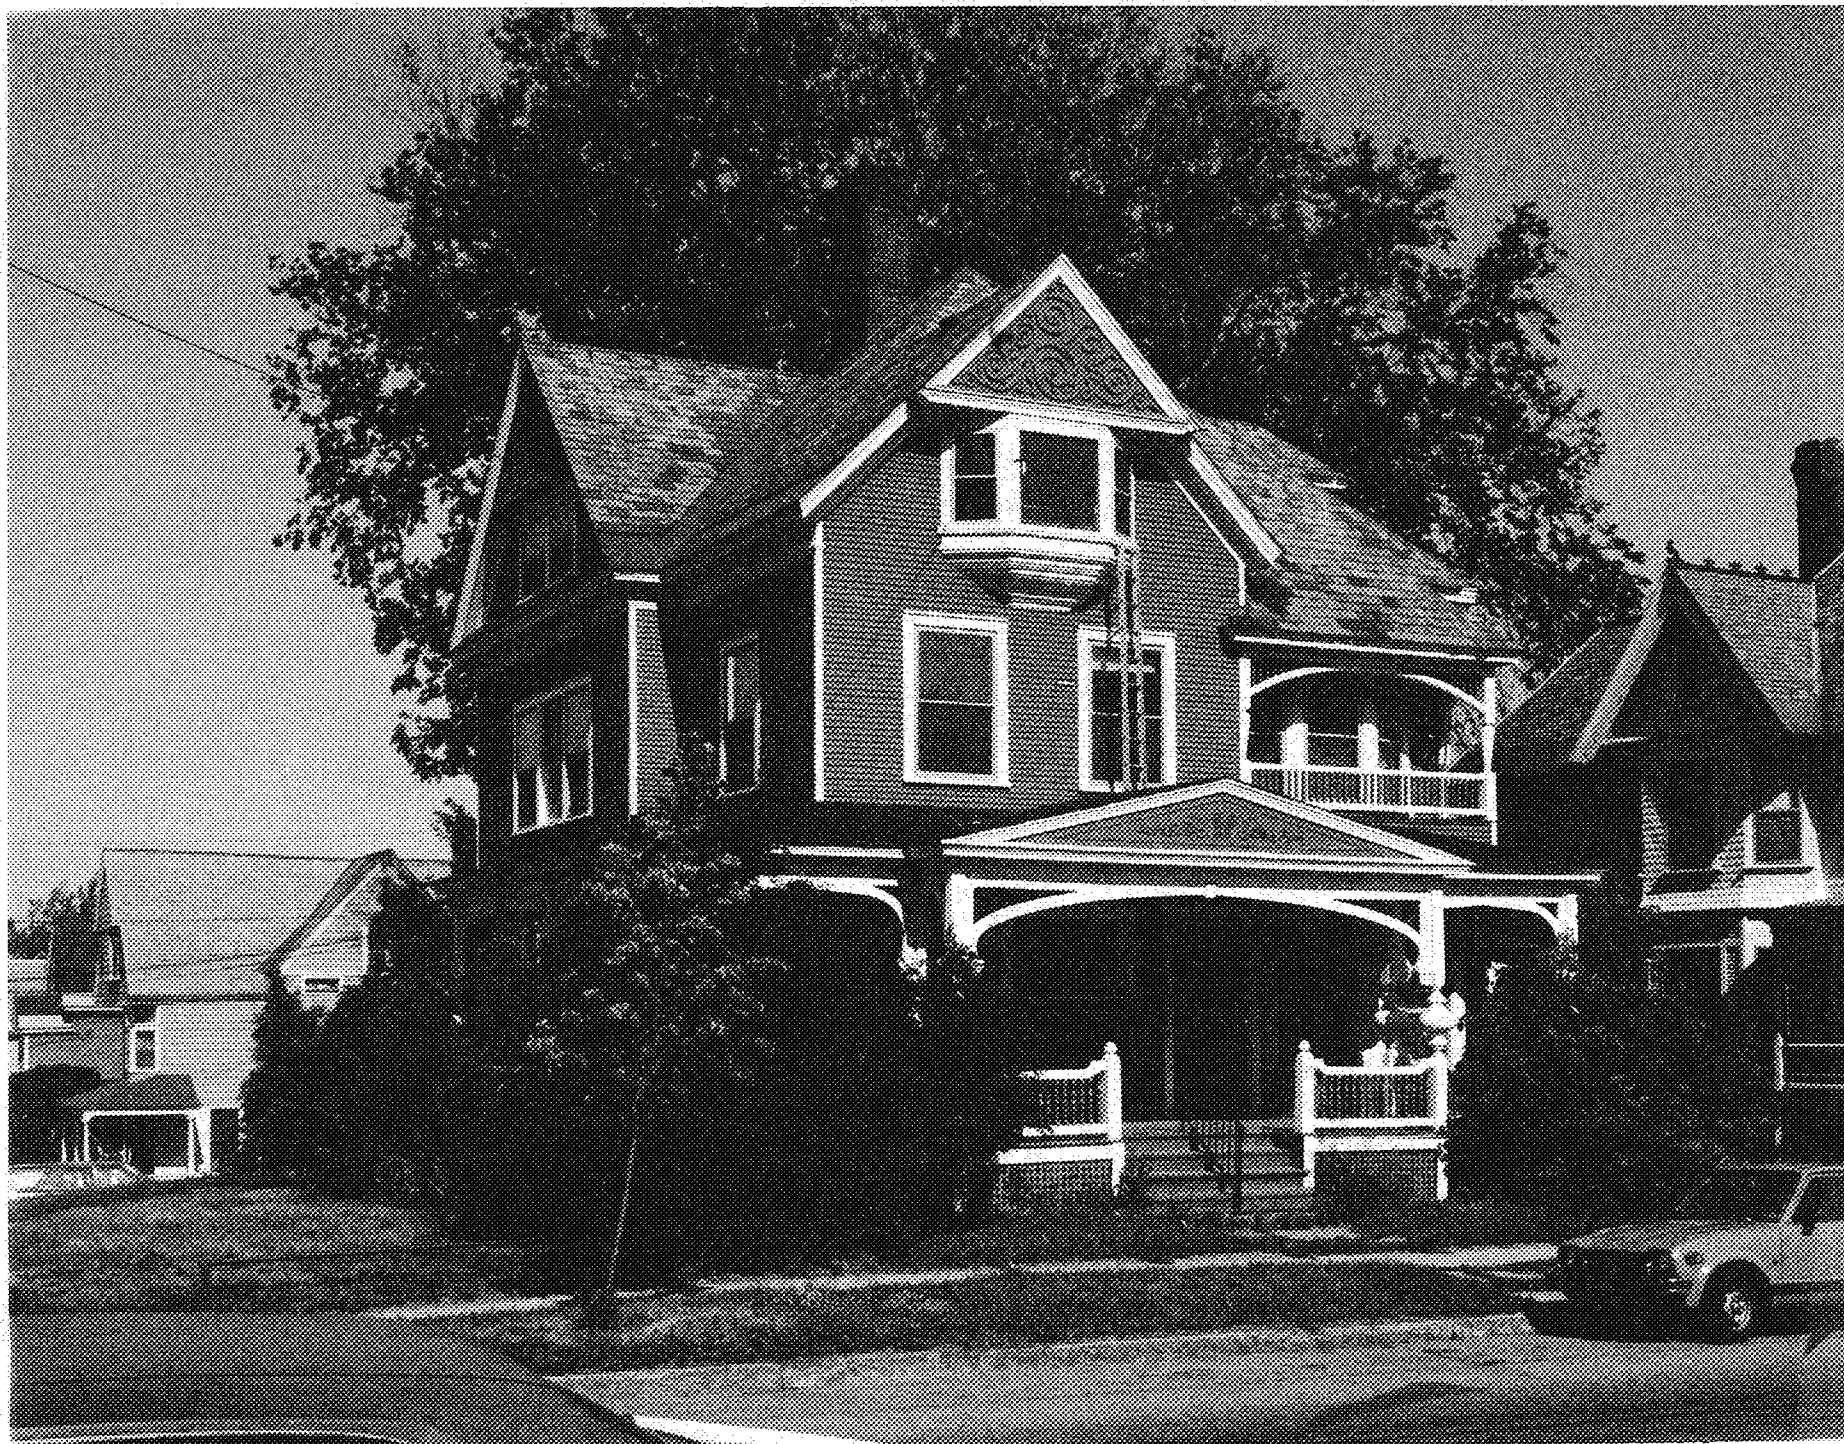
45 So Willard
77A 195

Massing - large square central block with hipped roof with an equally large gabled 2 1/2 story wing on the west side. The hipped roof is broken by 2 1/2 story projecting gabled bays on the N., E., S., walls. There are two hipped dormers on the N. slope of the roof. A 1 story porch wraps around the SE corner of the house

Fenestration - Queen Anne sash windows with color glass squares, modified Q. A. sash, 1/1 curved glass sash, 1/1 sash, beautiful stained glass on staircase on N. wall. Curved, wood sliding shutters behind carved glass (NE corner).

Large and important corner house with unique carving and oriel windows. This structure is perhaps one of the most important on the street. The porch columns, stained man who lived there and the character of the street. The majority of detail work is also very representative of the current technological achievements such as band saw scroll work and curved glass technology.

on 2nd floor south wall. Front porch with unique bulbus turned columns.

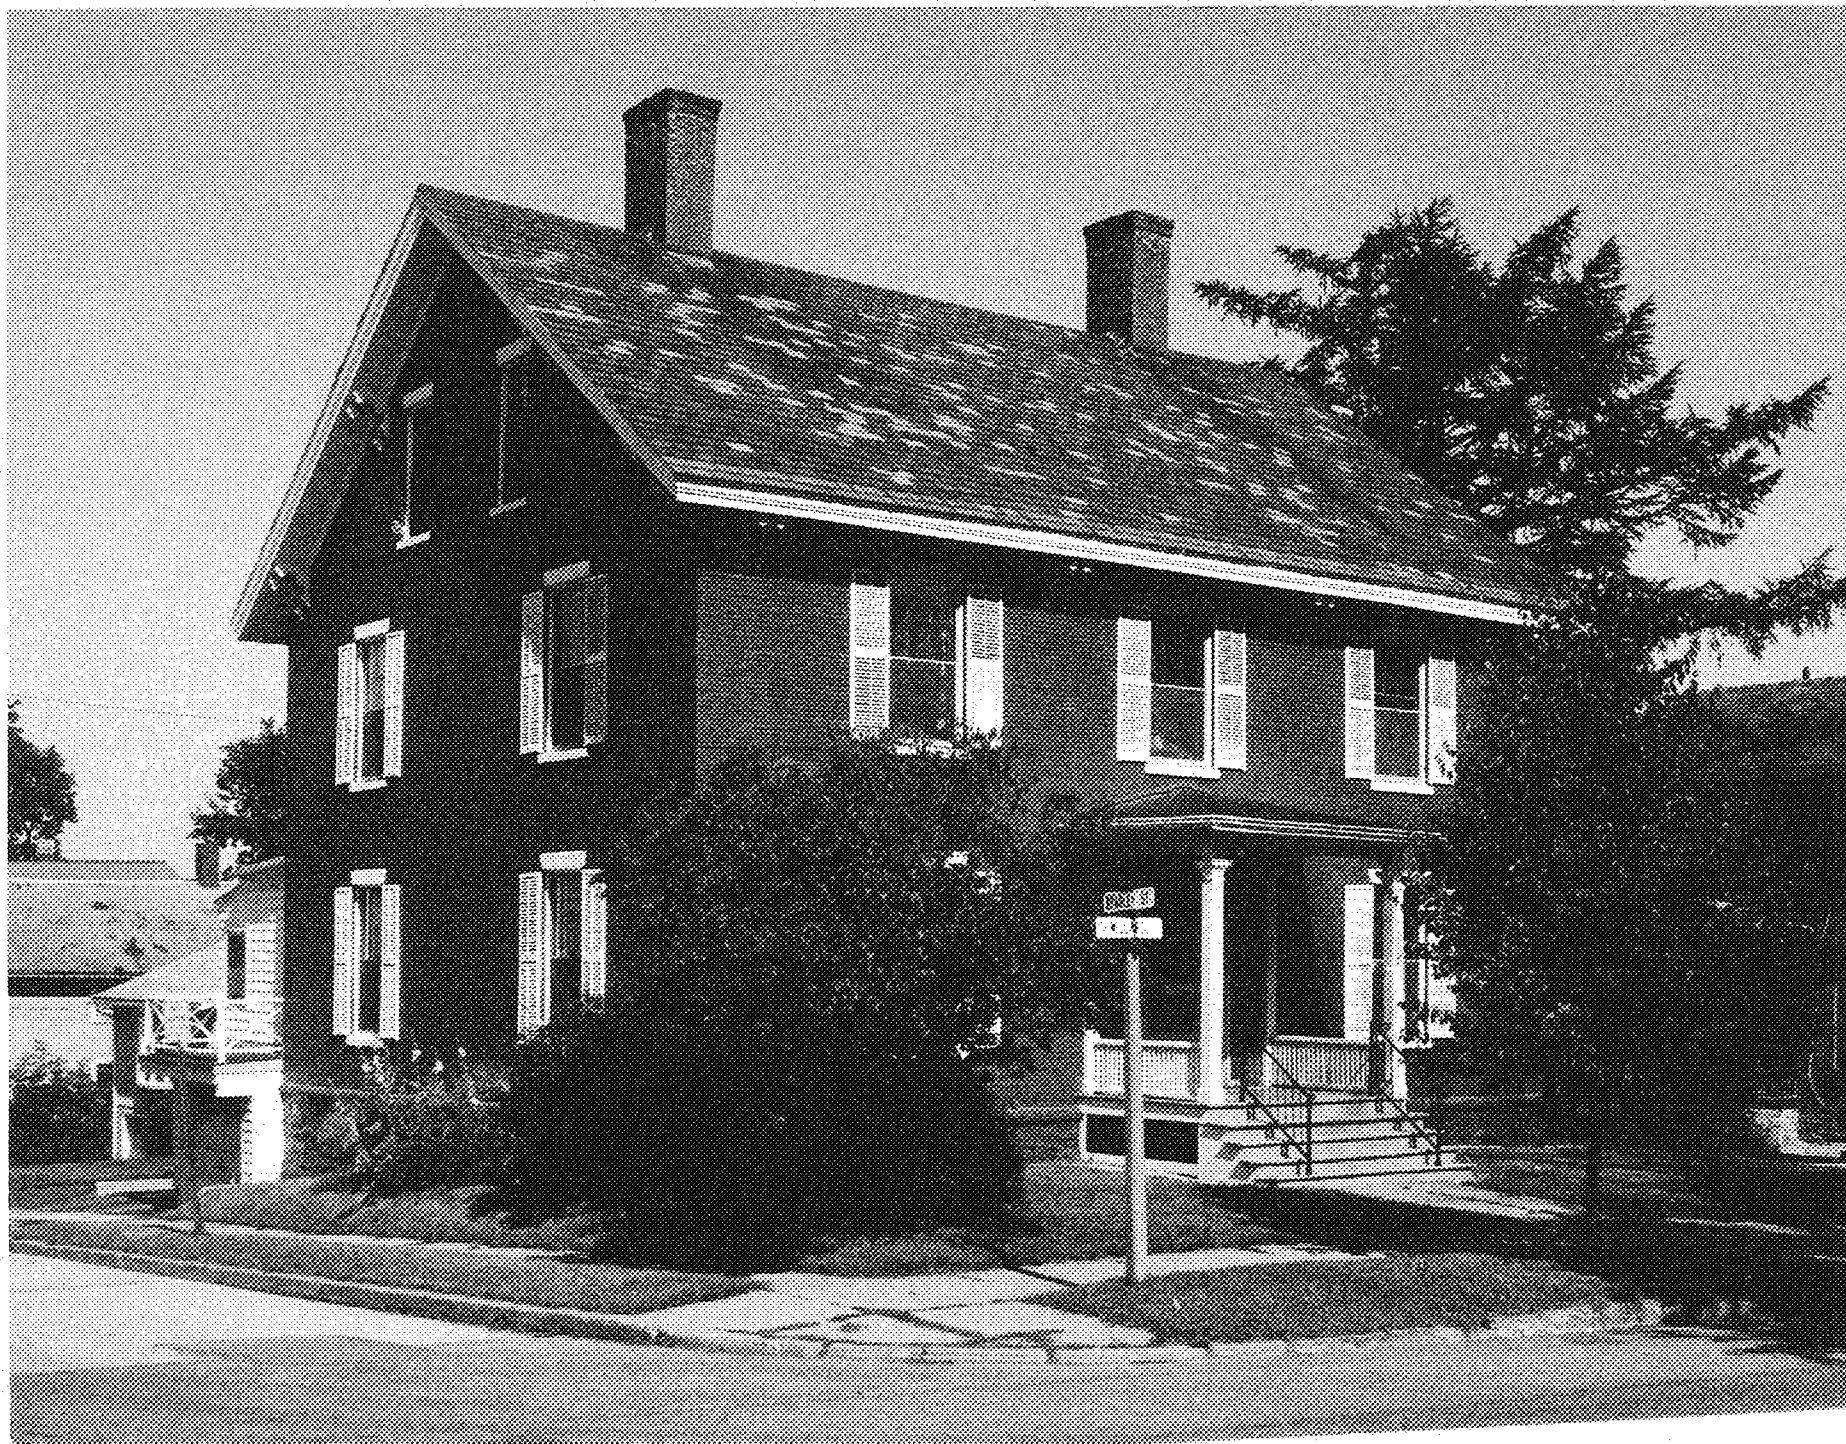
71 So. Willards St

This building was built in 1867 to house the 3rd Congregational Parsonage. It is an interesting combination of styles. The orientation, massing and two inside chimneys are reminiscent of Federal Style; the doorway and 6/6 windows are Greek Revival; the cornice with paired brackets is Italianate; the newell post and oval window are also Italianate. It is a unique conglomeration of styles not usually found in buildings of this period.
