96-98 So. Sillard
	NEGATIVE FILE NUMBER: 77-A-197
1 0	
STATE OF VERMONT	UTM REFERENCES:
Division for Historic Preservation	Zone/Easting/Northing
Montpelier, VT 05602	
HISTORIC SITES & STRUCTURES SURVEY	U.S.G.S. QUAD. MAP:
Individual Structure Survey Form	
	PRESENT FORMAL NAME:
COUNTY: Chittenden	ORIGINAL FORMAL NAME:
TOWN: Burlington	
LOCATION:	PRESENT USE: dwelling
	ORIGINAL USE: doctors offices & dwelling
	ARCHITECT/ENGINEER:
COMMON NAME:	
	BUILDER/CONTRACTOR:
FUNCTIONAL TYPE: dwelling	
OWNER: Yvonne Turk Estate	PHYSICAL CONDITION OF STRUCTURE:
ADDRESS: 98 So. Willard St.	Excellent Good
	Fair Poor D
ACCESSIBILITY TO PUBLIC:	THEME:
Yes No Restricted	STYLE: Greek Revival - altered
LEVEL OF SIGNIFICANCE:	DATE BUILT:
Local State National	ca. 1832
GENERAL DESCRIPTION:	
Structural System	
	☐ Concrete ☐ Concrete Block ☐ ☐

118 South Willard Street

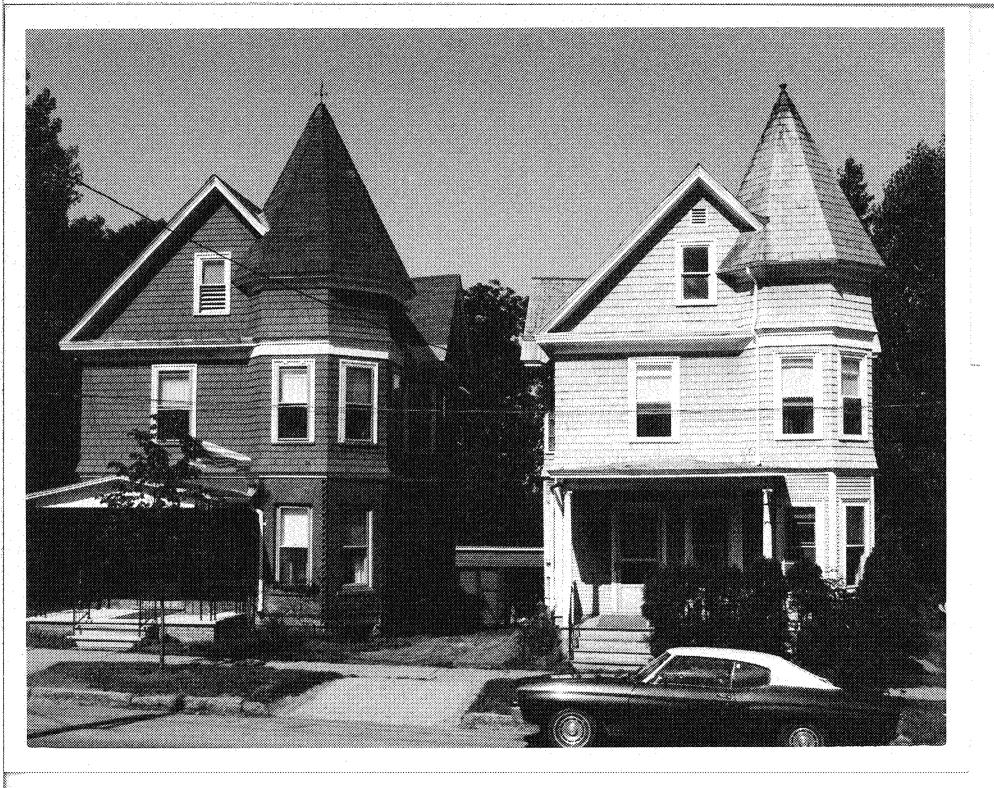
125 - 129 So Willard St 77 A 195 CS.

ADDITIONAL ARCHITECTURAL OR STRUCTUR	AL DESCRIPTION:
Massing - rectangular block with pedimento by a 2 story polygonal tower with polygona finial. 2 1/2 story canted bays with pedi-	al roof with sail boat weathervane imented gables project from the S. & N
walls. A rear shed had been attached to Fenestration - 1/1 sash, quarrel window or	n S. wall bay. Cornice - molded box
cornice with facia board. Entrance - pane first story, shingled 2nd & 3rd.	el door with glazed top half. Brick
DELATED CEDUCATIONS. Lauged brick vouses	ing ag window and down hands. We
RELATED STRUCTURES: Gauged brick vousso brick joints at canted corners of bays. H	oirs as window and door heads. Hinged Brick watertable course.
STATEMENT OF SIGNIFICANCE:	
neighbor #125 So. Willard and represents s	ntical in floor plan and elevation to its peculative building at the turn of the
century. The first residents were William	Watt, a student, and his mother in 1911.

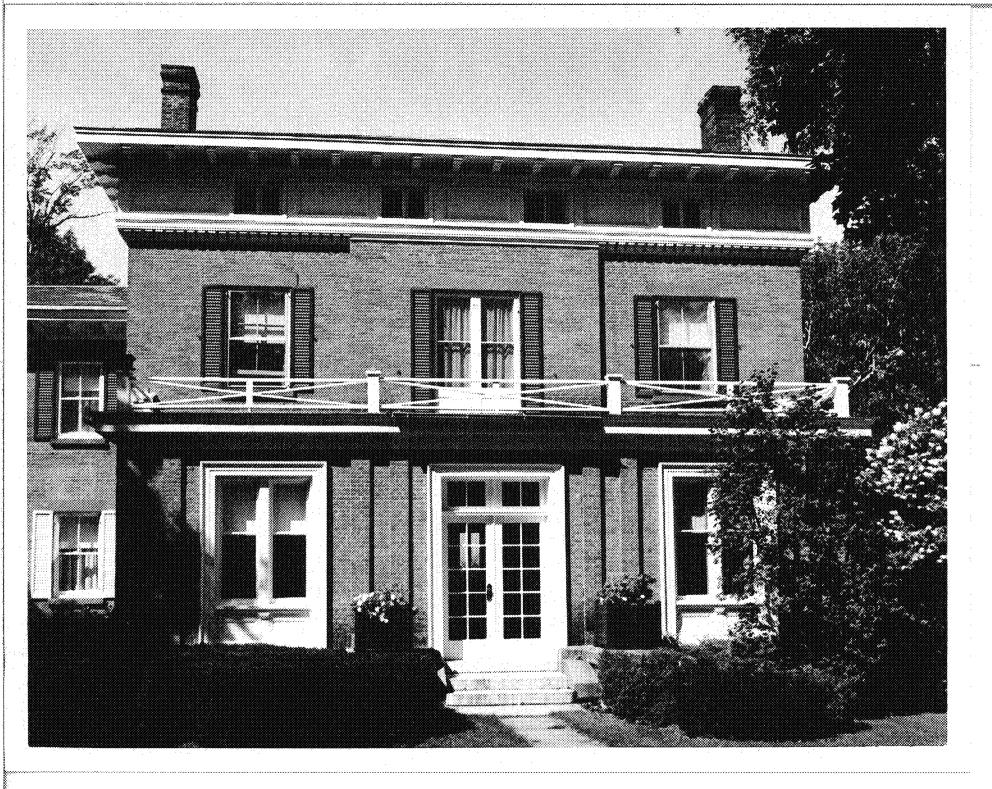
251 So. Willard 77 A 213 CS

Beautifully patterned red & blue slate roof. Huge yard.

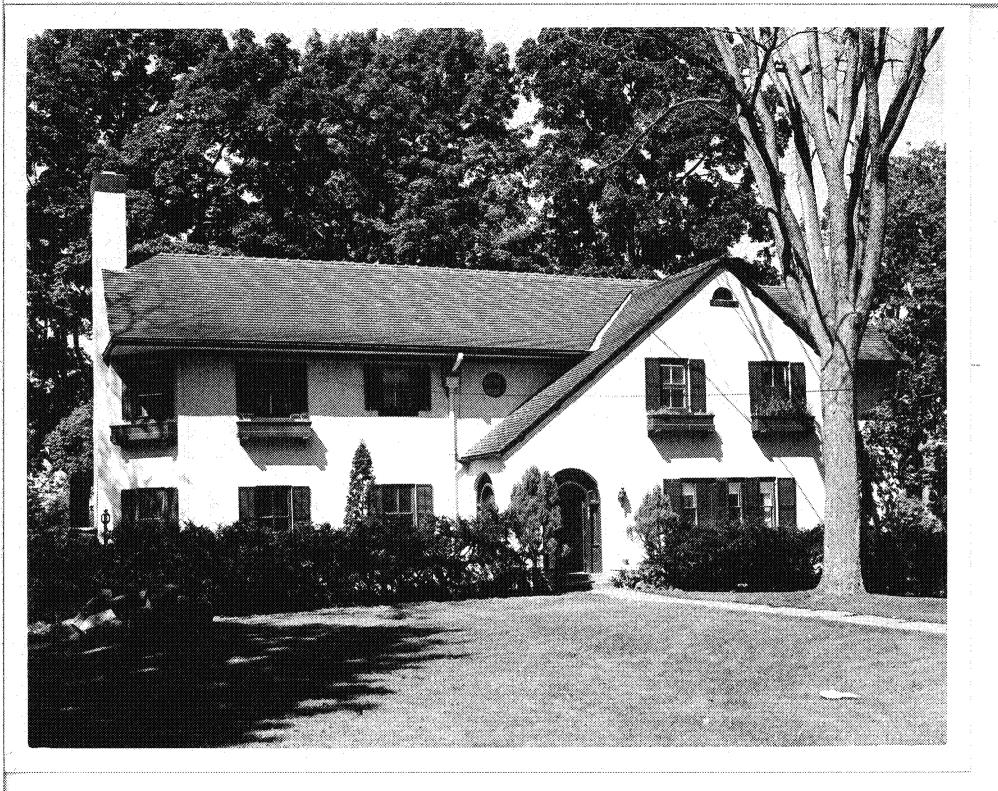
267 So Willard 77A213 es

ADDITIONAL ARCHITECTURAL OR STRUCTUR	AL DESCRIPTION:
Massing - rectangular block with main face projects from facade containing entrance. from west wall. Corners of south wall, me on west wall.	2 1/2 story rear gable bay projects
Fenestration - 2/2 sash. Entrance - round headed surround with 1/2 Cornice - overhanging box cornice with stu	sidelights. Door with quarrelled window accoed soffits. Variation of dentils
where soffit and wall meet. Tile roof. 2	
RELATED STRUCTURES:	
STATEMENT OF SIGNIFICANCE:	
This elegant residence reflects the manufacturers. Though it was bus grand and well designed as its 19th centur was built for Addison Buell in 1917. Buel Co., box manufacturers. This residence is and deserves attention because of that. I attitude, going to W. Y. C. for architects	ry counterparts along the street. It ll was the president of the Horatio Hickok s certainly a one of a kind in Burlington It represents a growing cosmopolitan

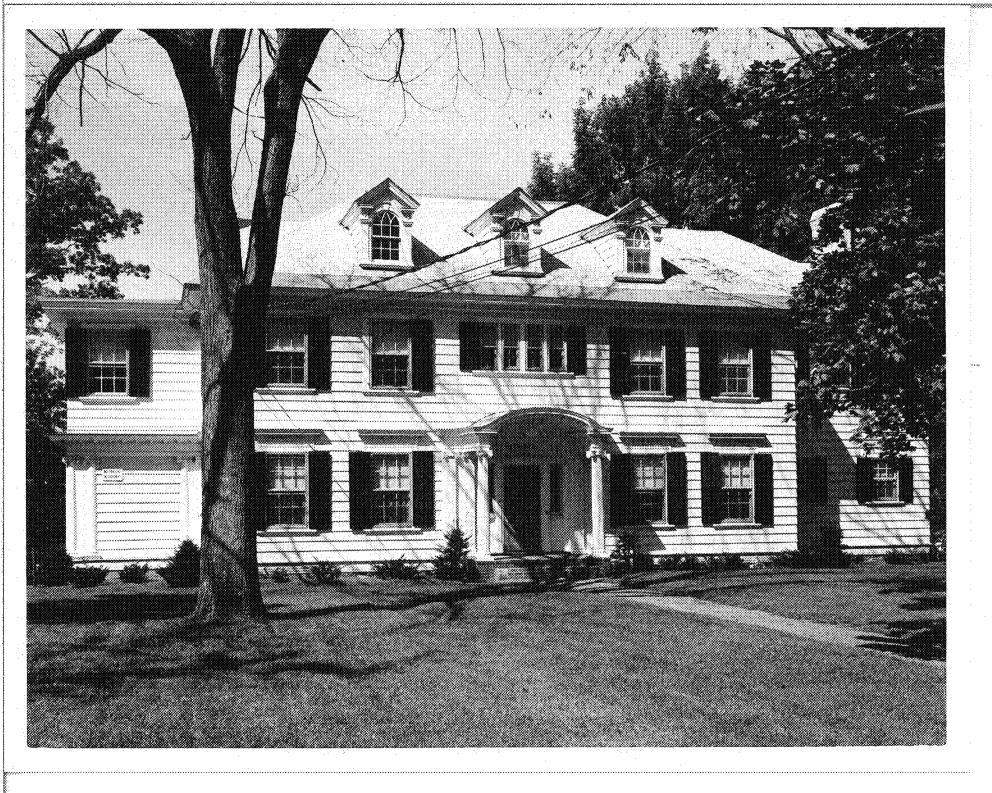
275 So Willard 77 A 213 C5

DDITIONAL ARCHITECTURAL OR STRUCTURA	AL DESCRIPTION:
Massing - rectangular block with hipped ro	
roof 2 story wing off north side. 2 story	
south side. Gablet around end chimneys.	
Fenestration - 6/6 sash with elevated comp	
with round headed window sashes.	
Entrance - elliptical shaped roof on entra	nce porch. Modillion dentil cornice on
porch. Supported by 2 fluted scomozi cap.	
wall. 2 panel door with 2 lights at top f	
Denticulated door cornice. Cornice - box	cornice with aluminum soffits.
RELATED STRUCTURES:	
Scomazi capitals on all porch colu	mns, south wall and west wall.
STATEMENT OF SIGNIFICANCE:	
This classical colonial revival resident	ence was built for Roy Leonard Patrick.
It is of a standard georgian plan with impo	ortance given to detailing and massing.
Patrick was the treasurer of G. S. Blodget	
when he had the house built. He was extrem	mely business oriented and within 15
years of the errection of this house was no	ot only in these same positions but also

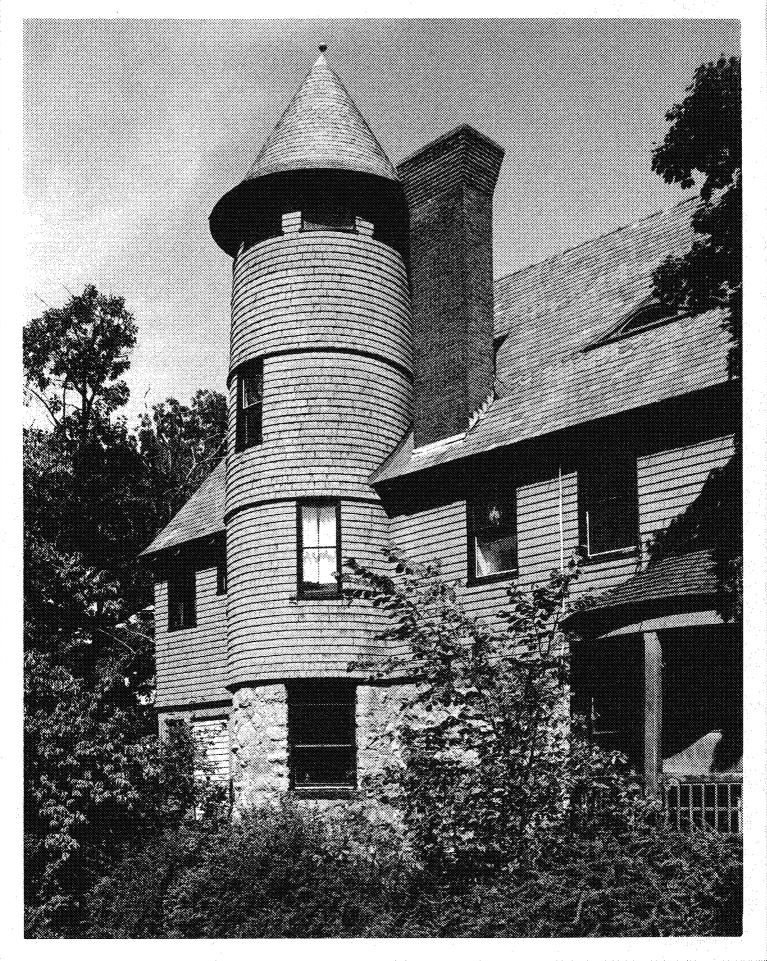
285 So. Willard 77 A 32/3

ADDITIONAL ARCHITECTURAL OR STRUCTURAL DESCRIPTION:		
Massing - rectangular block with main factories. Steep gabled dormer with Palladia 2 story swelled bay window. Large gabled story conical roofed porch on SE corner. roof on SW corner. Oriel window on N wall with 2 car garage. Fenestration - 1/1 sash with transom wind windows on S. slope. Stained glass on fa RELATED STRUCTURES: Redstone 1st story corbelled tops.	cade orientation. Right side of main roof in style window. Center of facade has a wall dormer on left side of facade. 1 Large 4 story round tower with conical 1 and porte cochere. Enclosed porch on wow on all 1st story windows. Eyebrow	
STATEMENT OF SIGNIFICANCE:		
This rambling shingle style - colonic Ballard, a Burlington Attorney and states H. H. Richardson, who had just completed I stone walled first story with its wide routrait. Clellan Fisher who likely designed in Albany and was thus well versed in the Romanesque style of Richardson. Henry Ballard built several houses in new house and then moved about every ten y dence and Frank Wells of the Wells & Richardson tant secretary in his fathers business. I becoming the home of Frank D. Abernathy, a of Abernathy's department store. He is rebusiness in Vermont in 1912.	Intings Library the year before. The and arched entrance is a Richardson this residence had received training styles of the times - especially the Burlington. It appears that he built a rears. In 1902 Ballard vacates this residration Co. moves in. Wells was the assisted on 1917 the house changes hands once again prominant dry goods merchant and owner eputed to have had the largest dry goods style to 258 and 301 So. Willard St.,

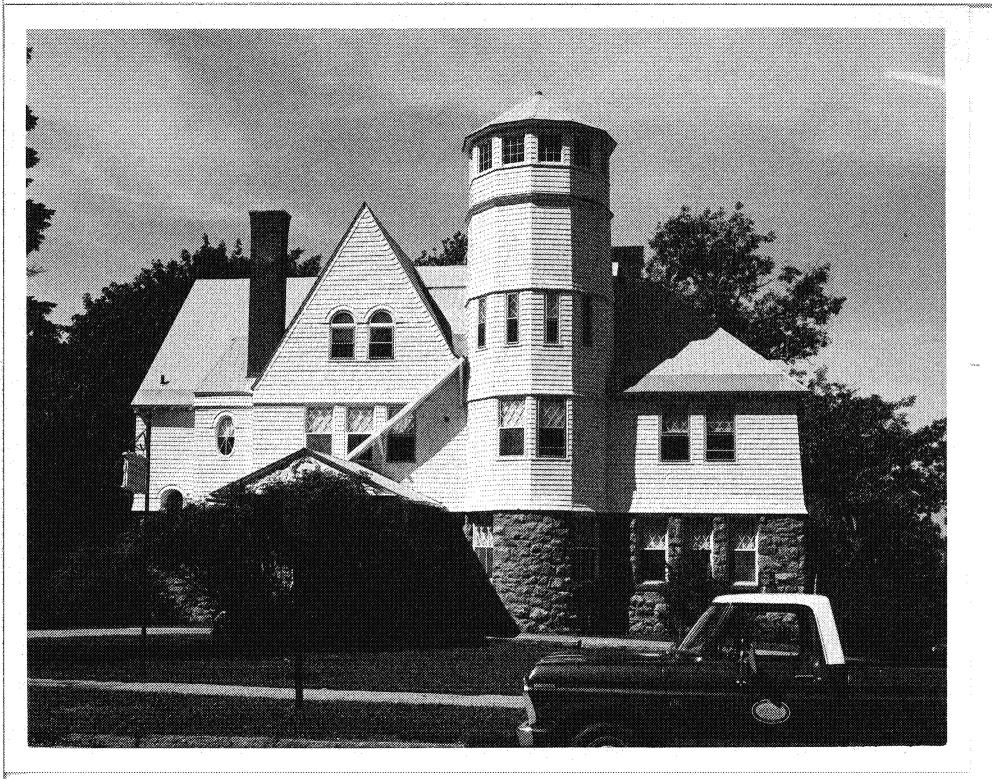
301 So. Willard 77 A 213 CS

round columns. Gable end of porte cochere has elaborate metal work delineating floral patterns.

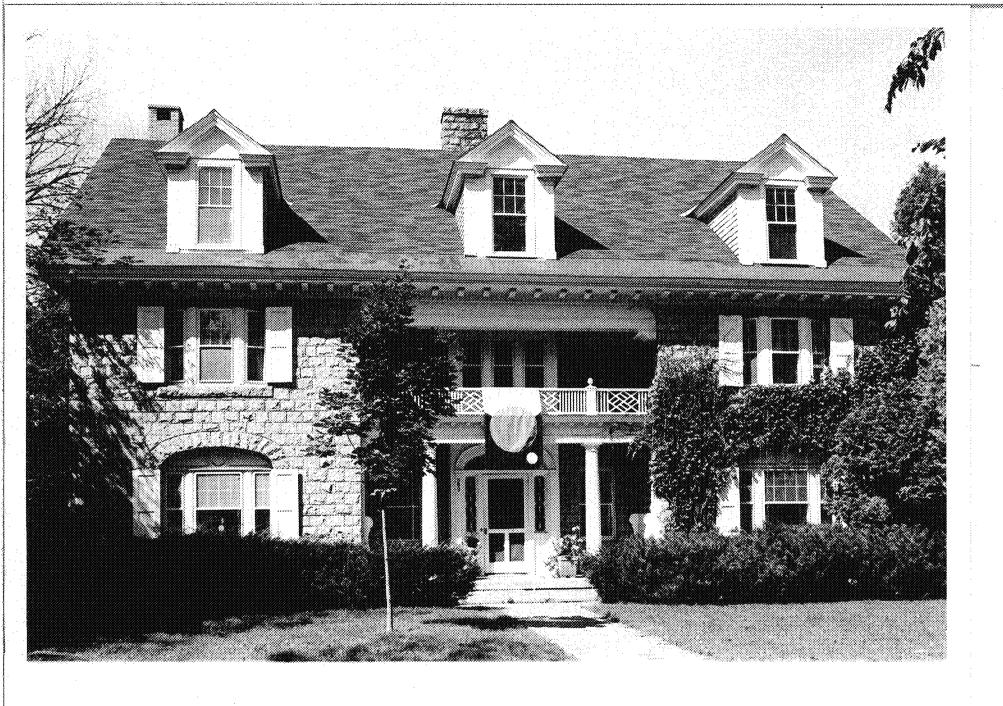
309 So Willard 77 A 213 CS

gable end. Complete structure of Barre granite. Palladian style window in gabled end on south wall.

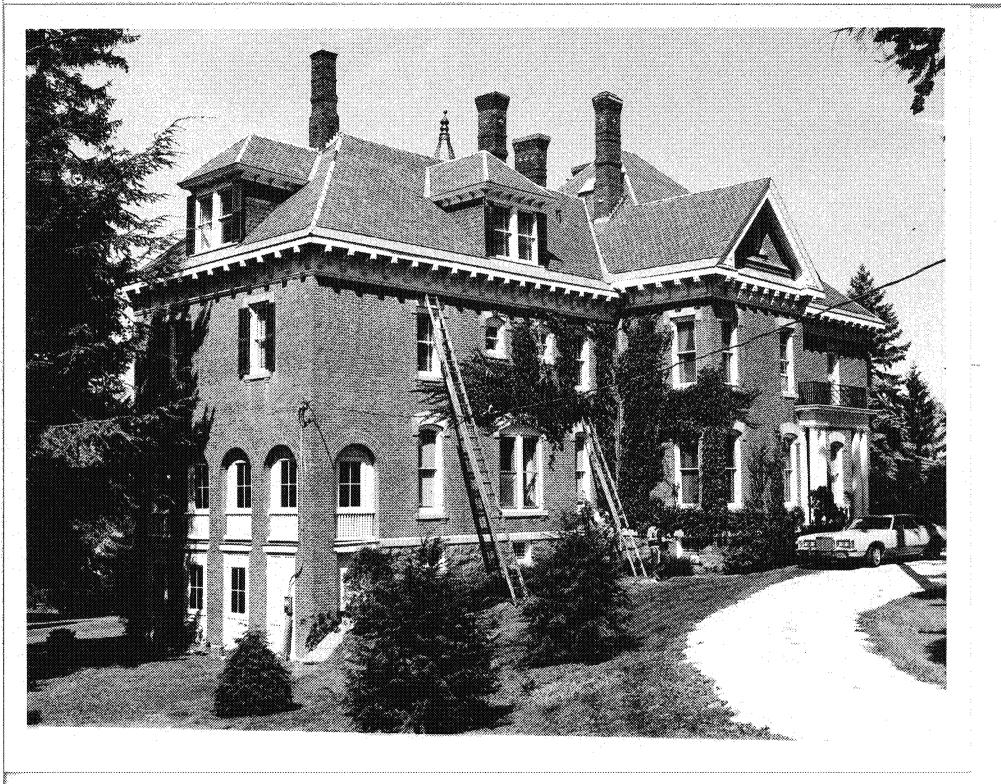
349 So. Willard 77 A 213

Cornice - bracketed cornice. Brick frieze with ornamental terra cotta. Isle la motte belt course above foundation. Interior in excellent condition. Carved vergeboards in each gabled end.
