TOWER TERRACE

HISTORIC SITES & STRUCTURES SURVEY
Individual Structure Survey Form

SURVEY NUMBER: 2 Tower Terrace
NEGATIVE FILE NUMBER: 77-A-213
UTM REFERENCES: Zone/Easting/Northing
U.S.G.S. QUAD. MAP:
PRESENT FORMAL NAME:
ORIGINAL FORMAL NAME: carriage house for 301 So. Willard
PRESENT USE: dwelling
ORIGINAL USE:
ARCHITECT/ENGINEER:
BUILDER/CONTRACTOR:
PHYSICAL CONDITION OF STRUCTURE: Excellent <input type="checkbox"/> Good <input checked="" type="checkbox"/> Fair <input type="checkbox"/> Poor <input type="checkbox"/>
THEME:
STYLE: shingle
DATE BUILT: 1895

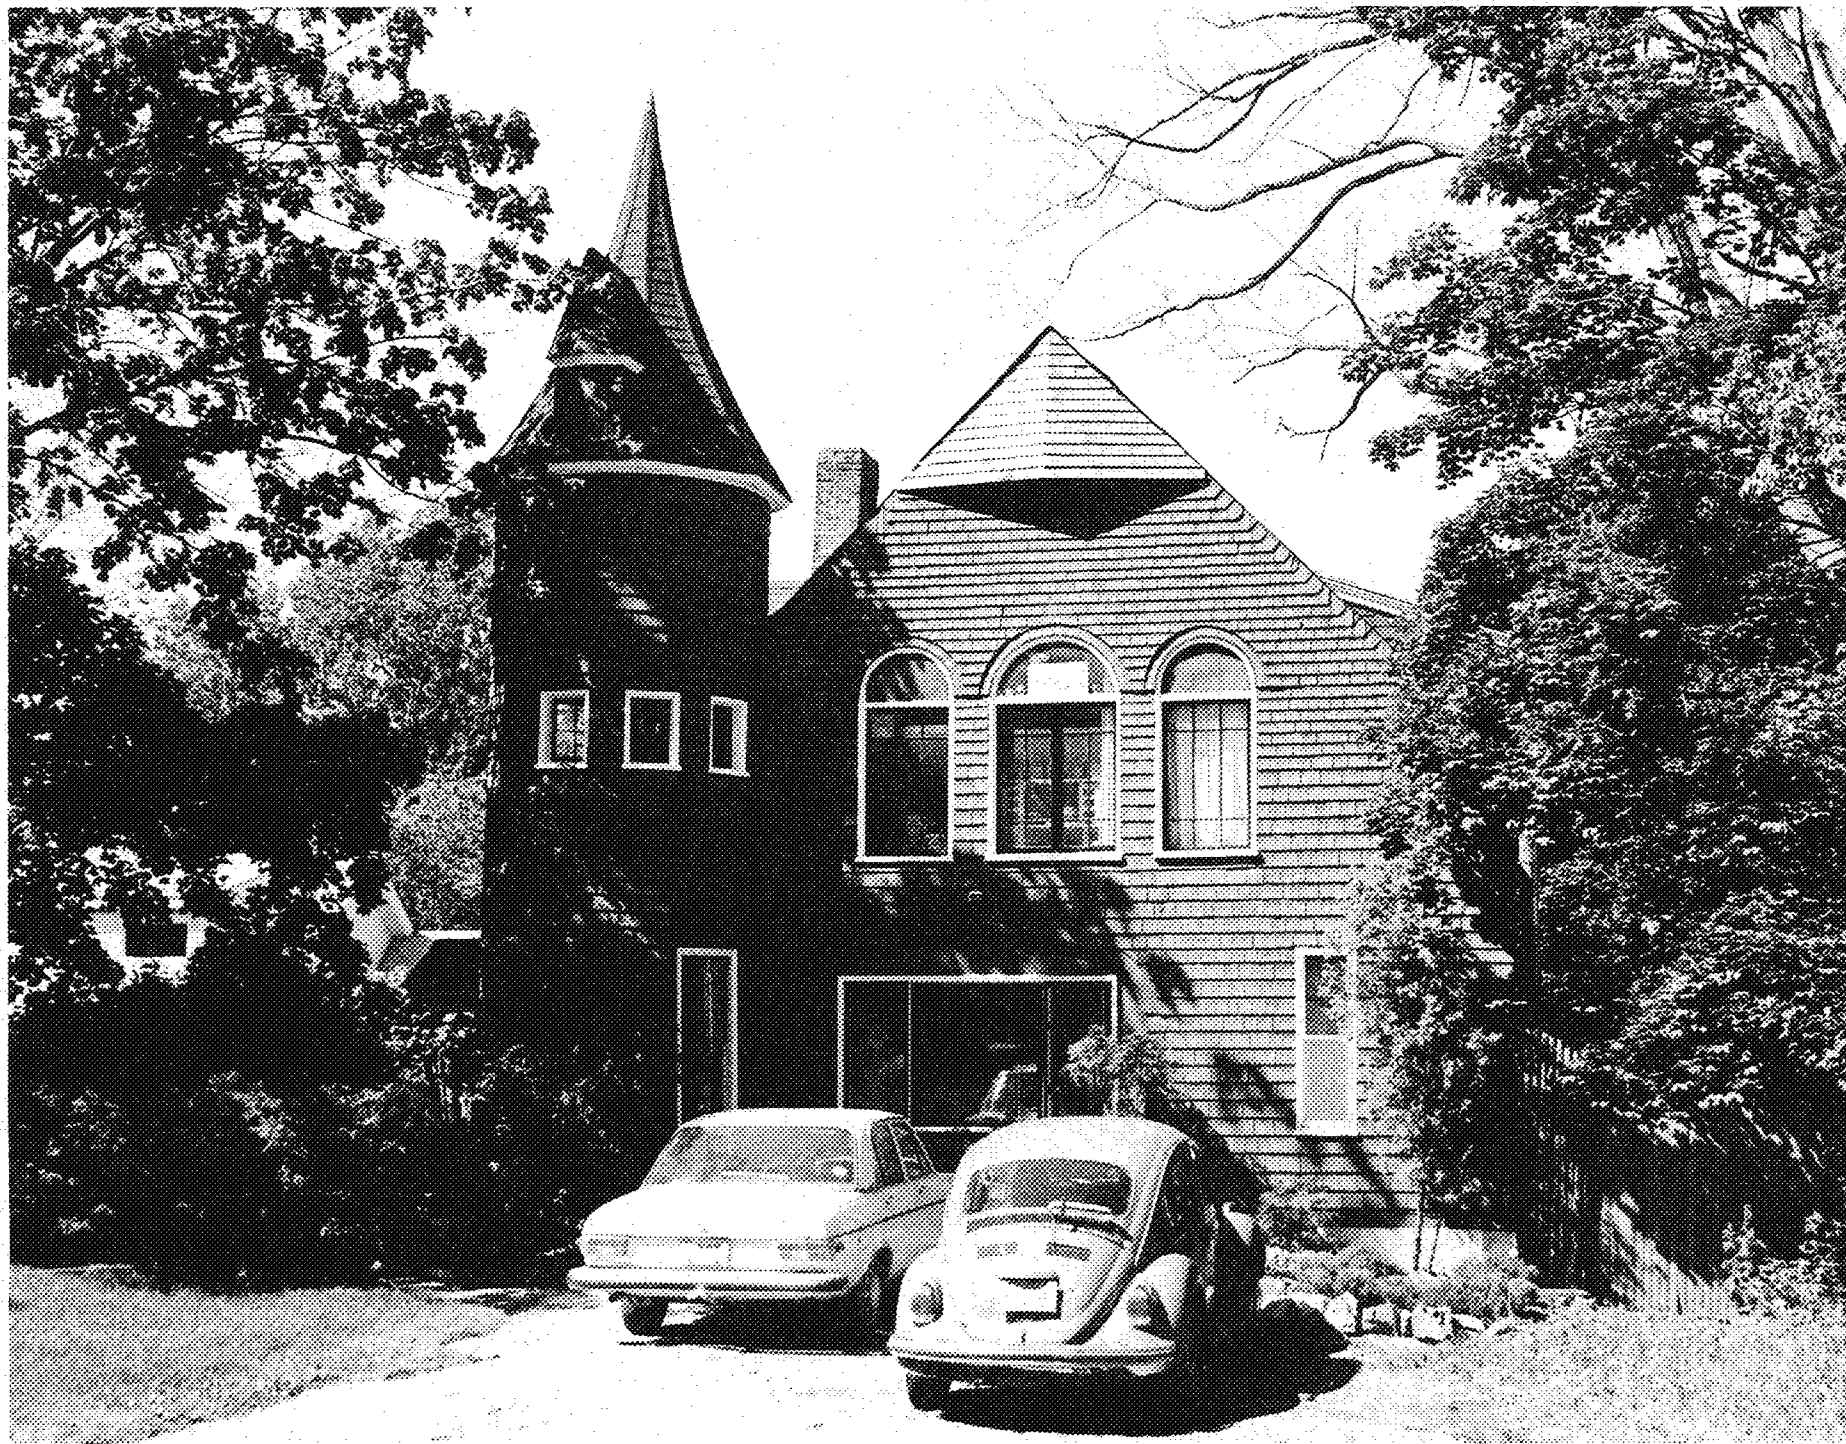
77 A 213

Massing - rectangular block with gable end orientation. 2 story round tower with polygonal belcast pointed roof with small steep hipped roof dormer. Large shed dormer on north wall.

Fenestration - 6/1 skinny sash. 3 round headed multi-pane windows on facade 2nd story with sawtooth shingle heads. Entrance - old carriage entrance with elliptical head has been converted to windows.

Cornice - molded wood cornice. Gable ends have slight roof screens. Converted to house.

2 Tower Terrace (301 So. W. Ward)
