SURVEY NUMBER:
		16 So. Winooski Ave.
· /	7A	NEGATIVE FILE NUMBER: 77-A-214
		UTM REFERENCES:
		Zone/Easting/Northing
		Zone/Easting/Northing
iden (	The second secon	
		U.S.G.S. QUAD. MAP:
	2 2	2
F-(0	A. A	PRESENT FORMAL NAME:

***		Congregational Parsonage
	COUNTY: Chittenden	ORIGINAL FORMAL NAME:
	TOWN: Burlington	Congregational Parsonage
	LOCATION:	PRESENT USE: Parsonage
l		ORIGINAL USE: Parsonage
ļ	COMPON MANUEL	ARCHITECT/ENGINEER:
	COMMON NAME: Congregational Church Parsonas	DULL DED (COMBDACHOD)
	FUNCTIONAL TYPE:	71
<u> </u>	OWNER: Congregational Church	A. B. Fisher PHYSICAL CONDITION OF STRUCTURE:
}	ADDRESS: 38 S. Winooski Ave., Burlington	
	ADDRESS: 30 2. WILLOUSE RIVER, DELILING BOIL	Fair Poor
<u> </u>	ACCESSIBILITY TO PUBLIC:	THEME:
	Yes No Restricted	STVI.F. Tholianaha
ŀ	LEVEL OF SIGNIFICANCE:	DATE BUILT: 1877
	Local State National	1877
ľ	GENERAL DESCRIPTION:	
	Structural System	
		☐ Concrete ☐ Concrete Block ☐

SURVEY NUMBER: 38 S. Winooski
	NEGATIVE FILE NUMBER: 77-A-214
STATE OF VERMONT	UTM REFERENCES:
Division for Historic Preservation Montpelier, VT 05602	Zone/Easting/Northing
HISTORIC SITES & STRUCTURES SURVEY Individual Structure Survey Form	U.S.G.S. QUAD. MAP:
	P

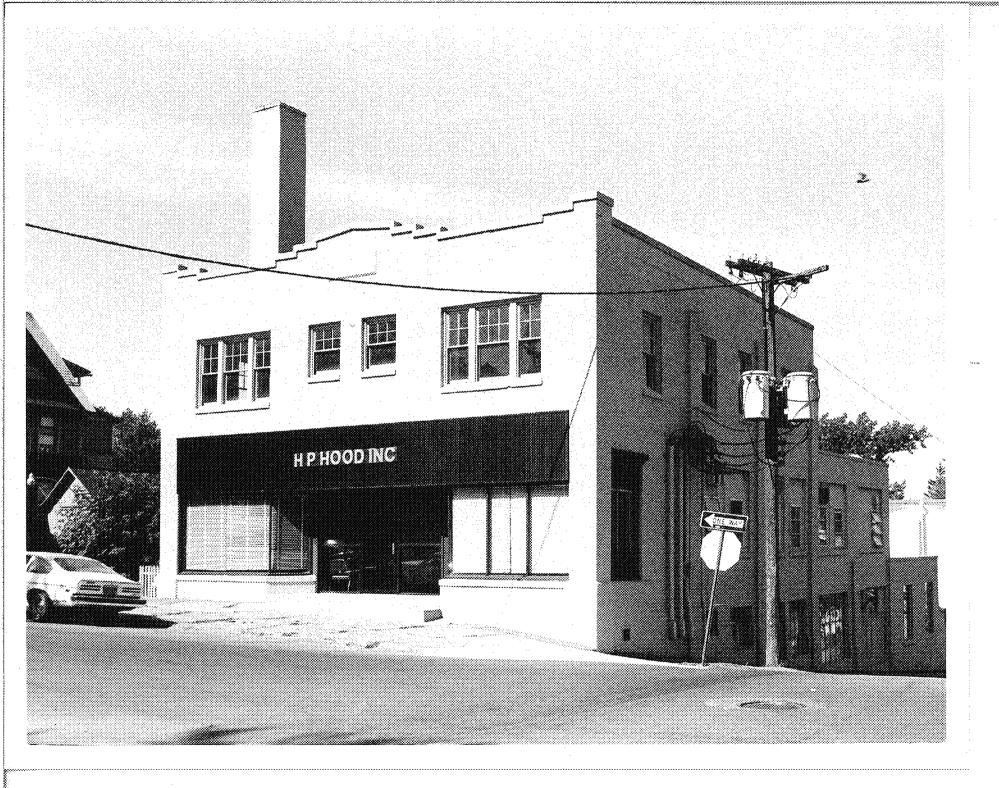
187 So Winovski Ave 77 A 198 C.S.

roof structure with brick-metal sheet siding and sheet metal roof. 1 1/2 story clapboarded 3 bay gable roof shed with asphalt & slate - pre 1889.

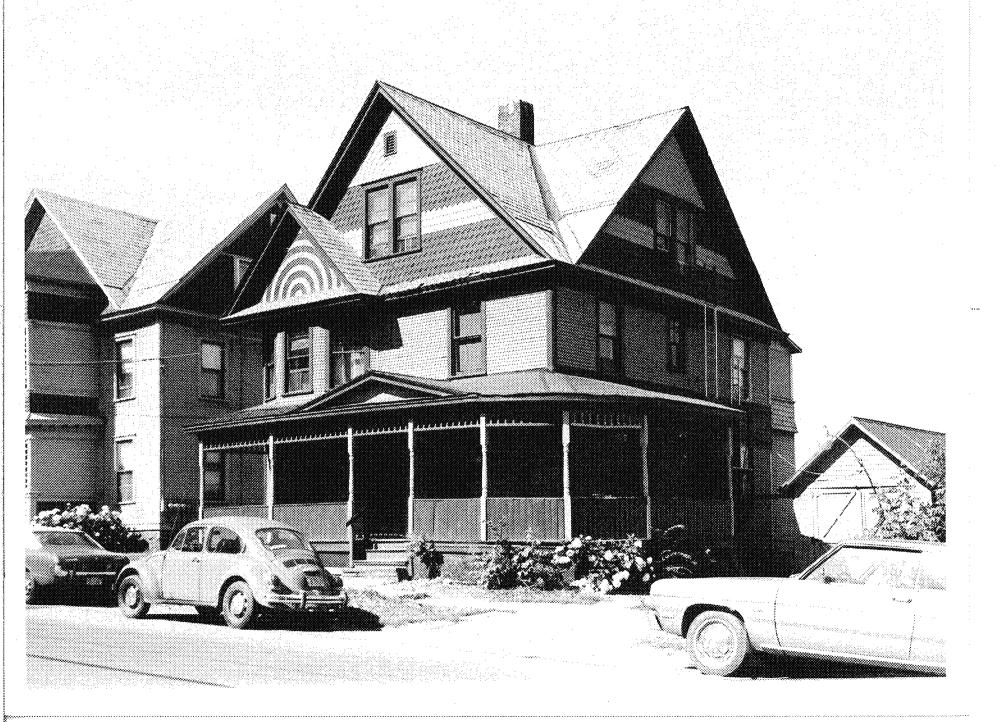
197 So. Winooski Ave 77 A 198 CS.

nating colors in banding. Concentric semi-circles of shingles in each gable end. <u>Porch</u> - turned posts, baluster valance, verticle bd. skirt.

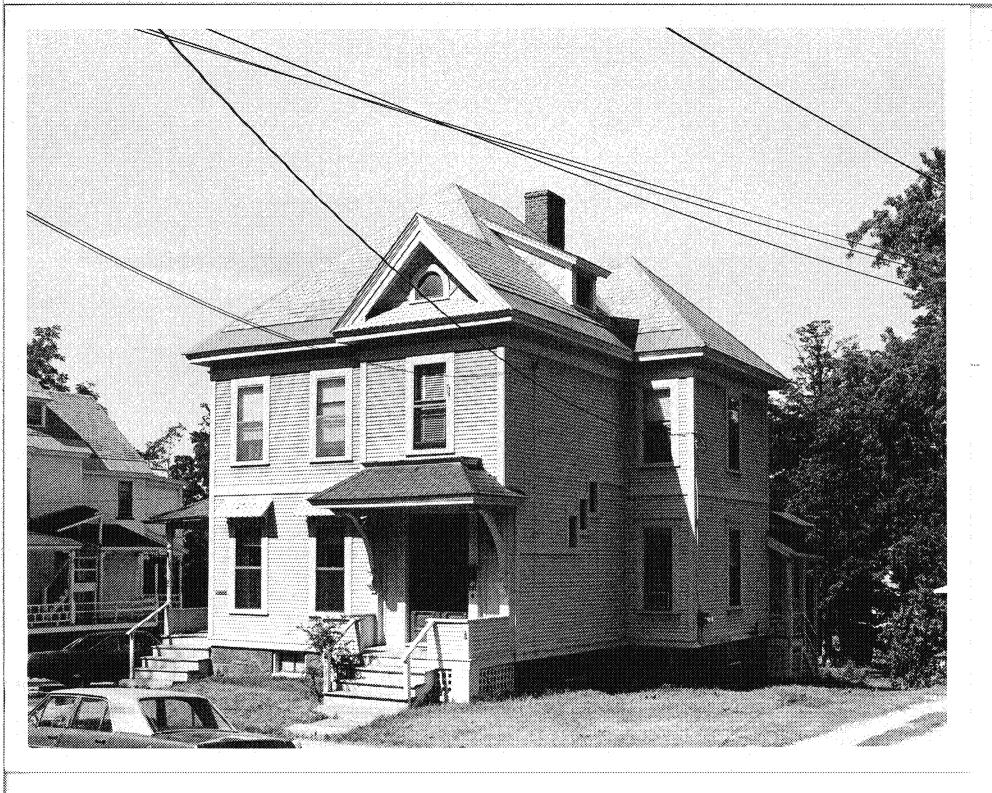
241 So Winooski Ave 77 A 199

Cornice - molded, box cornice with frieze & architrave.

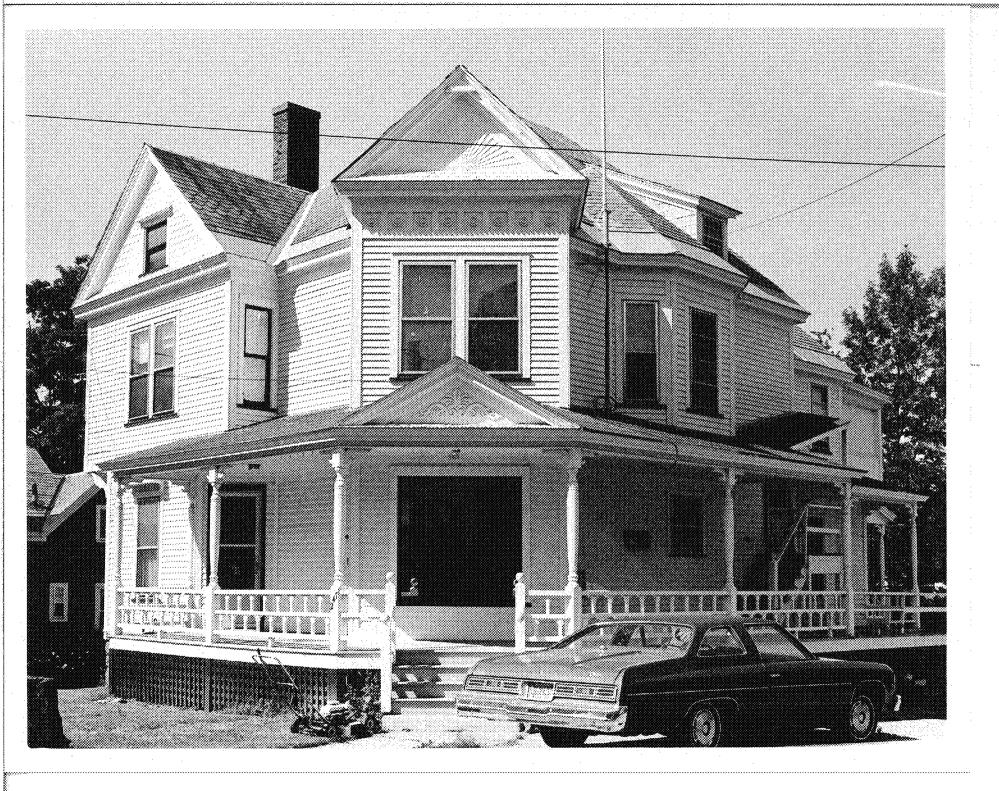
247 So. Winooski Ave 77 A 199 CS

over porch stairs. Shingled shed projection over 1st story window (facade) and in gable angle brackets. Porch with Queen Anne turned columns & brackets. 2 tier balustrade.
